Fire in hydrocarbons depot

14th June, 1991

Saint Ouen - [Seine-Saint-Denis]

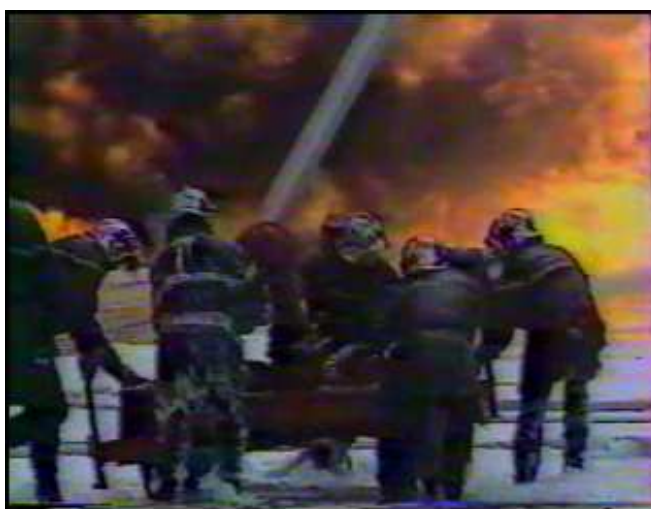
Friday 14th June at 11h15, a flash followed by a fire in a sheet of gasoline on the ground suddenly occurred close to the operators. Surprised, the workers turned around and saw their generator surrounded by flames. They immediately attempted to extinguish the fire with their extinguishers but it became too violent and spread rapidly over 100 m² of the ground. On being informed, the manager of the depot initiated the "POI" (Internal Operation Plan): he alerted the fire brigade on a direct line and initiated the emergency stop which commands the closure of all motorised valves in the depot in between 45 and 60 seconds, also cutting the general electricity supply. He also warned the depots in the Paris region, in the framework of the inter-oil company agreement, so that they could place at his disposal a part of their specific fire-fighting facilities, (essentially consisting of fire-hoses and reserves of emulsifier). Simultaneously, the 10 men present in the depot set up a water cannon and turned on the pressure booster pump of the internal fire network.

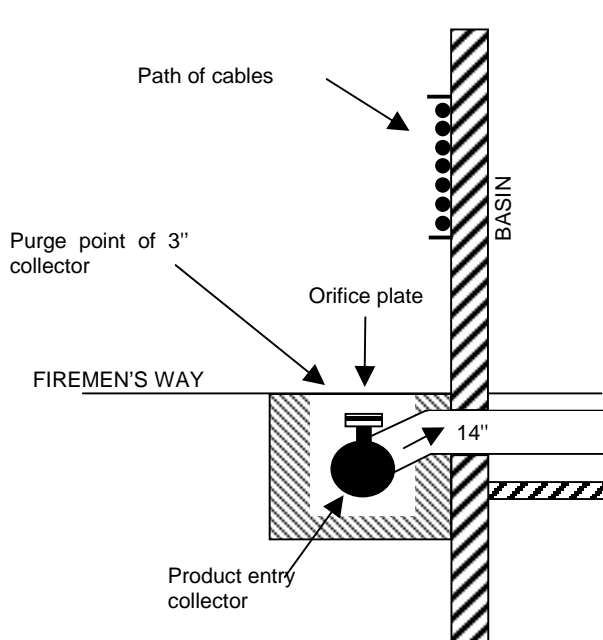
Diagram of purge

to the point of the fire and situated outside the bunds. These maintenance purge points consist of a pipe ending some thirty centimetres below ground level and sealed with a liquid proof orifice plate, retained by 4 bolts.

Under normal conditions

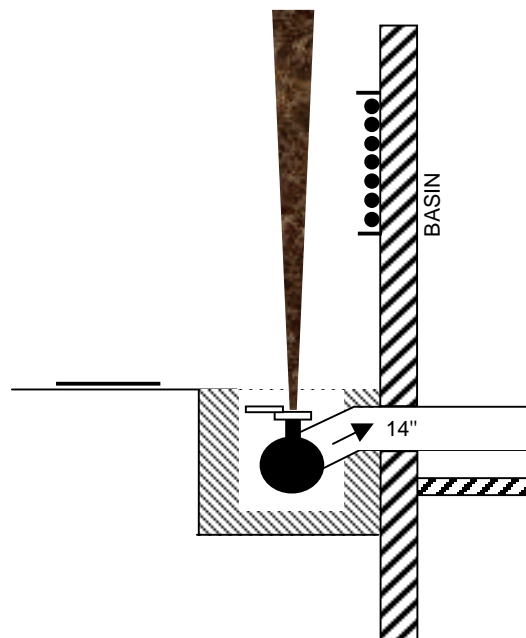
The product escaped through one of these purge points which was badly closed, (only 1 bolt tightened of the 4 bolts). The leak was of super grade gasoline (flow-rate : 150 m³/h) from tank N°1 which the bottom valve remained open despite the remotely controlled emergency shut-down.

During the incident

The following hypothesis has been retained: on Thursday evening, at the end of the day's work, the closing seal of a maintenance purge point was put back into place but only one bolt was used. On the 14th, the entry valve to tank 1 was found open for an unknown reason. The gasoline contained in the tank flows at a rate of 150 m³/h and the pressure causes the orifice plate of the purge point to pivot. The gasoline then squirted out and its vapour was ignited by a spark generated by the welding work in progress near by.

- ✓ Modification of the purge points (manual valve with visualisation of position, bunds, position above ground);
- ✓ 15 minute backup for control panel;
- ✓ Minimum fire-resistance of cables supplying power to valve motors increased 10 min;
- ✓ Backup of motorised valves by fuse operated shutters;
- ✓ Additional emergency shut-down buttons dispersed throughout the installation;
- ✓ Installation of 3 additional fire hydrants;
- ✓ Installation of a fixed conduit around the depot to avoid the requirement for numerous flexible hoses in the event of fire;
- ✓ Increase of the flow of water for fire-fighting (either by a pipe from the SEINE or a renewable reserve or any other means...);
- ✓ Revision of the Plant Operating Plan to take into account 5 additional accident scenarios.

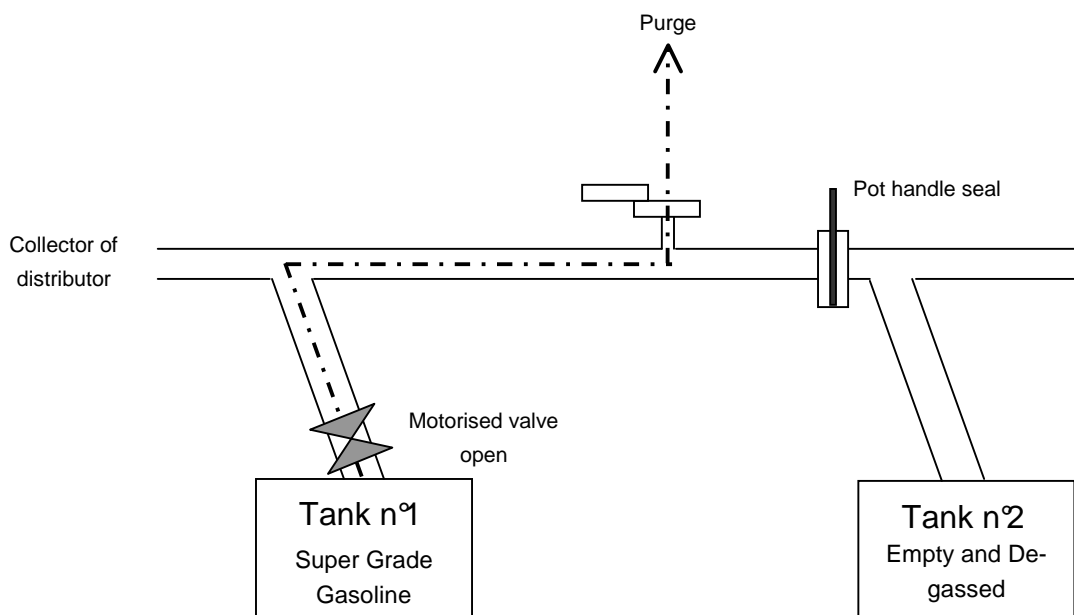
Piping diagram

15h53 : while the operation of suffocating the fire was starting to show results, it was observed that the valve at the foot of tank N°1, containing super grade gasoline, was open . It led to a conduit of which the purging orifice, precisely positioned at the spot from which the flaming leak emerged, was open. As soon as this valve was closed, the fire suddenly calmed down and only a fire of low intensity persisted at the level of the conduit in the bund of tank N°2. The director of the depot declared that this conduit should have been water-filled, given that welding work was in progress on the "firemen's way" and that, for this reason, it was not part of the check-list for valve closures nor on the control panel check.

There exist buried conduits at a depth of approximately 2 m, to the right of the starting point of the fire. They serve to supply the tanks from the manifold of the transport terminal, situated at the entry to the depot and to feed from the tanks the loading points for the tanker-trucks. Considering several low points on these conduits, they are equipped with maintenance purge points used when work is required on the tanks or the piping and which allow for pumping with a gland pump any remaining liquids. There are around 15 inspection hatches (section : 50 cm x 50 cm) enclosing these maintenance purge points close
