Perforation of a gaseous fuel distribution pipe

22 December 2007

Noisy-le-Sec (Seine-Saint-Denis)

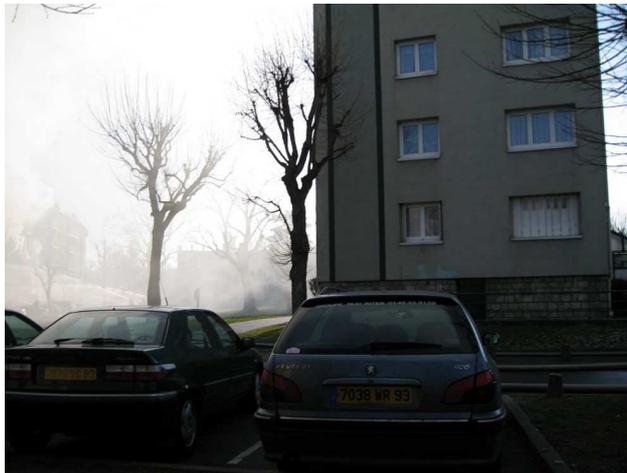
In the town of Noisy-le-Sec (Seine-Saint-Denis Department north of Paris), municipal gas supply is distributed by means of a public pipe network. The particular installation involved in this accident is the network supplying a group of buildings in the city centre within a so-called "private" district (i.e. non-subsidised housing).

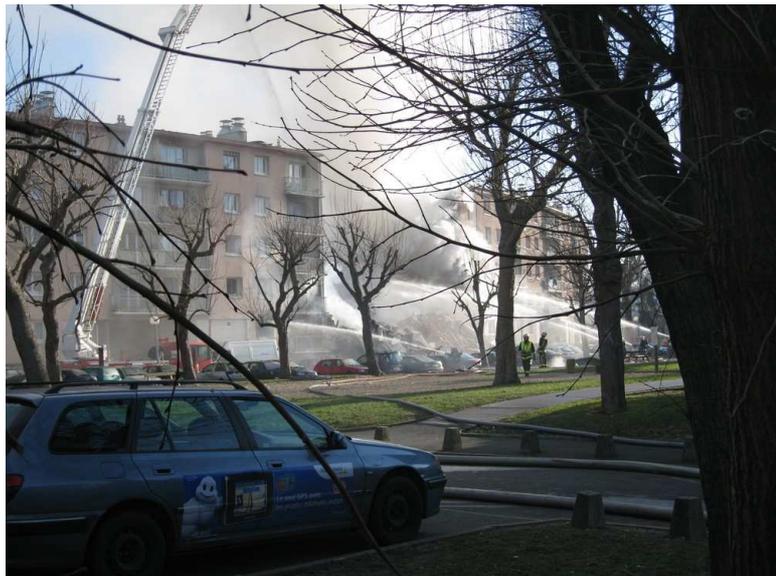
It must be emphasised that the building collapsed just 5 or 10 minutes after being completely evacuated.

Fire-fighters were heavily challenged to extinguish the fire that broke out following the two explosions. Of the entire housing block, both the central and right parts were totally levelled and burned. All building residents had to be relocated to alternative housing.

The window panes of buildings lying just opposite as well as those of a neighbouring school (empty at the time) were shattered.
