Fuel oil spill in an estuary during a transfer operation

March 16, 2008

**Donges – [Loire Atlantique]
France**

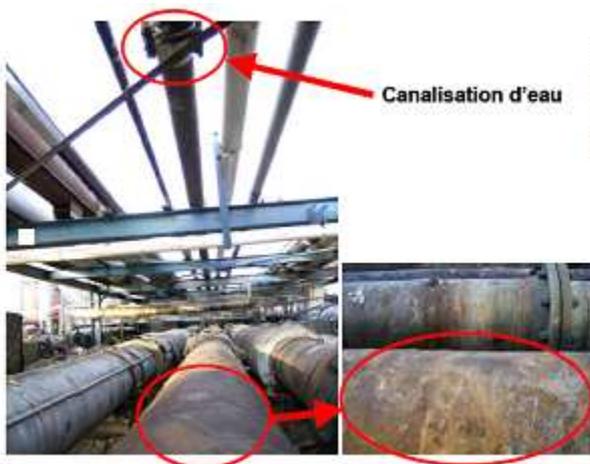
The defective pipe, 12 inches in diameter and lined with thermal insulation, was included in a group of facilities composed of some 20 pipes on two levels. An examination of the defective pipe section revealed the presence of a longitudinal crack approximately 16 cm long by 1 cm wide adjacent to observed local corrosion underneath the thermal insulator lining. Water flowing from a perforated pipe, positioned vertically with respect to the fuel oil pipeline, infiltrated under the leaky thermal insulation, first causing the steel to corrode and then perforating the pipe.
