Chlorine leak during connection of a rail tanker to prepare for an unloading operation

14 February 2008

**Château Arnoux - Saint Auban
(Alpes-de-Haute-Provence)
France**

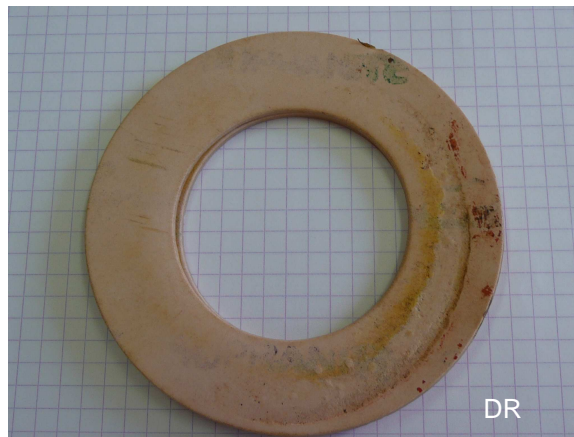
The origin of this accident can be traced back to a rupture of the transfer arm flange joint during a seal leak test.

- use of two 2-mm joints instead of one 4-mm joint,
- poor clamping of the sealing ring between the two liquid phase flanges,
- a seal leak test performed in an atmosphere containing chlorine and not nitrogen.

The use of two 2-mm joints instead of one 4-mm joint was due to the preferred product being out of stock. The technician responsible for performing this clamping operation was attending a training class under the supervision of the other two technicians, both of whom were not located nearby given the cluttered workstation configuration. The clamping operation using the bolting machine was unfamiliar. The technicians were not equipped with self-breathing apparatuses because the air compressor package only contained 2 outlets for 3 technicians. The water curtains were not automatically deployed; furthermore, technical staff from external companies was present in the sector during operations.

- a safety stock of the 4-mm thick joints was constituted, and a directive was issued prohibiting this type of operation from proceeding in the absence of the dedicated joint;
- a special training session devoted to assembling and clamping this type of joint onto test benches, with technician certification;
- reminder of the need for strict application of the guidelines both on wearing the self-breathing apparatus when opening circuits containing toxic products and on the proper procedure to follow when the number of breathing apparatuses falls short of the number of individuals present in the specific sector;
