## Disposal of wood treatment product

22<sup>nd</sup> April, 2008

Lannilis - Finistère

Toxic releases  
Wood treatment  
Water pollution  
Organization and  
human failure

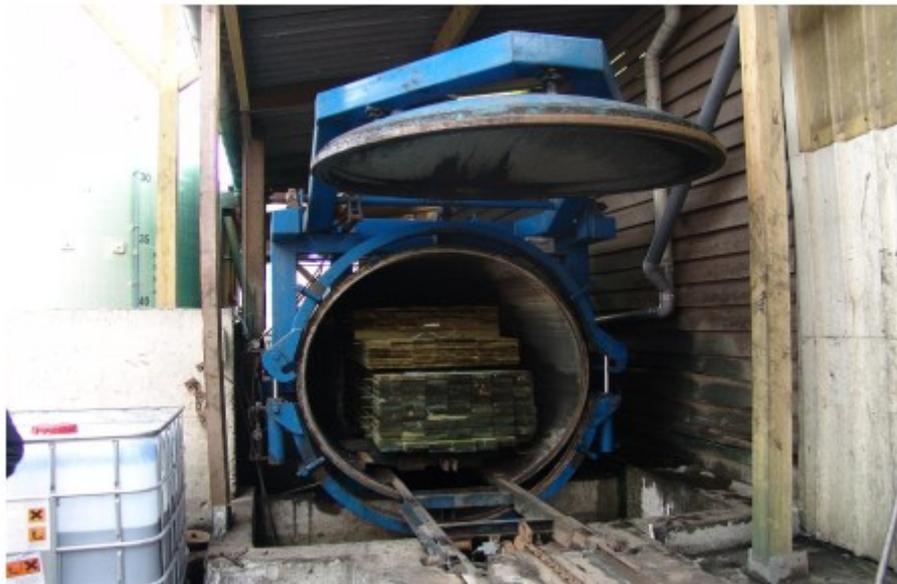
The wood treatment autoclave - Source: SDIS 29 (Departmental Fire Services)

Around 9:30 am, during the autoclave's first use, its door suddenly opened while the treatment product was still under pressure (11 bar). Given the door's size and the presence of pressure, the product spewed out in a single wave, with a large volume flowing over the retention basin edge. The quantity dispersed then separated into two volumes.

According to the investigation, the untimely opening of the autoclave door had apparently been caused by human error on the part of a technician. One of the two mechanical safety devices on the equipment had been displaced.

Moreover, a hydraulic jack hose used to lock the equipment was found in a poor state of repair.

- ✦ changing the door;
- ✦ introducing mechanical safety devices plus complementary electrical safety features;
- ✦ expanding the equipment retention facilities;
- ✦ improving communications between the various retention functions beneath the autoclave;
- ✦ installing a sealed deflector to the left of the autoclave door in order to channel the product back to the retention facility in the event of splattering.

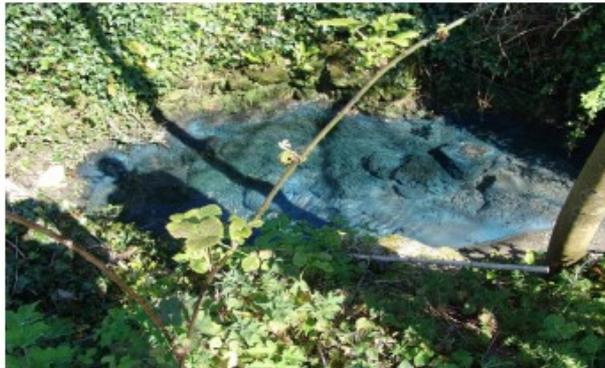
Subsequent to this event, the Le DIOURIC stream turned a blue colour that drew the attention of a group of hikers. High mortality rates among the aquatic fauna (crabs, worms) were observed over a 300 to 400-m stretch of river, where the municipal drain outlet was located. In contrast, no aberrant mortality was detected in the ABER BENOIT River; nonetheless, traces of copper sulphate were discovered and removed by scraping.

Bluish discoloration of "Le DIOURIC" - source : SDIS 29

- ✦ 23<sup>rd</sup> April: pumping by a specialist subcontractor of the plant's stormwater pipes, manholes, gutters and sump bottoms;
- ✦ 24<sup>th</sup> April: cleaning of Lannilis' municipal storm drain network by a specialised firm;
- ✦ 25<sup>th</sup> April: Scouring operations along the entire length of the DIOURIC stream.

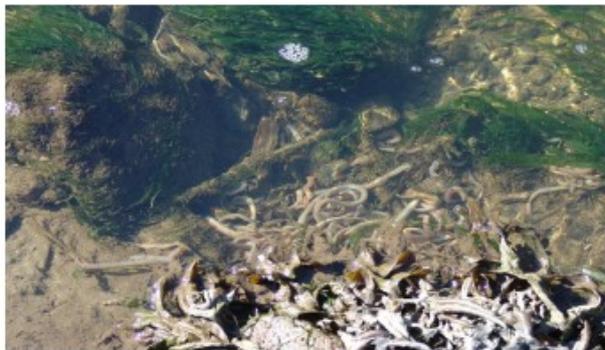
Fish mortality - source : SDIS 29

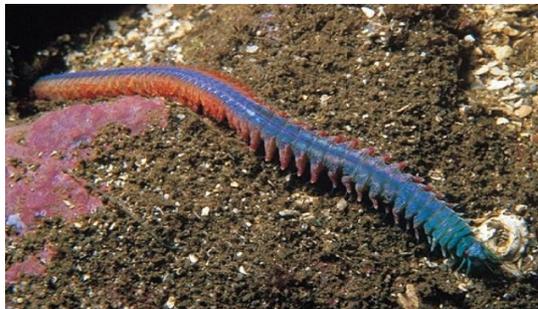
A specialised body performed a site inspection during the afternoon of 23<sup>rd</sup> April, in recording a number of observations on the upstream part of the ABER BENOIT, more precisely at the level of the Trouz ar C'Hant cove, where Le DIOURIC flows into the estuary. Many mounds of dead polychaete (bristle worms) could be identified in the Le DIOURIC riverbed.

A polychaete (bristle worm) - All rights reserved

On 24<sup>th</sup> April, the mounds of dead polychaete were less voluminous and had apparently been washed away by the tides. Moreover, live polychaete were found in the upper part of the foreshore, which served to demonstrate that:
