Explosion of a shell within a scrap metal recovery company

May 14, 2008

Vierzon [Cher]

Scrap metal storage
Munitions (shells)
Picric acid
Explosion
Organisation /
procedural aspects

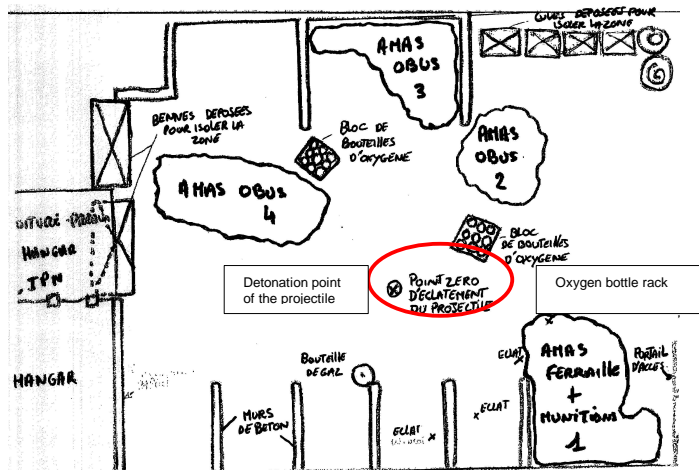
(Source: Mine Clearance Unit)

The civil security mine clearance unit arrived on the site during the evening and proceeded with the installation of containers for demarcating a security boundary around the stockpiles and prohibiting access to company equipment and staff (see diagram below). This unit determined that the picric acid traces no longer presented any risk since the acid had been wetted by water poured onto the storage area by both fire-fighters and the subsequent rains.

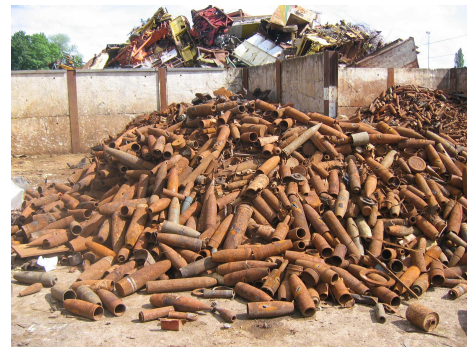
(Source: DRIRE Agency)

The safety perimeter was kept in place: personnel access, in compliance with strict security requirements, was tightly controlled and gave rise to a procedural notice distributed to all staff and posted on the premises. It also included the physical extent of storage areas devoted to blank shells, discarded shell casings, inert training shells and other non-explosive shells originating from a variety of local companies specialised in armament.

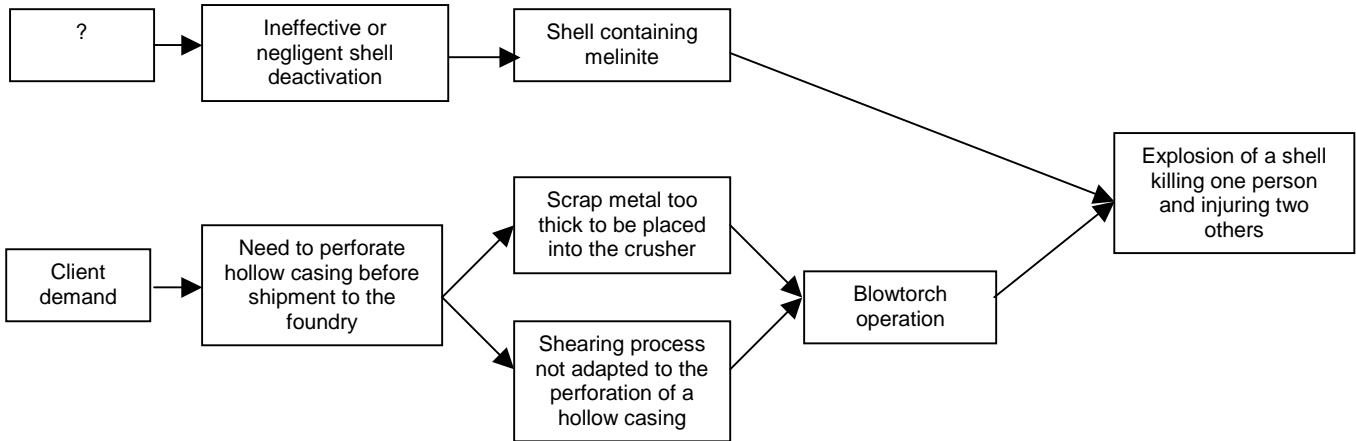
Within the scope of work performed at this site, the operator did not verify the skill level possessed by the subcontracted personnel; moreover, the object cutting procedure was not communicated to any of the assigned individuals and no hot work permit or emergency response plan had been produced. The operator therefore had not correctly assessed the risks relative to these operations.

The company had circulated an internal instruction for cases of shells found in batches that had not been produced by the armament industry. This instruction included guidelines on how to secure the perimeter and notify the hierarchy, who in turn would call in the mine clearance unit. In all likelihood, the subcontracting firm had not been informed of this instruction. Even if the subcontractor knew the procedure, it is not certain that the blowtorch operator would have been able to recognise a non-inert shell. It should be noted that this instruction had not been applied during the morning accident.

Tree diagram of causes proposed by the facility operator, who did not list establishing the fire authorisation or verification of personnel skills or credentials, since the operator felt that neither the hot work permit nor the blowtorch specialist's credentials could have allowed anticipating the presence of a pyrotechnic product in a stockpiled shell.
