High-risk derailment in a city centre

16th March, 1992

Aix-les-Bains (Savoy)

Transport of dangerous goods
by rail

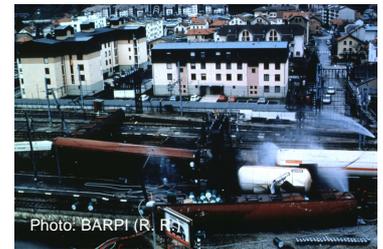
At 2:25 am, le train rolling at 70 km/h derailed at the station entrance. The head of the convoy stopped at the level of the station's passenger terminal building. Both locomotives and the first two railcars did not derail. The convoy became unhitched from cars 3 through 8. Tanker car no. 9 filled with ammonia did not derail either.

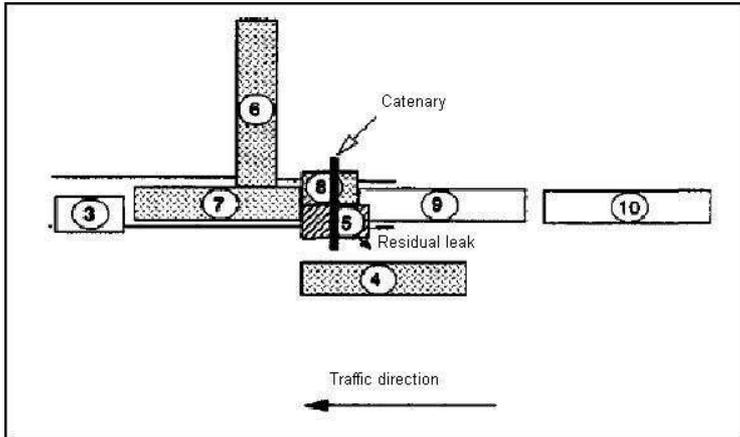
Position of the railcars after the accident:

The DMA car, which was heavily damaged, lay on its side on the station platform, blocking tanker car no. 8, which had not yet been degassed and had previously contained flammable liquid (MEK). This car no. 8 was pinned under a track signal crane and ignited after the catenary fell. The other tipped railcars blocked the major section of track on the Culoz-Chambery line. Some catenary lines were torn apart, while others were deformed by the heat of the fire.

- 3) Empty, 2-axle grain car destined for the scrap yard
- 4) Closed car transporting new, empty 200-litre barrels
- 5) Car containing dimethylamine (22 tonnes of DMA)
- 6) Closed car transporting new, empty 200-liter barrels
- 7) Closed car transporting new, empty 200-liter barrels
- 8) Car containing methyl ethyl ketone (empty but under MEK atmosphere)
- 9) Car containing liquefied ammonia (40 tonnes of NH_3)
- 10) Empty flatbed car

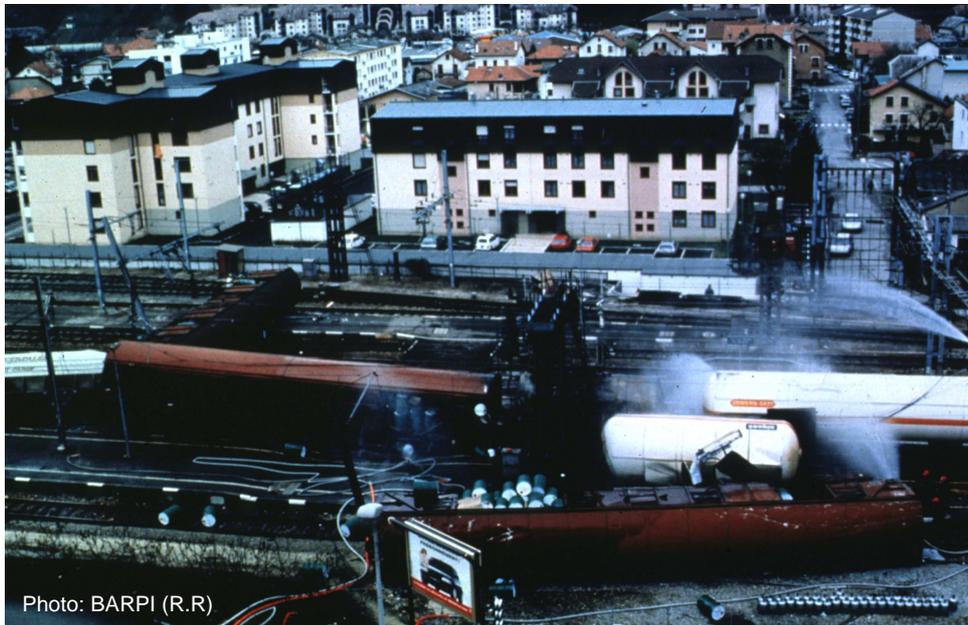
The results of these measurements demonstrated the efficiency of the response: the high-risk zone was limited to approx. 50 meters. The 400-m safety perimeter was maintained. The source of the cloud, which could be detected on the DMA car at around 5 am, was only isolated with precision at around 10 am; the leak stemmed from a suction flange damaged during the derailment and was estimated to be discharging at a rate of 100 g / minute.

An emergency operational command post was set up at 10:30 am. The task of clogging the residual leak with a new blind flange proved a delicate step, since it could not be carried out with the equipment at hand, hence specialist assistance was sought. The local Prefect activated the TRANSAID procedure, which facilitated the deployment of experts in case of an accident involving the transport of hazardous substances.

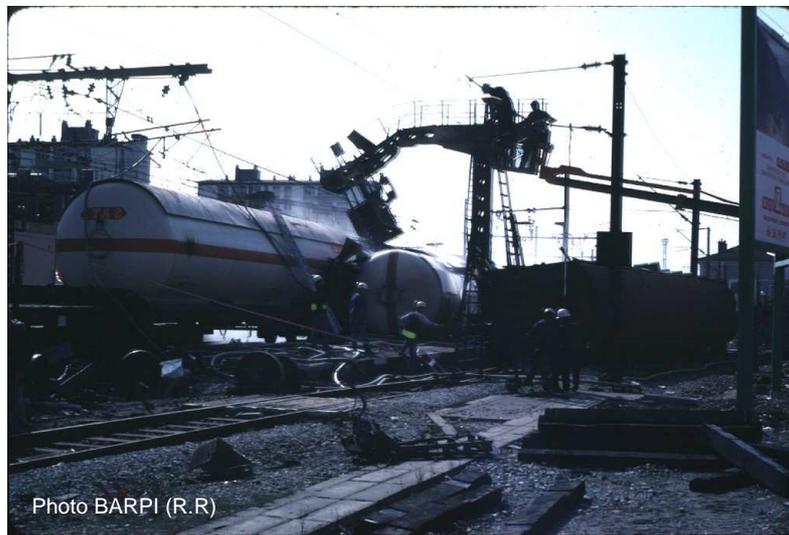
The damage observed on the tracks both leading to the station and at the station itself, as well as observations recorded on the derailed cars, led to forwarding the following scenario: railcar no. 3, the empty 2-axle grain car on its way to the scrap yard, would have left the rails at 1.6 km before reaching the station, as a result of several factors: a track compliant with standards, yet with a tendency for gauge expansion; a damaged car no. 3, rolling empty (12-tonne weight) with 2 axles on the curved part of the track, and framed by much heavier cars (respectively 25 and 35 tonnes) fitted with bogies. Arriving at the station out of alignment, car no. 3 would have struck the cranes supporting the catenary lines and platforms, which in turn would have caused derailment of the subsequent cars.
