Wall rupture of a cereal storage silo and "domino effect" on a propane tank

August 19, 2008

**Saint-Hilaire-sur-Puiseaux (Loiret)
France**

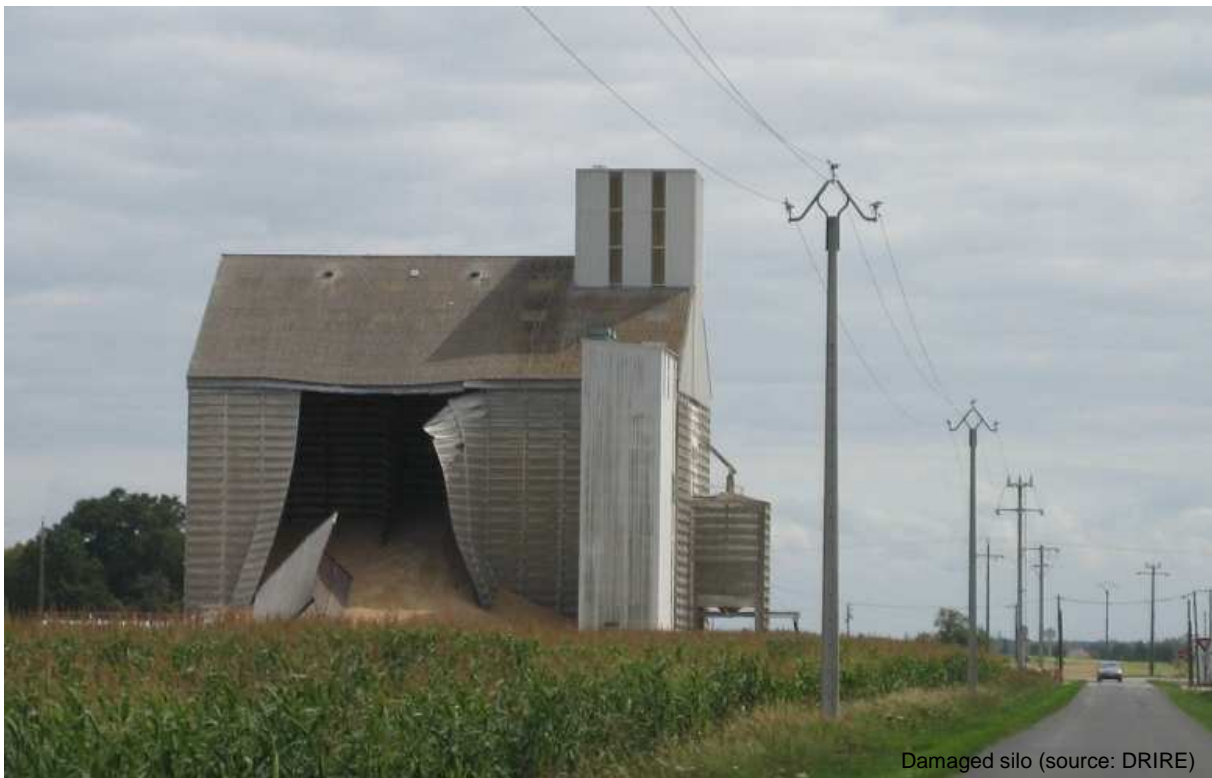
2,100 tonnes of wheat and 1,000 tonnes of corn spread over a distance of roughly 15 metres following the wall rupture on cells 3 and 5, each with a 3,000-m³ capacity, causing partial collapse of the propane tank installed in the vicinity.

This overflow of grains caused the tank to move laterally and in turn burst the LPG pipe (in gaseous phase) between the tank and the relief valve; the flow limiter positioned at the level of the tank was closed yet retained a minimum leak that was sealed off when fire-fighters closed the valve placed on the pipeline located upstream of the rupture.

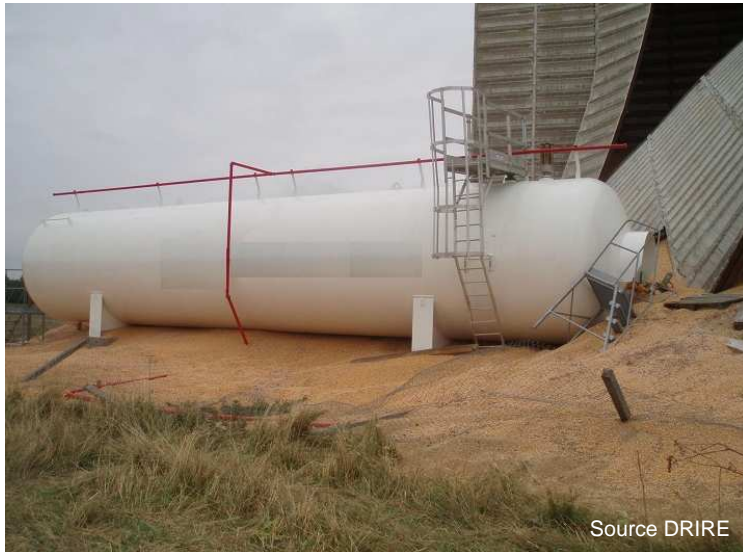
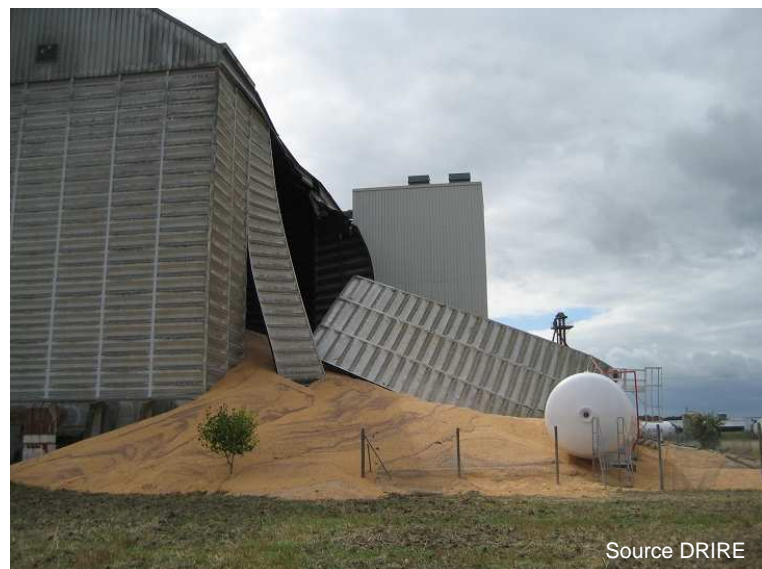
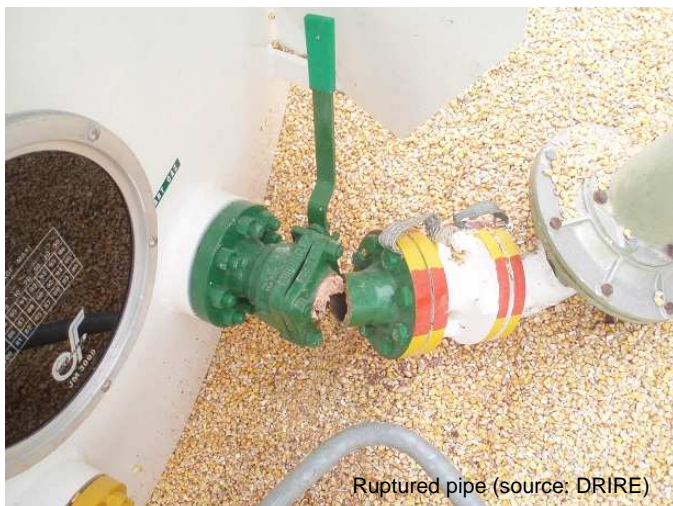
Only property damage was declared; no impact on the personnel, third parties or the environment was observed.

The accident was related to the rupture of silo walls due to both the state of structural fatigue and a drop in cereal stock along with the partial tank collapse, thereby causing a gas leak. A flaw had been detected by the operator during silo construction in 1989, triggering the need for structural reinforcement works on the site in 1990.

The cause of this accident might have originated from the rupture of silo walls, which had not undergone any special monitoring or inspection for signs of structural ageing, under the effect of fatigue and the weight of moving cereal stocks.

- ✓ 1 – Site closure
- ✓ 2 – Inerting the LPG tank
- ✓ 3 – Onsite monitoring
- ✓ 4 – Verification of silo structural condition
- ✓ 5 – Drainage of all silo contents
- ✓ 6 – Issuance of a burning permit
- ✓ 7 – Service start-up only after expert review.
