Explosion and fire in a hydrogen peroxide plant

22nd April 1992

Jarrie - [Isère]
France

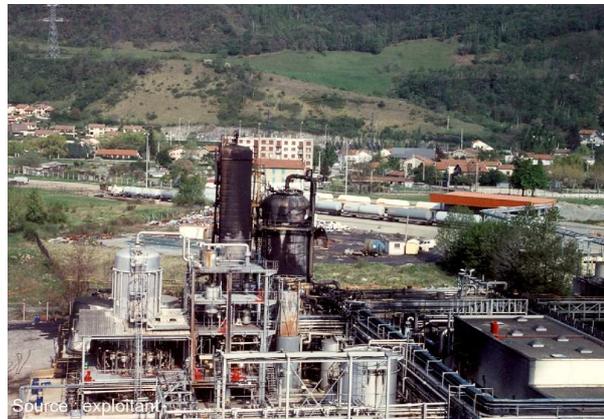
At 23h09 and in less than 5 min, the temperature in this section rose suddenly (70 → 200 °C) as did the pressure. The pipeline linking the oxidiser to the extractor burst and the equipment emptied. The “working solution” released from the installation ignited almost immediately.

An explosion was heard tens of kilometres away and a raging fire propagated itself in the drains. During 2h15, this fire ravaged the oxidation/extraction installations of unit OS2. There was a fear of domino effects as the production unit of 4 000 m² surface area was close to the hydrogen and chlorine reservoirs. The internal emergency plan (POI) was initiated and the first emergency services arrived at 23h30. A safety perimeter was set up.

The intervention mobilised 34 in-house firemen, some hundred external firemen of whom 15 came from a factory close by as well as 35 vehicles. 10 m³ of foam and almost 2 600 m³ of water were used to fight the fire and to protect nearby installations. The fire was declared to be extinguished around 1h29.

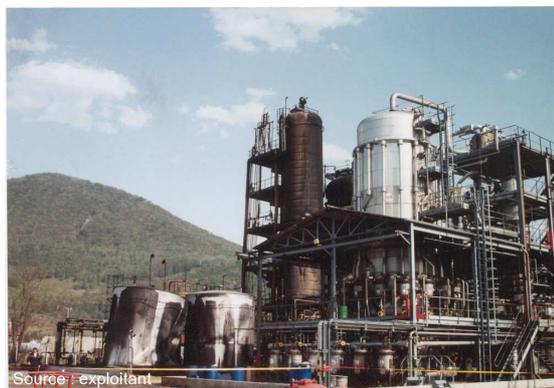
These agents initiated and then accelerated the exothermic decomposition of the H₂O₂ (exponential temperature climb to 200 °C), the formation of O₂ (1 l d'H₂O₂ to 48 % weight → 187 l of O₂ released) and the rise in pressure between the downstream valve of the oxidiser and the upstream valve of the extraction column, both closed.

✚ The stainless steel piping (diameter. 273 mm, thickness. 2mm) connecting the oxidiser to the extractor burst at 23h09, the extraction column emptied into the retaining basin and then the reacting mixture ignited on contact with a heat source.
