# Flooding of a pharmaceutical plant

01/11/2008

Saint-Germain-Laprade (43)

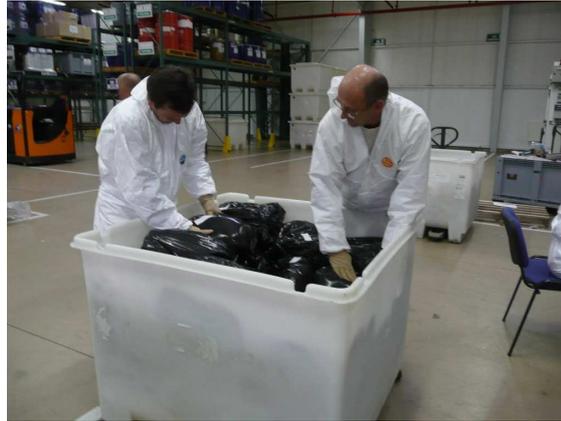
Some wet administrative documents (manufacturing files, product quality certificates for instance) were packed in water tight bags to be recovered using cryogenic treatment.

*Preparation of wet documents in plastic bags for cryogenic treatment*

- Wet documents can be conserved through proper treatment (storage in air tight bags and special cryogenic treatment).
- The onsite presence of equipment enabling intervention in flooded zones such as large-wheeled power lift trucks with exhaust pipes and air vents at higher levels, as well as powerful pumping devices is extremely useful in securing sites and draining the flood water. Especially safety equipment such as fire pumps and their accessories such as starter batteries and their fuel tanks must well above ground level.

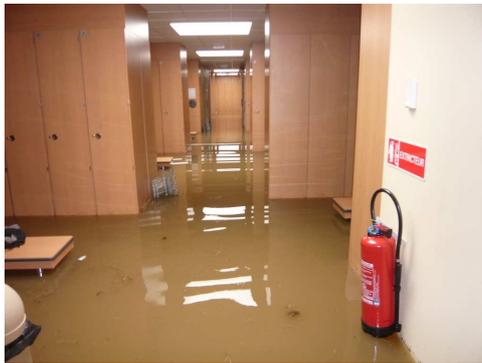
The chemical plant was completely flooded where the water level was between 0.2 et 1 m. Damage within the plant was relatively limited thanks to the prompt action taken by the operator. The flooding however resulted in significant water damage on some equipment or in certain premises (Perimetrical system for the detection of intrusions, changing rooms, laboratory partitions, low-lying equipment, etc.). The operating losses were limited despite the shut down of the plant for several days.

*Changing rooms during flood*

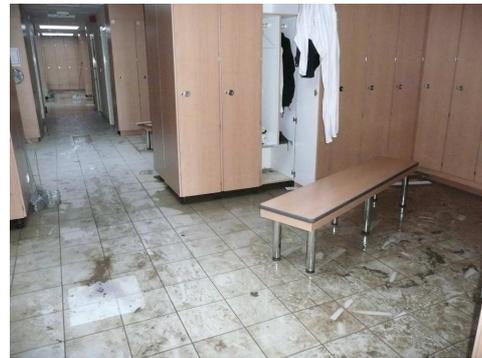
*Changing rooms after flood*

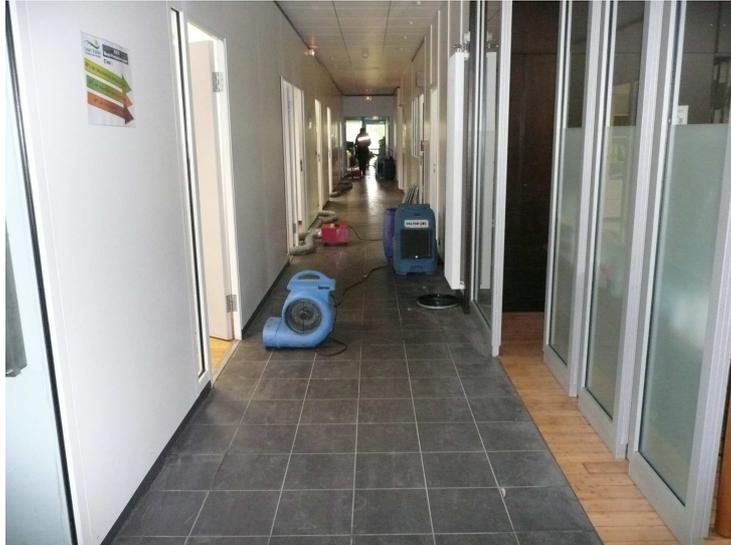
*Drying and dehumidification of premises after cleaning and disinfection*

- Electrical equipment can be re-commissioned only once they are dried (in case of equipment not having been in contact with water and consequently showing a low hygrometer reading, it seems useful to monitor the hygrometry especially during hot season or in a hot zone).

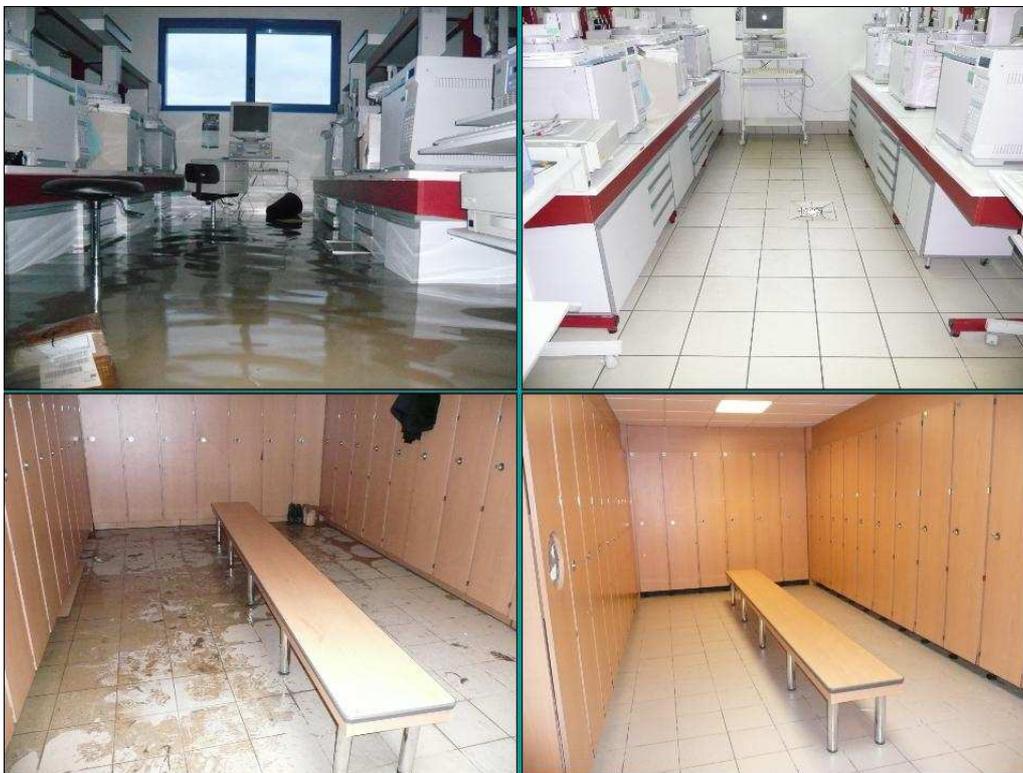
***Quick overhaul of facilities (drainage of water, cleaning, drying, tidying up)***
