Blaze at an ethylene pipeline and a nearby acrylonitrile tank

17 March 2008

**Köln (North-Rhine-Westphalia)
Germany**

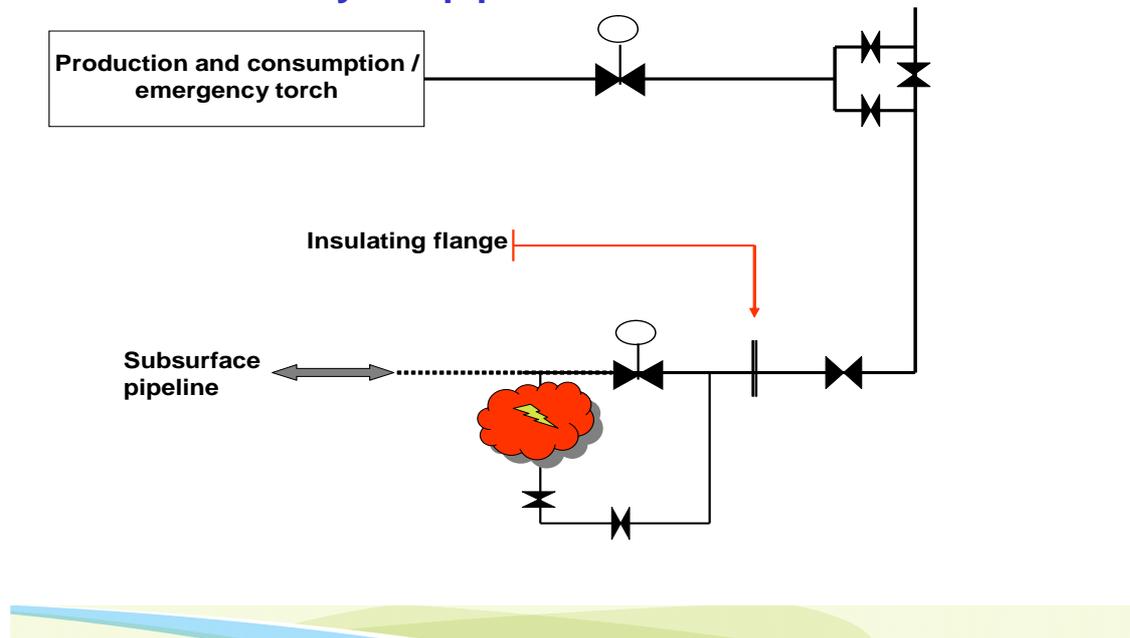
Figure 1: Scheme of the ARG ethylene pipeline at the site.

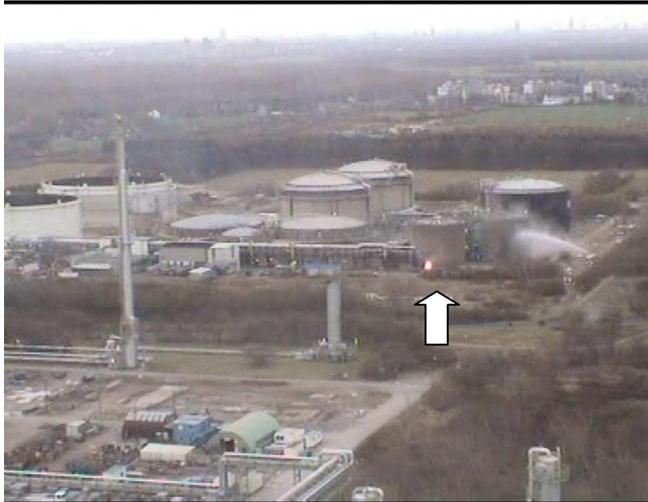
Figure 2: Ethylene flame from the leakage at the insulating flange (arrow) and cooling of the acrylonitrile tanks by the fire brigade

The influence of the maintenance work could not be clarified by the surveys because of an ongoing investigation of the department of public prosecution. But the expert figured out that a leakage at the insulating flange could evolve during the maintenance work when the sequence of the tightening of the screws is not followed correctly or when the wrong torque is applied.

Concerning the cause of the ignition of the exhausting gas both surveys came to identical results. The most probable mechanism of ignition was electrostatic charging because all other ignition sources could be excluded. According to both surveys the cause of the expansion of the fire and the following exposure of the gate valve and the bypass to the fire could not be clarified definitely. The most probable cause is the destruction of the hydraulic oil tank with subsequent leakage of the hot and inflammable hydraulic oil. The influence of the cooling water that came into contact with the hot hydraulic oil is discussed controversially. An insertion of drifting water droplets could not be avoided during cooling of the nearby acrylonitrile tank (Figure 4). As it is technical accepted to let a gas flame burn until the gas is consumed the fire brigade did not use the water for quenching of the gas flame.

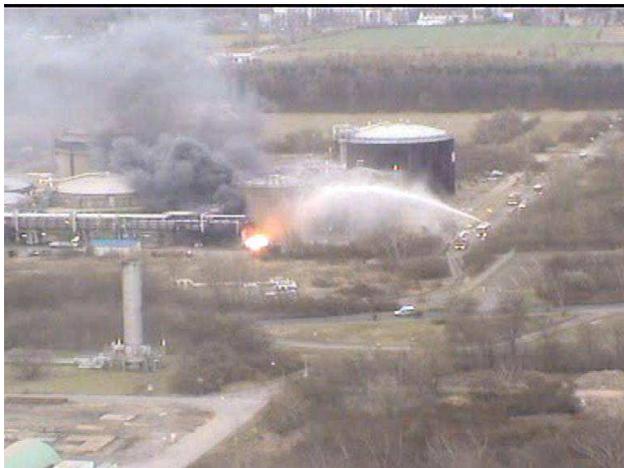
Immediately after the announcement, the injection of ethylene from the plant was stopped, the injection valve was blocked and the remaining gas in the transect was directed to an excess gas burner (Figure 1). In consequence of the leakage and these measures the gas pressure dropped from 83 bars to a few mbars within 12 minutes. Simultaneously the gas temperature dropped from 16°C to -30°C. Shortly after the ignition the height of the flame was about 3 to 4 meters with decreasing tendency. At 2:36 it had nearly gone out in consequence of the decreasing gas pressure. But from 2:38 pm on it increased again and after a short time it set the hydraulic valve under fire which was only two meters away from the insulating flange. A reason for this was probably the destruction of the hydraulic oil tank at the valve in consequence of the high flame temperature. Short time before the fire brigade had begun with cooling the acrylonitrile tanks to guard them against ignition. Maybe some of the cooling water drifted to the burning pipeline because of the small distance to the neighbouring tank. A few seconds later the hydraulic valve and the bypass were completely under fire (Figure 3).

Figure 3: Increasing of the flame in direction of the hydraulic valve and the bypass. Support of the flame by the hot and inflammable hydraulic oil from the broken holding tank of the valve is most likely.

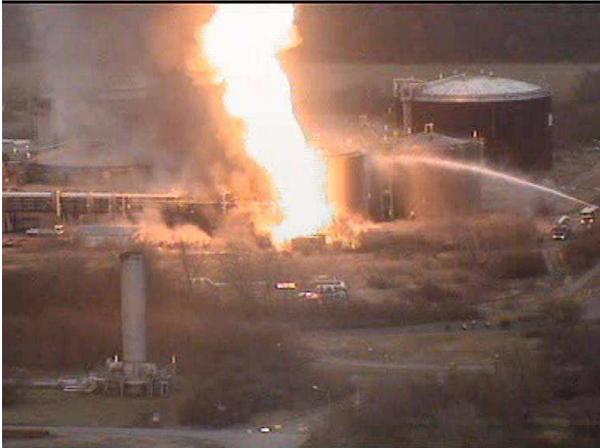
Immediately after the destruction of the bypass at 2:43 pm a jet flame with a height of about 30 to 40 meters formed in the direct vicinity of the acrylonitrile tank (Figure 4). This flame burnt with the same height until 5:30 pm, then began to decrease until it extinguished at 7:26 pm. From 3:00 pm on the Cologne fire brigade a lot of other auxiliary fire brigades supported the fight against the fire.

Figure 4: Ethylene jet flame from the broken bypass of the gate valve; gas pressure: 83 bars. Half an hour later the nearest acrylonitrile tank caught fire.

The cause for the bypass breakdown was with high probability a thermal decomposition of the ethylene. Under certain pressure and temperature conditions the property of ethylene is to decompose explosively. Temperatures of up to 1500°C could occur during this process. According to the surveyors the conditions for decomposition were given. Due to the spontaneous rise in pressure and the softening of the bypass caused by the flame heat the breakdown of the bypass was inevitable. The chain reaction - first burning of the exhausting ethylene and then destruction of the hydraulic oil tank with subsequent under firing of the bypass and eventually destruction of the bypass - could have been avoided, if there was a bigger distance between the insulating flange and the other fittings.

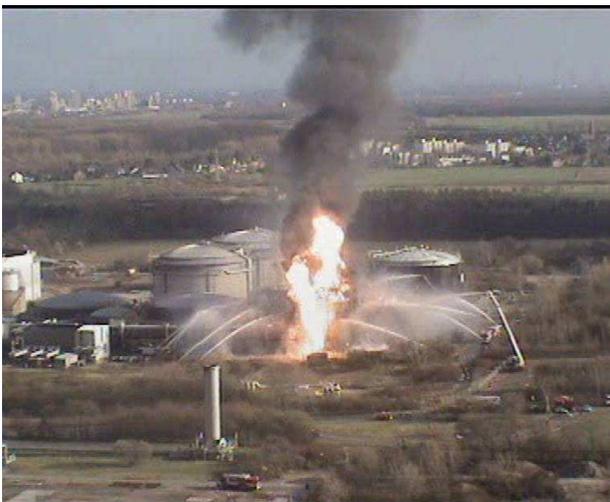
Figure 5: Whole roof area of the acrylonitrile tank is burning at 4:30 pm.

During the first phase of the fire the acrylonitrile tank was only marginally affected by the heat. Only from 2:43 pm on as the bypass was destroyed and the jet flame with a height of 30 to 50 meters appeared the tank was affected by relevant heat radiation. The survey comes to the conclusion that due to the long time of heat radiation and the direct flame exposure of the tank roof part of the aluminium roof melted and gave way to acrylonitrile vapour that ignited. The

additional heat formation of these secondary fires had a supportive effect on the meltdown of the aluminium roof. At 4:30 pm the roof had completely melted down so that the complete tank square was free to burn.

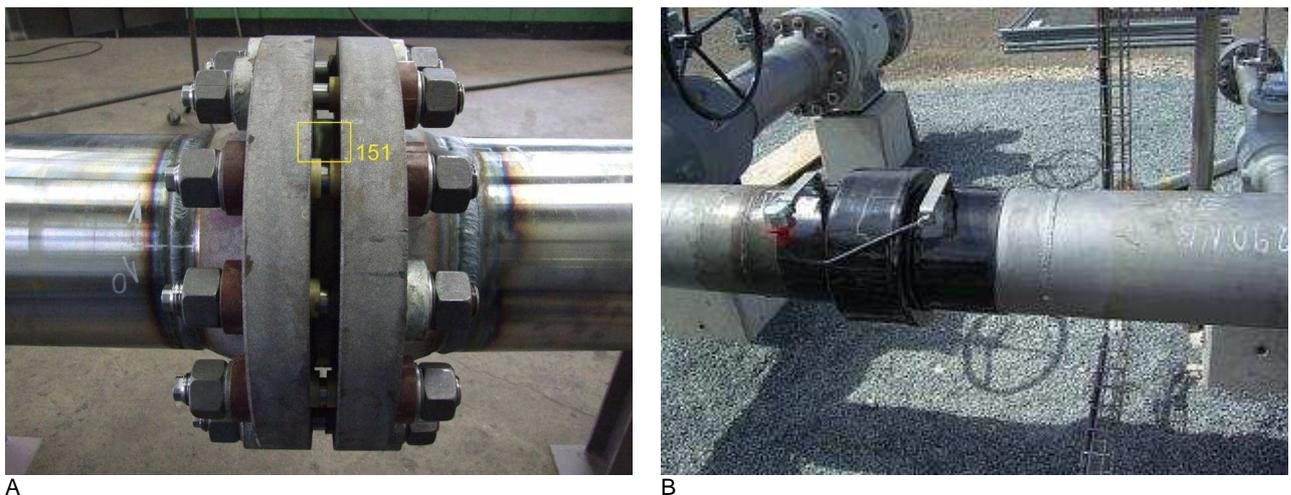
Figure 8: Insulating flange with inserted nuts (A), maintenance-free welded insulating connector (B)

The low contaminated water used for cooling of the acrylonitrile tanks was given to Currenta's own waste water treatment plant and after purification discharged into the river Rhine without exceeding of emission limit values. The mixture of fire water and acrylonitrile from the tank was given to an incineration facility. The tank remains were removed to give place for a new construction. The ethylene pipeline was displaced and the blocking station reconstructed at a distance of 62 meters from the tank field. The insulating flange with inserted nuts was removed by a maintenance-free welded insulating connector (Figure 8).

We learned from the expert surveys that a leakage at the insulating flange of a high pressure gas pipeline could evolve during the maintenance work when the sequence of the tightening of the screws is not followed correctly or when the wrong torque is applied. In the case of pipelines with inflammable gases it is very important to prepare very detailed standard operation procedures and employ very skilled technicians to performance the maintenance work when the pipeline is under full pressure. A similar situation appeared a year before this accident as during maintenance work a leakage was detected. At that time the gas didn't ignite and the flange was renewed and used again after tests by an independent surveillance organisation. The best way to reduce the risk of leakages and subsequent fires is to use maintenance-free welded insulating connectors as shown in Figure 8(B).
