Chlorine cloud resulting from a failure in handling hazardous substances

5th October 2007

Frankfurt
Germany

Distributor of chemicals
Sodium hypochlorite
Mix up of connections
Generation of chlorine

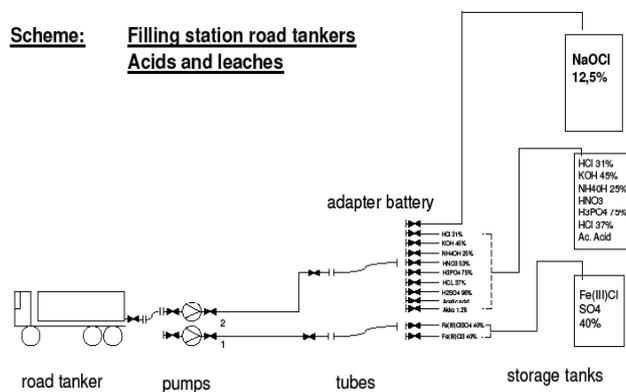
At the delivery station for tankers there is a connection for FeCl₃-Solution and only one connection for all the other chemicals. A pump transports the fluids via pipe to a connection battery / filling station for drums, which is near the tanks. At the battery a worker connects the pipe, by using a hose, to the right tank. Before filling, the road tanker should be weighed, delivery documents checked and a sample of the tanker withdrawn. The sample is analyzed (specific weight) in the laboratory. Then the filling is released.
