# Derailment of LPG tank-wagons followed by a UVCE explosion and an intense fire

29 June 2009

Viareggio

Freight transport  
Derailment  
LPG  
Maintenance  
Tanker-wagon  
Explosion (UVCE)

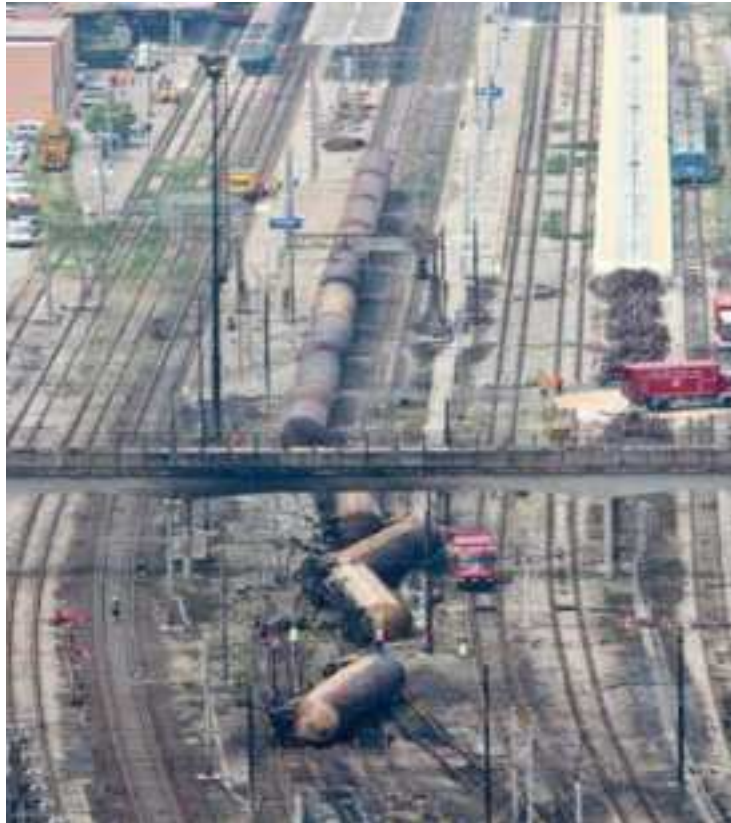
Fig. 2

On the 29<sup>th</sup> of June 2009, shortly before midnight, the 50325 train derailed while crossing the station of Viareggio and five of fourteen rail tankers overturned (fig. 2) [4]. The train was travelling at about 90 km/h (below the speed limit set at 100 km/h) [1] [5]. The first rail tanker plowed the ground and breached probably after the hit with a signaling stake beside the railway or with a rail switch (this point is at the time of writing under investigation during the trial) : the impact caused a hole, about 40 cm long and about 2 to 5 cm wide [3] [2], from which all the LPG escaped (45 t). No loss of containment occurred from the other 13 rail tankers vessels.

The main cause of the accident seems to be a mechanical failure in the first LPG tanker of the train. One of the axles was found broken probably due to a fatigue crack (also under investigation).

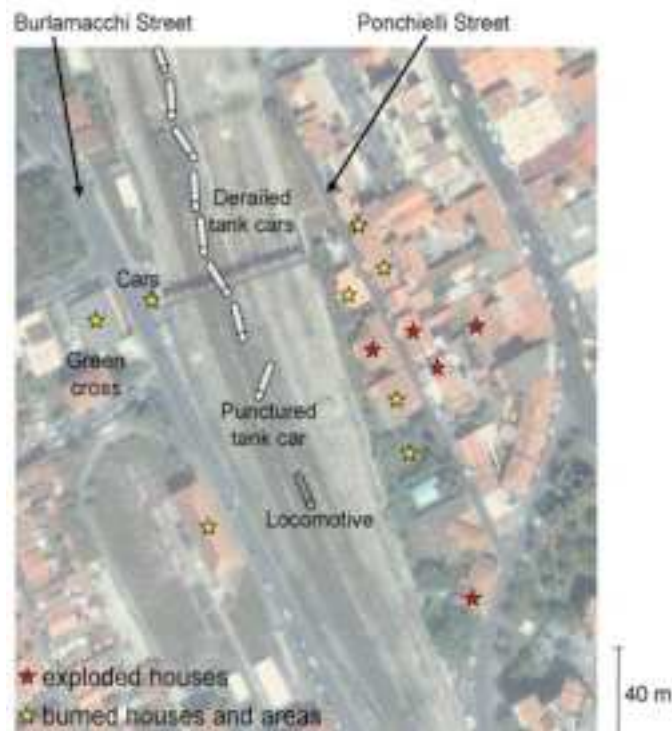
Fig. 3

The buildings along via Ponchielli, and the neighbouring streets were on fire, with approximately 200 metres of flames on both sides of the road. Five houses collapsed due to inner explosions. Almost all the remaining houses of via Ponchielli burned due to the subsequent fires that engulfed also other areas surrounding the station (fig. 3) [4] including trees in a small public children's park some bushes and parked cars and trucks (fig. 4) [4]. The poolfire from the liquid-phase LPG could be noticed far away with flames as high as 20-25 m [2] [3].

Fourteen people died immediately: some under the collapse of buildings or suffocated by the smoke inside their houses ; some burned because standing inside the flash area. The fatalities rose to 22 people the day of the state funerals. Finally, there were 32 fatalities (one woman had a heart attack), the last person died exactly two months after the accident. More than thirty people were seriously injured. About 1100 people had to evacuate their homes for safety reasons.

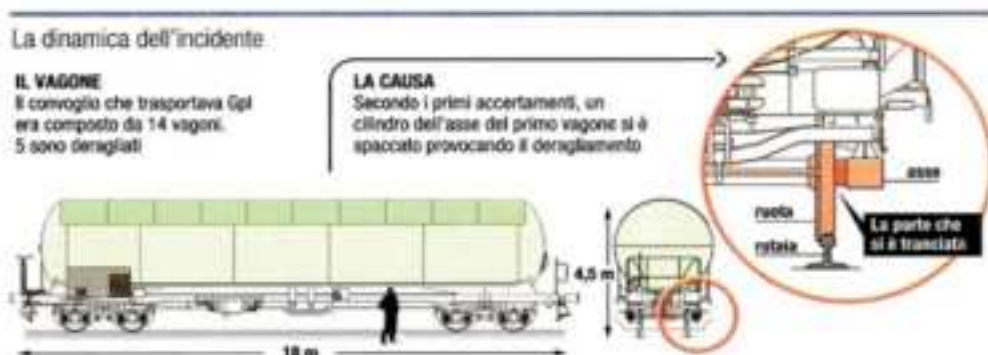
Fig. 5

- 1) Mechanical failure of the front axle of the first wagon. The failure occurred exactly between the wheel and the axle (fig. 5) [7] probably when the train was at the entrance of the station, and the train derailed after about 700-800 m [7], then the truck (the whole complex wheels-axle) was projected at about 70-80 m away [7], and the first wagon overturned (fig. 6a). The section of the rupture looks smooth on more than 90% of the surface (fig. 6b and 6c) [4], the other part of the section appears instead coarse and corrugated. These elements seem to suggest a fatigue-type rupture [1] [4], that developed in a relatively medium - long period, and consequently raise questions about identification of the problem, control inspection procedures and adequacy of verification techniques applied: is there any evidence that this kind of rupture happened in the past ? Was a risk analysis conducted identifying this kind of failure and possible consequences? Do tanker control inspection procedures require specific attention to the system wheels - axle? What is required in terms of integrity test of that specific part? Is the kind of test required sufficient to identify the potential problems ? Is the time period between controls short enough to prevent that kind of failure? In case of transportation of dangerous substances are these controls sufficiently stressed?

- a) fatigue-type rupture of the axle, if confirmed by the conclusion of the investigation, will point out the need to reinforce the check-inspections, in particular in terms of :

- o efficiency of the inspections-controls actually in force for the mechanical device origin of the accident (axle-wheels system) ;
  - o review of techniques and procedures for this type of mechanical device, and if needed addition of new and more specific control tests ;

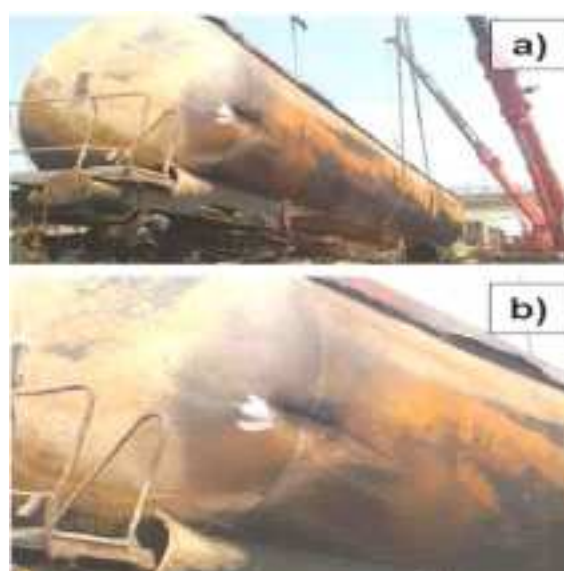
Fig. 8

- 3) A breach, about 40cm long and 2-5 cm wide (fig. 8) [4], was produced in the first rail tanker after the derailment. The cause of the breach is still under discussion, highly suspected are either the I-shaped stakes disposed close to the railway line (fig. 7) [4], used as references to control rail stability, or the "common crossing" (or "frog") of a rail switch [1].

- b) train speed at about 90 km/h and presence of structures (stakes/switches) along the railroad line: a specific risk assessment should have been used to assess their compatibility. A risk assessment study, in particular for transport of dangerous substances, should consider all the risk factors present along the railroad line (i.e. allowable speed of the train, presence of nearby structures, level of vulnerability and urbanization of crossed areas, etc.) and its results could consequently useful to identify, if needed, additional technical/managerial measures to adopt, for example :

- o speed limitations to trains carrying dangerous substances when crossing populated areas ;
  - o additional safety devices like RTB installation (temperature-detectors of the truck), Derailment Detection Device (DDD) [1] ;

- o adoption of different types of stakes/switches in the rail (plastic or metal-alloy stakes with low mechanical resistance) or possible prohibition of them ;
