Explosion of a sulphuric acid tank

4 August 2009

Gonfreville-l'Orcher

Chemistry
Sulphuric acid
Hydrogen
Explosion
Tank
Maintenance
Equipment defect
Organisation / controls

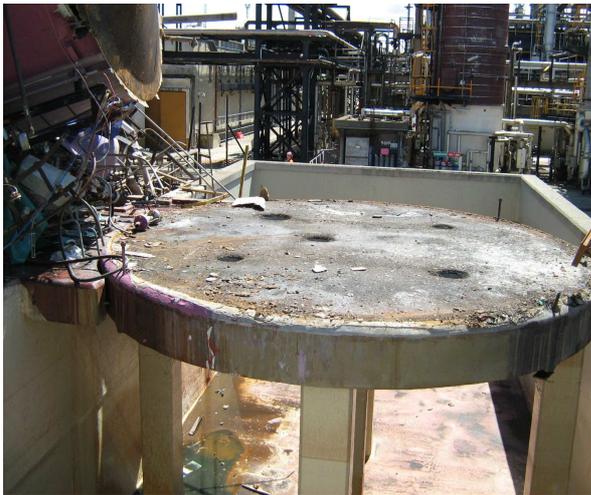
The damages were limited to destruction of the tank and all connecting piping; the unit was shut down. The tank was torn apart over half the shell/bottom junction circumference. Its anchorages were also ripped out.

Photos courtesy of DREAL:
Concrete base where the tank was positioned

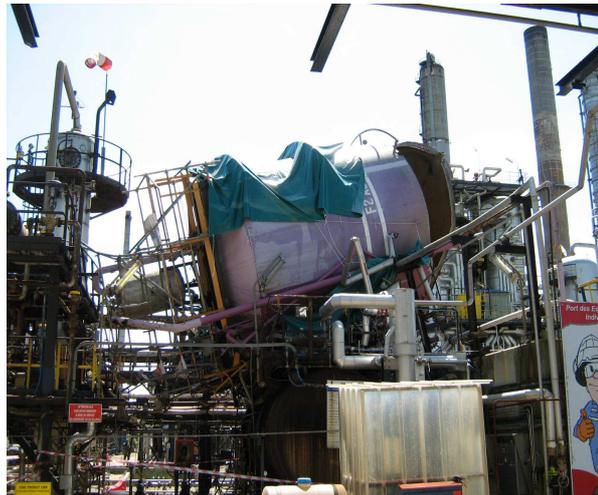
The F2 tank, empty at the time of the accident, was suddenly lifted 2 or 3 m high and then fell back to the ground on top of a nearby drum. As it was falling, the tank brought down the scaffolding that had been installed for upcoming maintenance.

Damaged tank

Insufficient rinsing of the tank (just a single rinsing cycle was performed) combined with the presence of a low concentration of sulphuric acid caused an acid attack of the metal, leading to the formation and accumulation of hydrogen at the top of the tank (dome-shaped tank roof). The explosion occurred by means of igniting the flammable mix created with air at the time of splitting the corroded bolts on the dome manhole with a grinder.

- Design : The new tank would be fitted with a bleed valve that was both accessible and manoeuvrable.
- Tank availability (through steps of drainage and rinsing) was improved. The completed drainage step, facilitated by tank design, was to be visually inspected by opening a manhole at a high point. This improved accessibility will serve to minimise the quantity of residual acid to just drippings at the tank bottom and on its sidewalls, in addition to enhancing not only acid neutralisation to return to a neutral pH but also tank rinsing. Moreover, this operation avoids producing diluted acid and attacking the tank.

- The tank was to be rebuilt using carbon steel; this solution was preferred over a composite so as to streamline inspections.
- During the normal operations phase, a very minor hydrogen release into the tank remains a possibility. Measures were taken to minimise hydrogen production and prevent its accumulation by means of :

- The classified facilities inspectorate requested that the tank be made breakable at the shell-roof junction, so that in case of an incident, the tank would remain in place and its contents not ejected.

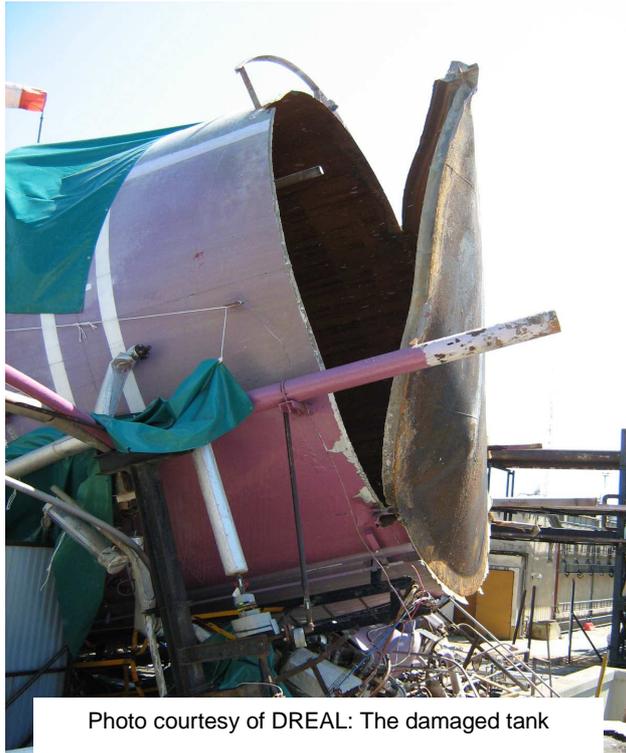
The metallurgical assessment performed on this tank indicated the presence of extensive internal corrosion over the lower part of the structure. This observation confirmed the sudden onset of corrosion at the tank sidewall due to diluted acid, thus generating a source of hydrogen production.
