Explosion of a truck carrying explosives

22 March 1989

**Peterborough
United Kingdom**

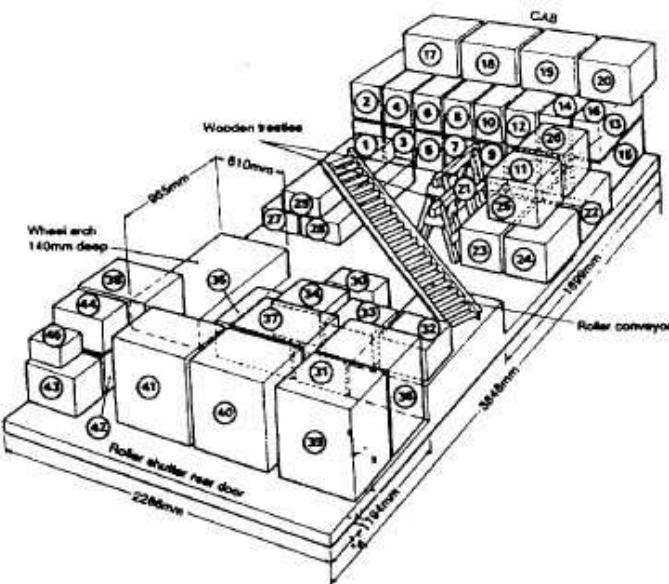
*Distribution of load inside the vehicle [2]*

The Cerium fusehead combs however were found to be packed in unauthorised and unsafe packaging. The transport package consisted of an outer wooden box containing 2 metal boxes of 400 combs (each with 20 heads) placed lid to lid and surrounded by sawdust. The type of packaging used was both illegal and dangerous in that there were excessive numbers of fuseheads per box, the packaging was loose resulting in presence of loose composition inside metal boxes, and presence of rust.

The initial minor explosion was probably caused by ignition of the Cerium fusehead combs when the vehicle jolted over the speed ramp control. The likely mechanism for ignition being impact or friction of the fusehead debris or loose composition against the metal box packaging. The fusehead composition was probably sensitised by the presence of rust. The fireball which followed threw burning debris around the load compartment, starting a number of fires.

The packaging of the Cerium fuseheads revealed illegal and unsafe, making the release of loose composition possible during normal transportation. It was then a "matter of time" (in that case, probably chock when falling) before it reacted. A safe and adapted packaging is essential for the transportation of explosives. The explosive company operating the truck was fined £250,000 for breaching Section 3 of the Health and Safety at Work Act 1974.

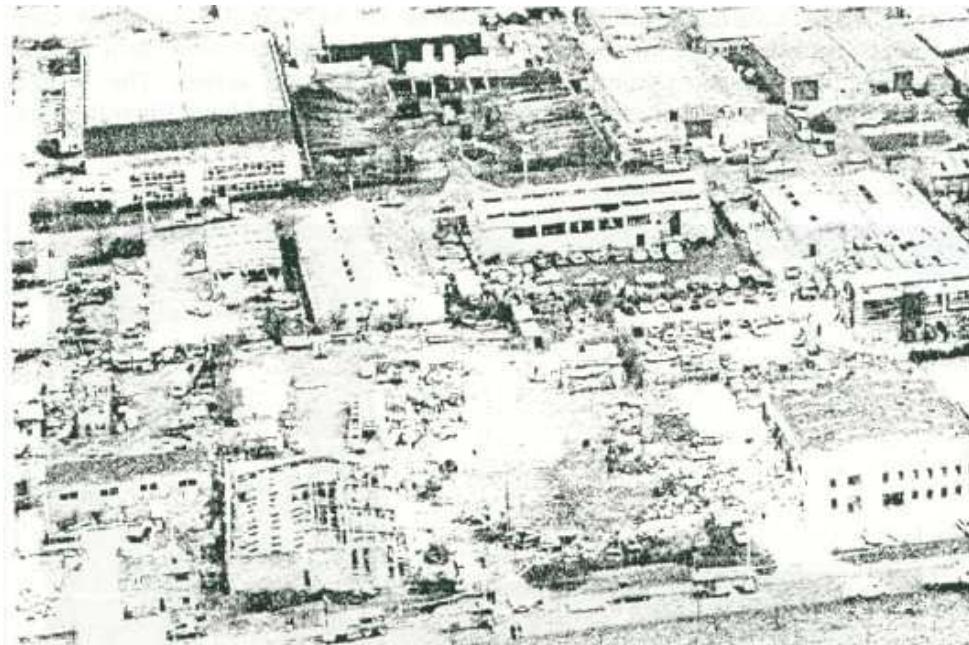
The explosion created a crater of 3.5 m radius by 46 cm depth in the tarmac surface of the yard. The floor of the explosives vehicle was approximately 1 meter off the floor.

Blast damage to the two buildings on either side of the explosion was considerable. The closest building had to be demolished. Damage to buildings further afield consists of large doors blown in, metal cladding removed, asbestos roofs collapsed, metal cladding damaged, window frames blown in, extensive window damage etc. About 150 buildings were significantly damaged. Window damage was extensive reaching as far out as some 1 200 m away.

Overall, the blast damage appears to be consistent with a high order detonation of a quantity of explosives equivalent to 800kg of TNT [1, 3].

Aerial view of the disaster [3]

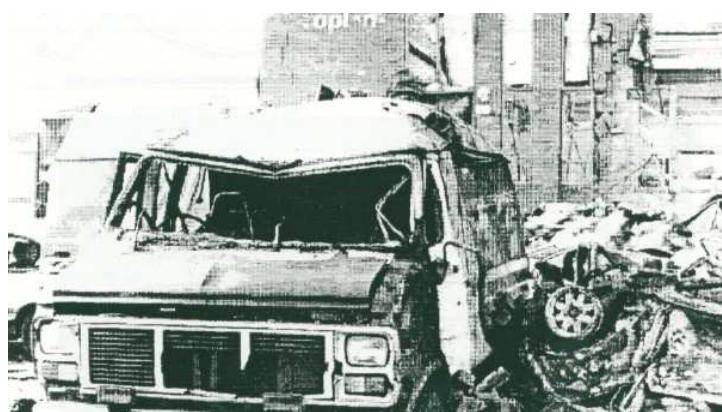
Approximately 130 cars were damaged to varying degrees, that is about 60 beyond viable repair, 13 badly damaged, 51 slightly damaged, and the remainder superficially damaged.

Destroyed car at about 40 m from the explosion [3]
