Fire in a warehouse covered with photovoltaic panels

12th January, 2010

Val-de-Reuil (Eure)

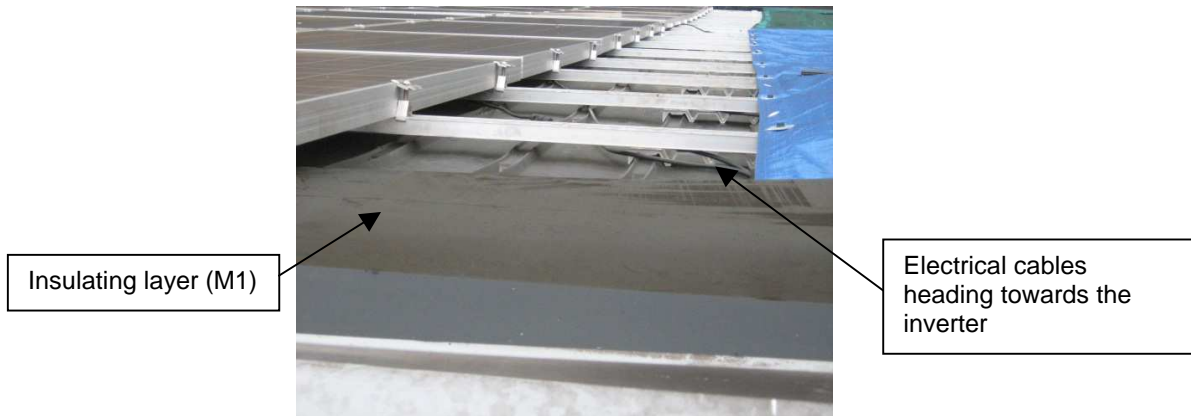
View of the sealed cables located underneath the photovoltaic panels (source: DREAL)

- ⤴ fire spreading into the space between the roof and the photovoltaic panels via cables and sealed cover, given that the cables and cover did not display non-combustible characteristics. The strong slope effect associated with this roof undoubtedly facilitated spreading of the fire;

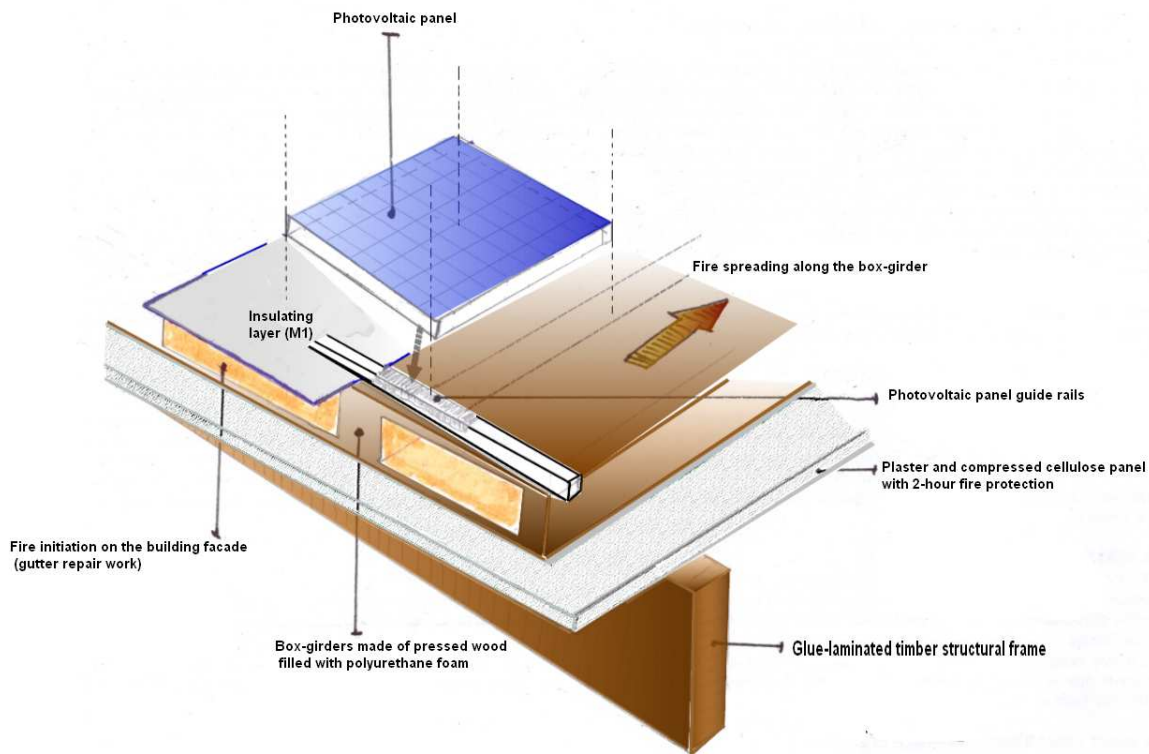
The fire source, located at the centre of the roof structure, threatened the entire surface of the photovoltaic panel display. Nozzles were deployed, yet these proved relatively inefficient, as the fire was spreading underneath the insulating layer within a wooden box-girder filled with foam.

Simplified diagram of the industrial building roof

- ⤴ difficulties in accessing the box-girder of pressed wood (see diagram on p. 2) in order to extinguish the fire, as the photovoltaic panels were solidly fastened.

- ⤴ fire wall between the utility premises and storage cells;
- ⤴ 2-hour fire-resistant panel composed of plaster and compressed cellulose underneath the photovoltaic structure (see diagram on p. 2).

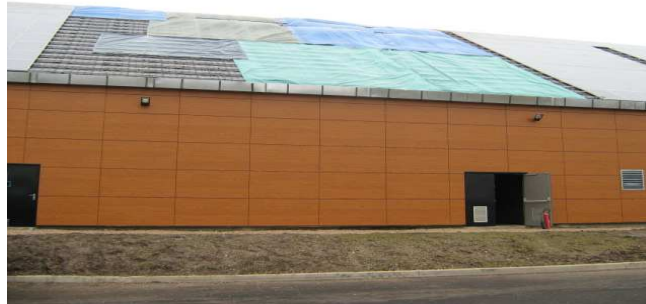
Given the risk that this fire would rekindle, the damaged roof was covered by a tarp and electrical circuits were isolated.

Covering of the damaged roof with a tarp (source: DREAL)

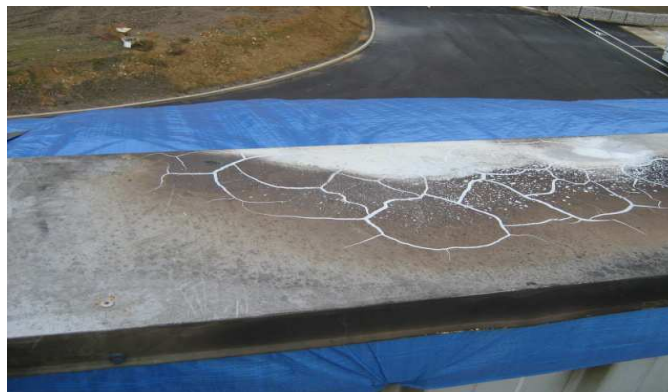
This accident caused significant property damage and operating losses. The total amount was estimated at between €350,000 and €400,000. Moreover, the photovoltaic installation would be shut down for nearly 6 months, including a full month to disassemble all of the panels. The fire wound up destroying 1/3 of the total photovoltaic panel surface area.

Close-up of property damage (source: DREAL)

The panels damaged due to this accident could not be reused. This damage was revealed by:

- ⤴ black traces caused by the fire (see photograph of property damage, p. 3);
- ⤴ marks of hatchet or hammer strokes during removal attempts.

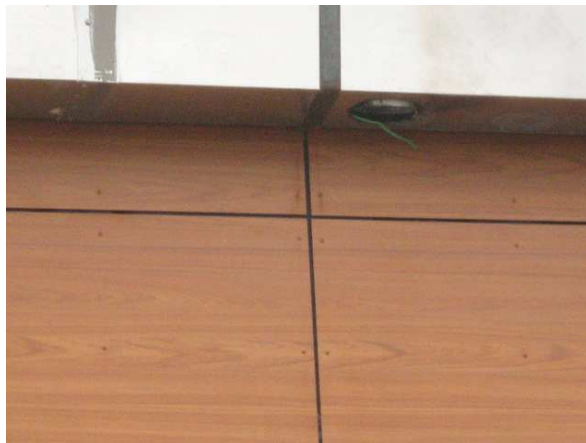
The causes of this fire outbreak were initially attributed to an electric arc that would have been produced when placing a metal part on the gutter. Nonetheless, when viewing the security video, it was in fact revealed that the subcontractor assigned to perform the gutter repairs arrived onsite with a flame source. These works were neither scheduled nor authorised by the warehouse operator.

Location of the exact spot where works took place (source: DREAL)
