## Explosion inside an underground storage of explosives

November 2, 1992

« Steingletscher », Swiss Alps  
 Switzerland

Pyrotechnics  
 Underground storage  
 Risk analysis  
 Waste  
 Ammunition

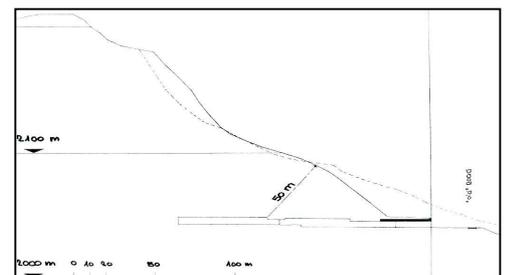
*Longitudinal Section through the Mountain and the Installation before and after the event*

The blast destroyed part of rock above the chamber ; due to the steep mountain slope, a large quantity of rock material broke loose from the top of the mountain and covered the area where the installation had been located. The bad geological zone recognized during the construction of the installation, worked as a gliding zone for this material.

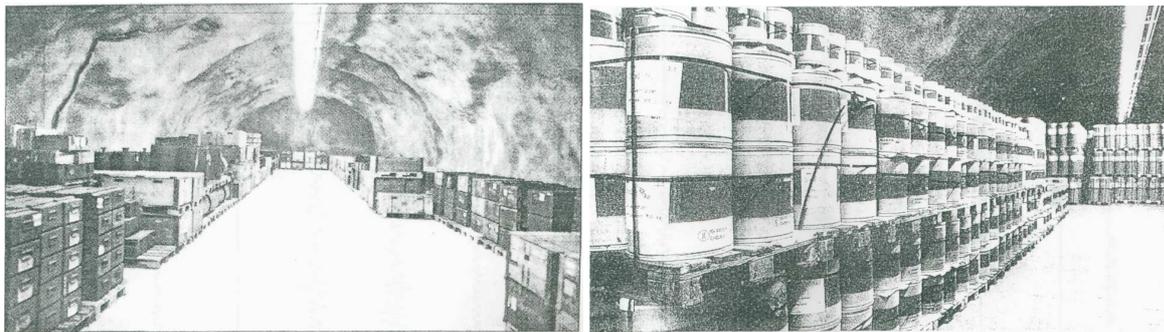
The day of the explosion, the storing chambers contained several hundred gross tons of material (TNT-flakes in cardboard drums, waste from fabrication, parts from disassembled old ammunition, including parts from illuminating grenades, small to medium calibre rounds...), which TNT-equivalent can be evaluated at 200 tons. The average loading density of the two chambers was around 40 kg/m<sup>3</sup>.

Material Stored a few days before the explosion (left: chamber 1 ; right: chamber 2).

Nevertheless, it should be noted that the material stored in the depot was peculiar (TNT-flakes in cardboard drums, waste from fabrication, parts from disassembled old ammunition, including parts from illuminating grenades, small to medium calibre rounds...) and differed from normal ammunition storage conditions. The waste material might have been more reactive than "normal products", which increased the probability of the event. No information is available concerning that point nor the risk analysis of the installation.

**It is recommended to destroy explosive waste as fast as possible in order to avoid the accumulation of huge quantities and the ageing of already less stable and less "known" products.**

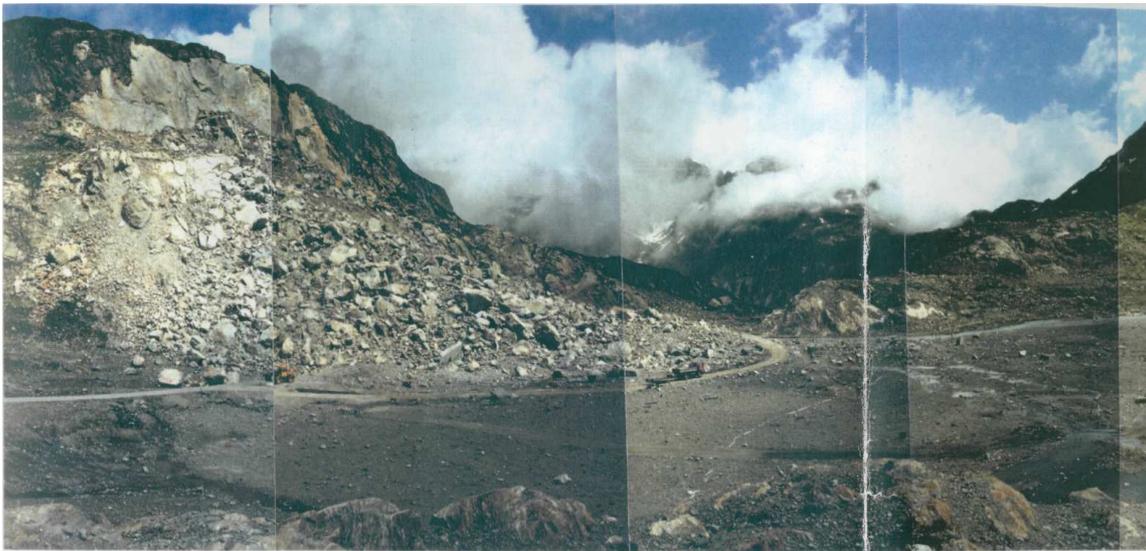
After the explosion, some explosives material burnt inside the mountain as flames could be seen emerging from cracks in the rock.

*Overview of the whole area*

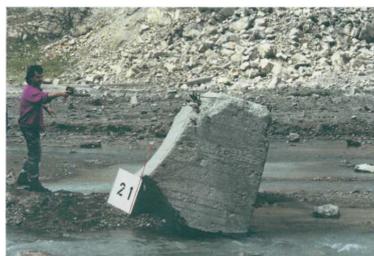
The entrance building was torn to big pieces and dislocated 50 to 100 m from its original place. Some parts, up to 20 tons a pièce, were hurled over the plateau to a distance of up to 600 m and were only stopped by the steep mountain slope on the other side of the plain.

*Debris from the entrance building arch, found 370 m away (weight: 15 t).*

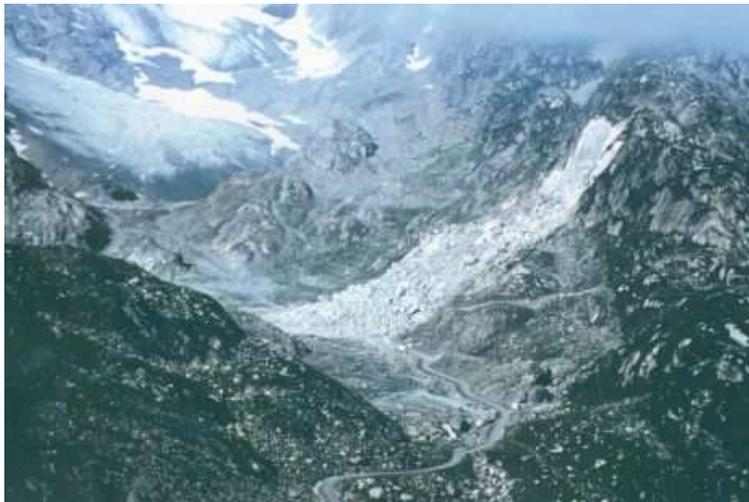
The installation was completely destroyed. Rock material from the overburden was thrown to the surrounding up to a distance of 500 m.

*Overview of the scene after the explosion*

The cause of the fire leading to the explosion remains unknown, due to the full destruction of all installations.
