# Explosion of a gunpowder factory

8<sup>th</sup> December, 1972

Muiden

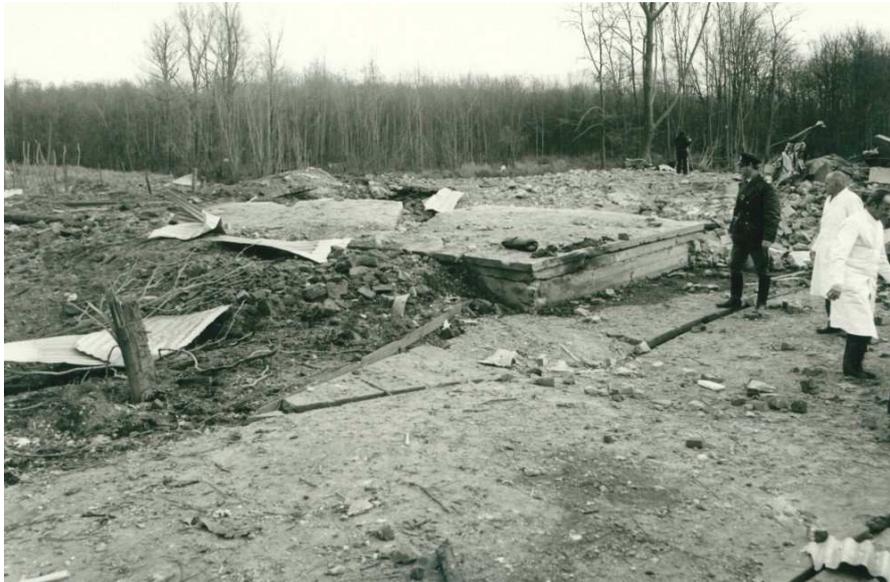
Building 7 was completely destroyed; the only part left was a small section of the concrete entrance steps. The locations of the 2 drying chambers were recognised by the presence of deep craters.

*Entrance to Building 7, viewed from the west (the damaged forest can be seen in the background) [1]*

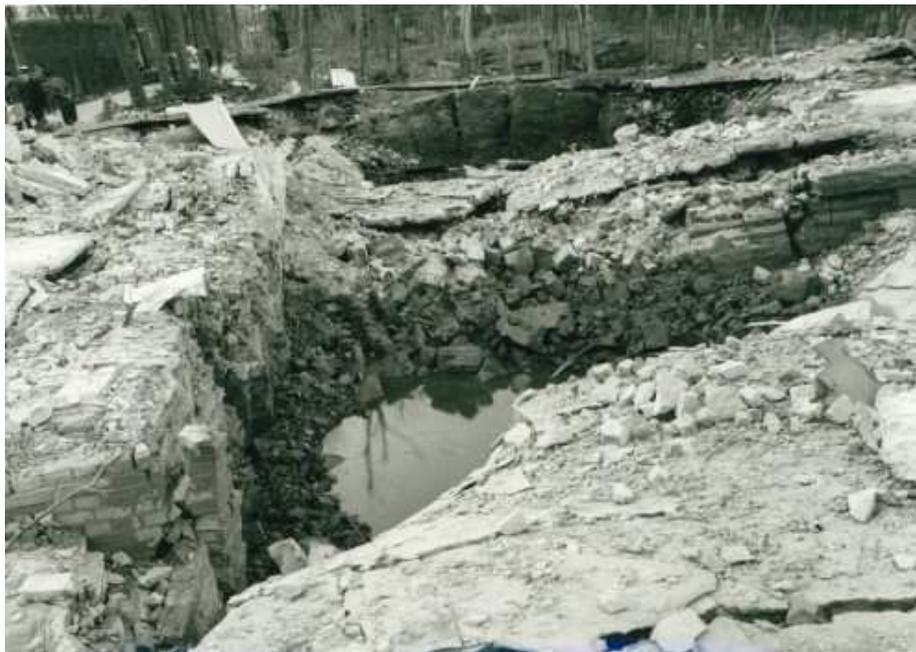
*View of the eastern crater (foreground) and western crater (background), as seen from the east. Between the two craters are the remains of the reinforced concrete floor from the machine room [1].*

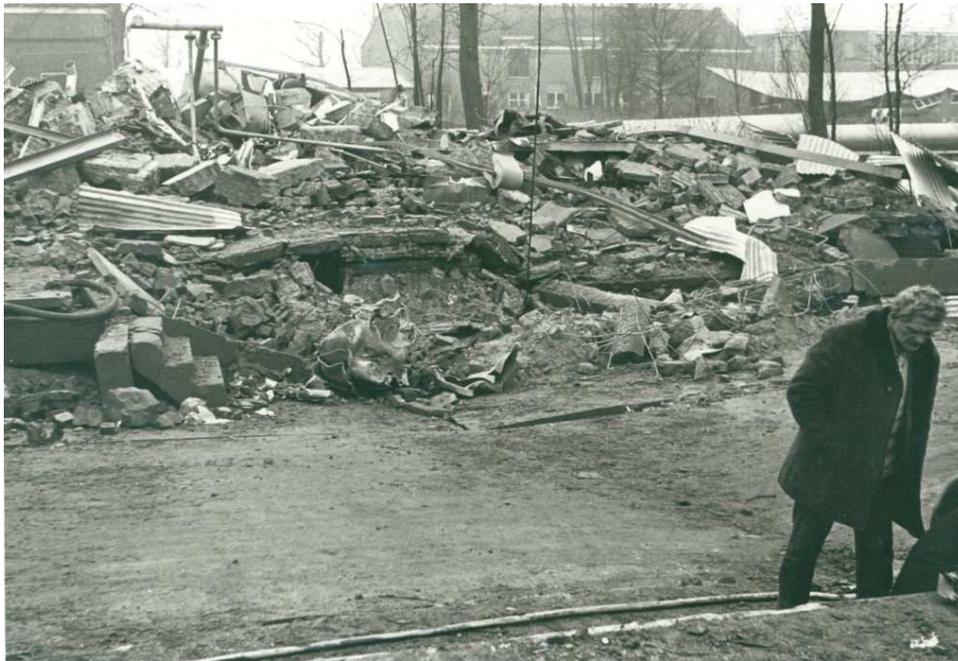
Building 7A, located about ten metres away, was blasted apart, collapsed and then buried under considerable rubble and debris from Building 7.

*Remnants of Building 7A (with debris and materials stemming from Building 7) [1]*

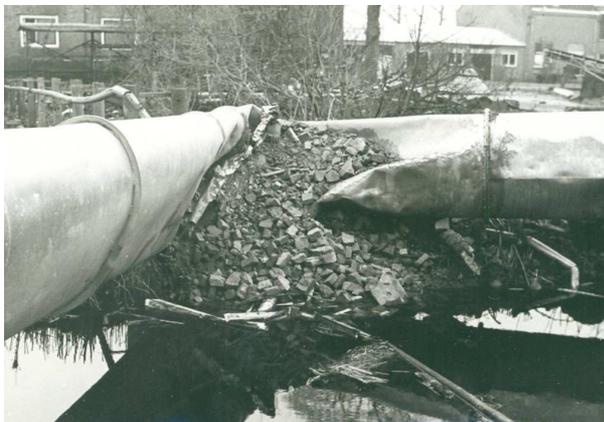
Many factory buildings were seriously damaged and all sustained broken windows. Several pipelines crossing the factory were also destroyed.

*Damaged pipeline [1]*

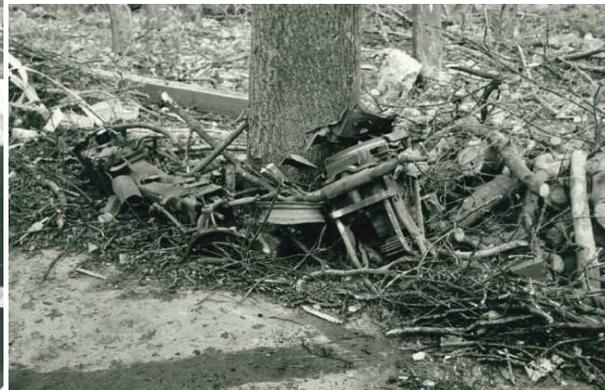
*Remains of the diesel tractor [1]*

The evaluation of craters, debris and projections from buildings and machines (including the tractor, platform truck, forklift, etc.) enabled investigators to conclude that all 7 tanks inside or adjacent to Building 7 detonated and moreover that the explosion source was located inside Building 7. This first blast then caused 2 dry gunpowder tanks to explode on the platform truck parked outside the building.

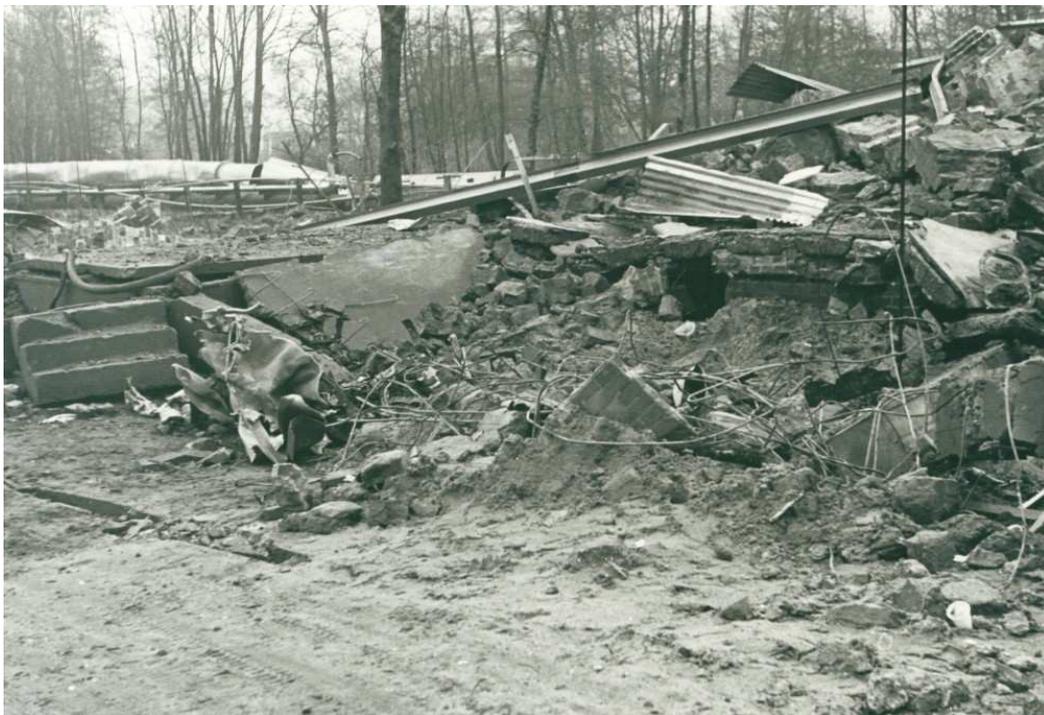
*Rubble that was once Building 7A [1]*
