Explosion and fire at a pesticide manufacturing plant

28 August 2008

Institute, West Virginia
United-States

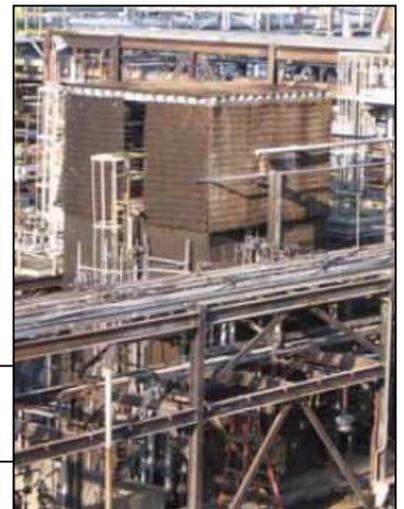
*MIC day tank shield blanket structure
(Picture CSB – R.R.)*

This accident also underlines the importance of the study of potential domino effects. The analysis of the structure of the MIC day tank concluded that the structure provided only marginal impact energy absorption protection from a large fragment strike at velocities predicted to result from an explosion such as the one that happened. Had the residue treater travelled in the direction of the MIC day tank, and struck the shield structure, the relief valve vent pipe might have been impacted, causing the release of highly toxic MIC vapour into the atmosphere (domino effect), which could have led to much catastrophic consequences in a urbanised area. That is why the operator reduced the risks created by the MIC storage at the source after the accident (see above / actions taken).

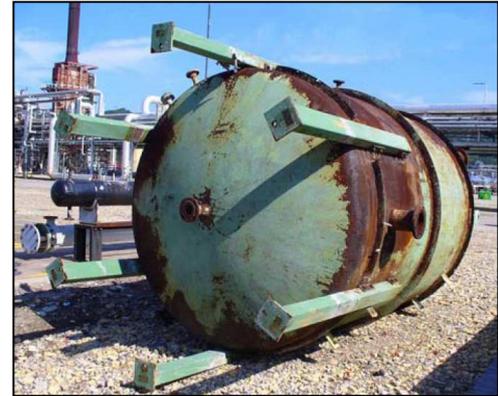
¹ The "vessel mechanical integrity program" inspection results found that the 25-year-old vessel had sustained significant wall thinning due to generalized corrosion. Using its management of change (MOC) program, the operator planned to replace the vessel with a new stainless steel pressure vessel to improve corrosion resistance. The existing recirculation piping, controls, and instruments were not modified.

Old residue Treater / Picture CSB (R.R.)

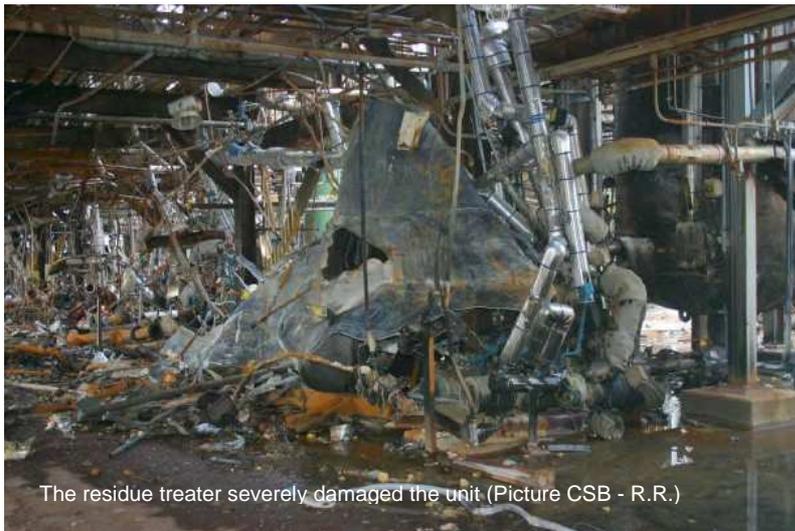
But the runaway reaction could not be controlled. Around 10:33, the tank relief valves opened, followed by the violent rupture of the residue treater, destroying part of the production unit (piping, electrical conduit and a structural steel support column).

The residue treater severely damaged the unit (Picture CSB - R.R.)

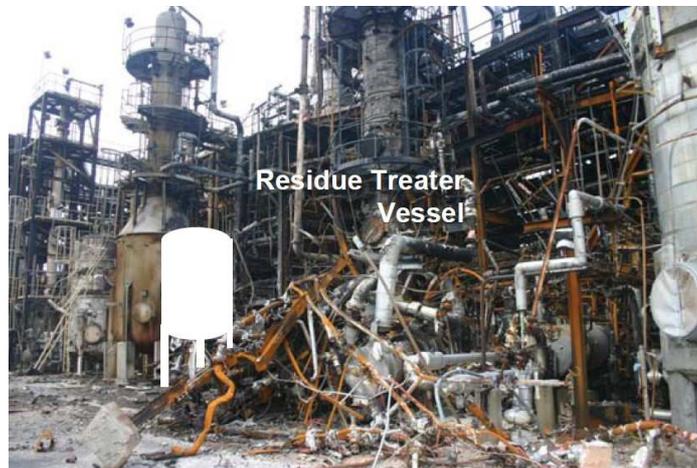
Destruction of the unit and former place of the residue treater vessel (picture CSB / R.R)
