VCE in a waste treatment tank of a pharmaceutical plant

10 June 2010

Brindisi (Apulia)

Explosive atmosphere
Modifications
Hot work
Fermentation
Risk analysis

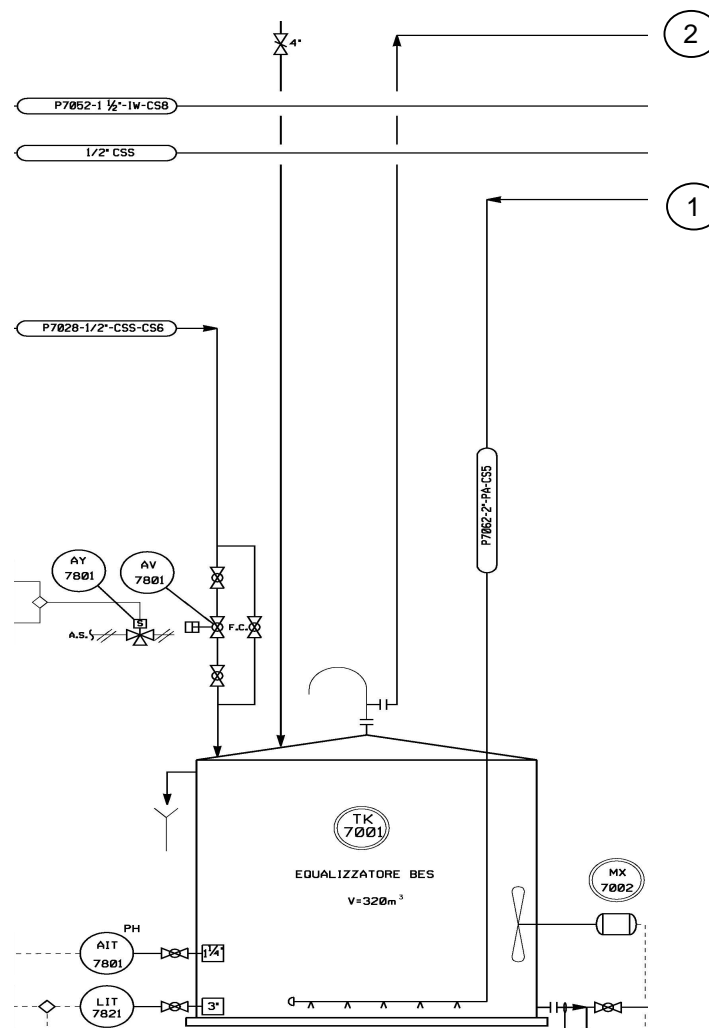
In its original design, the TKX was equipped with an internal system to insert and spread the air and an external system to suck air out. These systems, not operative at the moment of the accident, should have been active during normal TKX operation (Figure 3), planned as follows:

In March 2000, during revamping of the TKX, the air system was considered as “additional” with respect to the internal helical lateral mixer, and “responsible” for causing bad smell and foam. As a consequence, it was locked off.

Fig. 3: Normal TKX operation principle (source: operator)

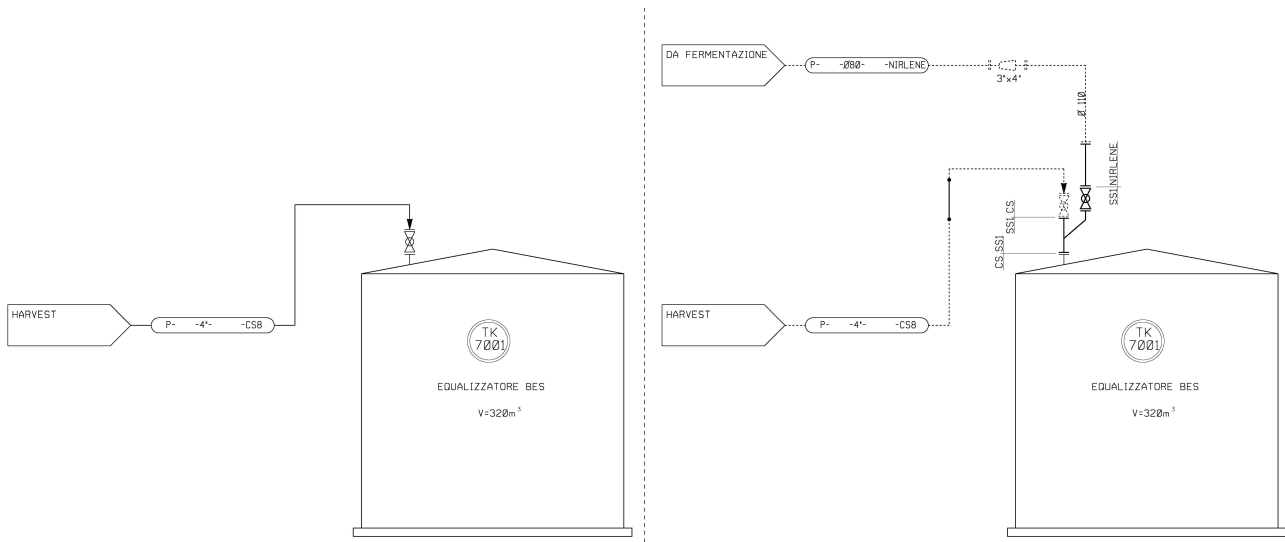
The aim of the operation was to add a second feed line to the TKX (Figure 4). Coming from the fermentation unit, it should have allowed the delivery into the TKX of the waste broth from a new antibiotic production unit. The existing feed line had been cleared up and disconnected from the tank, without closing (blind flange) the tank or the line. The tank was half filled with BES.

Fig. 4: (Left) Existing TKX; (Right) modification project at right (source: operator)

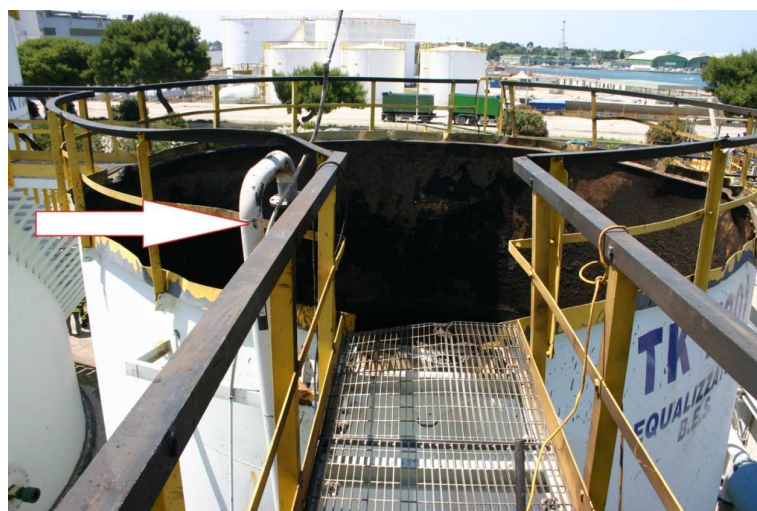
When the explosion occurred, the roof was torn out along the circular welding line (Figures 5 to 7) and thrown at a distance of 20 m, pulling up the air sparger line (Figures 8 and 9). The contractor on the roof was thrown on the roof of the TKY and died.

Fig. 5: Pulled-off sparger line on the TKX viewed from the walkway (source: ARPA Puglia)

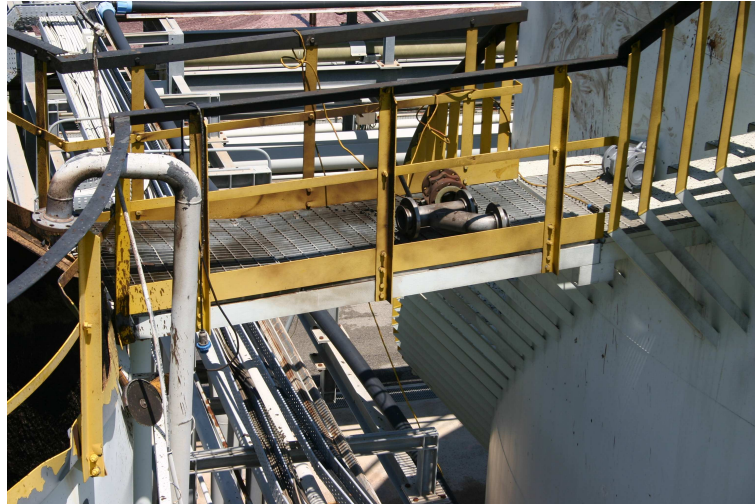
Five workers were present when the explosion occurred: four contractors and an employee of the operator. One contractor standing on the roof was holding the line to be cut, the others workers were on the walkway leading to the tank (Figure 5).

Fig. 6: Walkway between TKX and TKY (source: ARPA Puglia)

- A. An explosive atmosphere was present inside the TKX, which was ignited by the sparks generated while cutting the feed pipeline by the electrical cutter. The feed line had been cleaned up and disconnected from the tank without closing them with blind flanges, and leaving the nozzle on the tank opened (Figures 6 and 9).

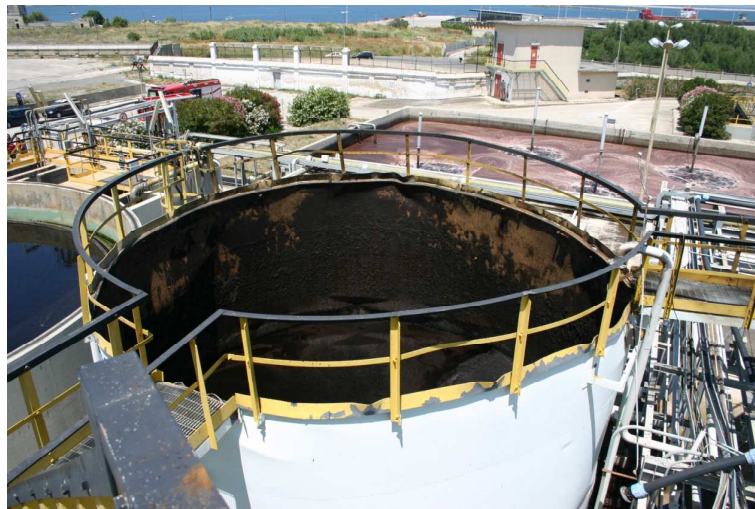
Fig. 7: Exploded TKX (source: ARPA Puglia)

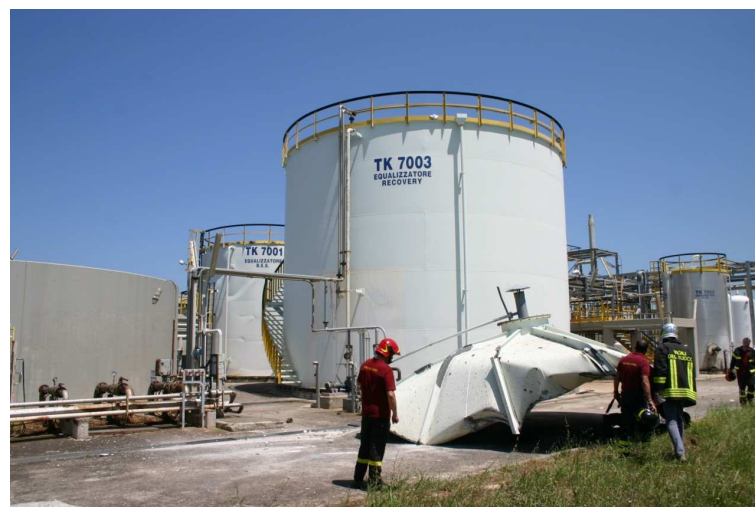
Fig. 8: Projected roof at the foot of the TKX (source: ARPA Puglia)

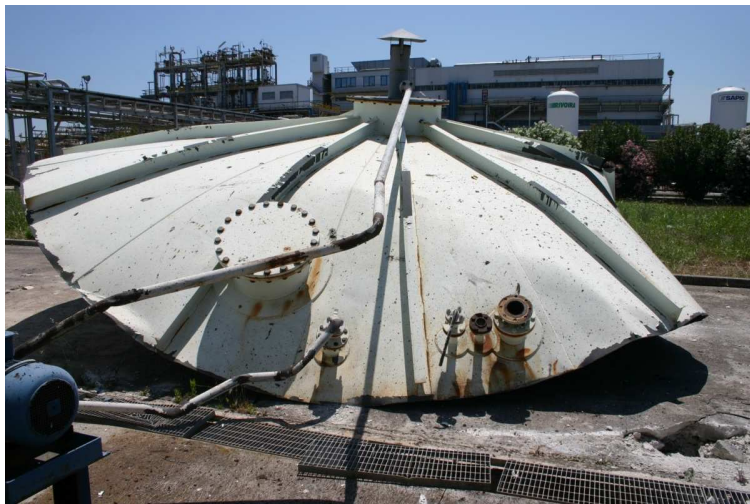
Fig. 9: Exploded roof, note the absence of plain flange on the air line (source: ARPA Puglia)

a. The contact between the sparks generated while cutting the feed pipeline and the explosive atmosphere was made possible by the absence of mechanical closing of the tank with blind flanges. This should have been done before the maintenance operation, according to the work permit procedure of the operator that required indicating:

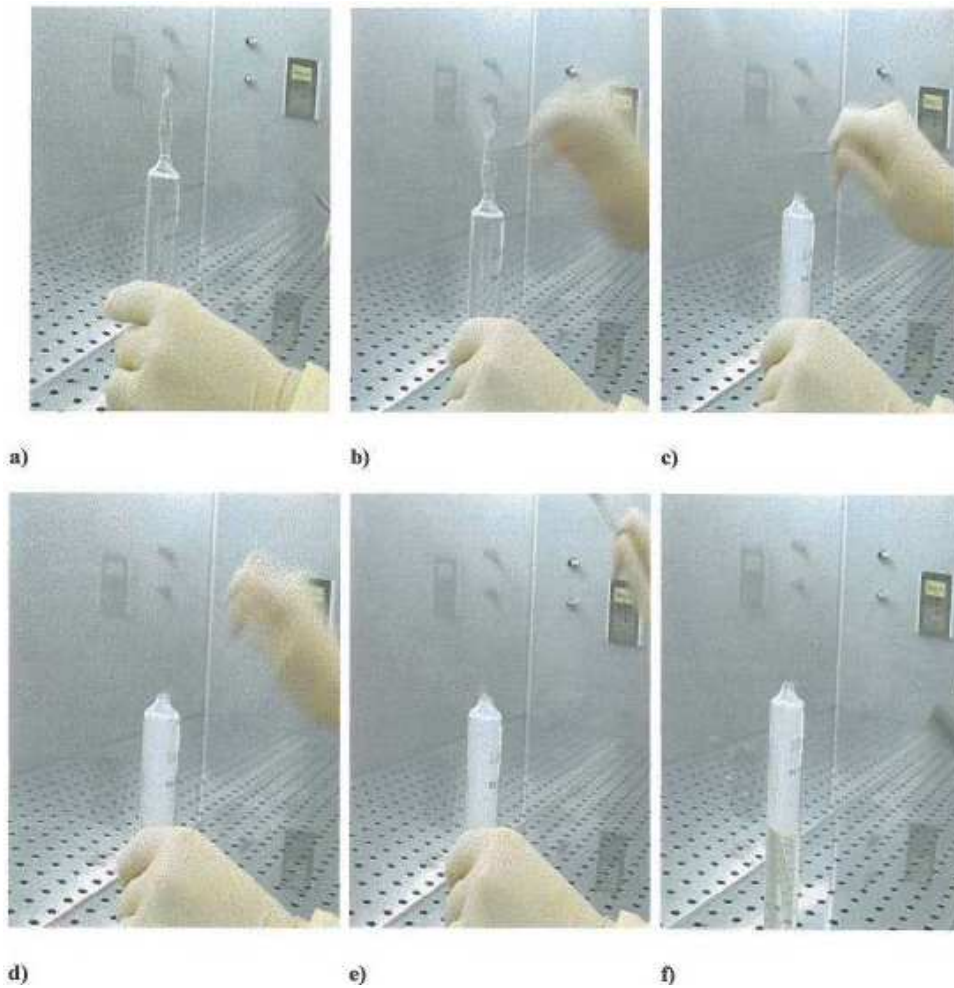
Gas-vapour phase: after the accident, BES samples were collected from the bottom of the tank. After an anaerobic fermentation in sealed ampoules, a gas-chromatography identification of gases formed was done. A high pressure had developed inside the ampoules, and some of them exploded due to overpressure after three weeks (Figure 10). The gas analysis confirmed the presence of traces of methane (CH₄), hydrogen (H₂), methanethiol (CH₃SH) and flammable sulphides compounds, probably formed from the solid phase accumulated at the bottom of the tank in the absence of aeration system.

Fig. 10: Gas overpressure after anaerobic fermentation in sealed BES samples ampoules (source: ARPA Puglia)

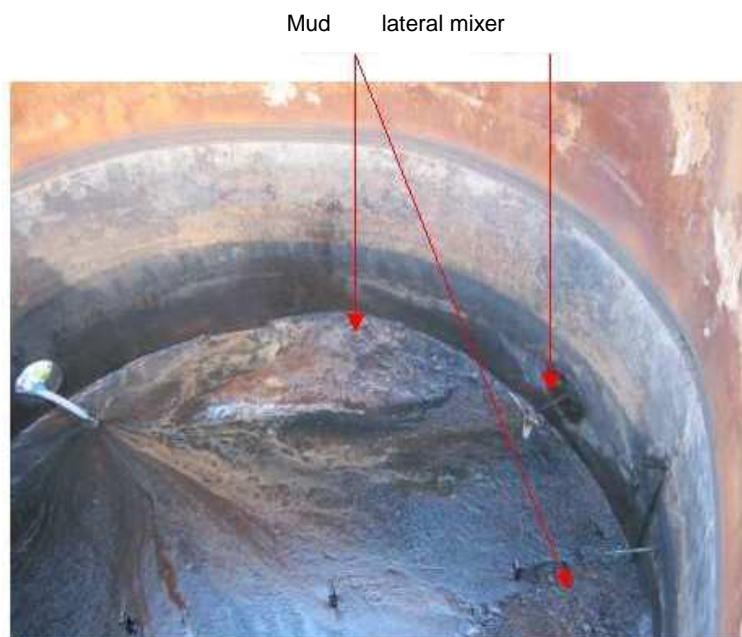
Solid phase: the analysis carried out by the operator on gas produced by the solid phase or paste residues collected in December 2010 from several parts of the tank (bottom and lateral sides, Figures 11 and 12), revealed the presence of carbon disulphide, carbonyl sulphide, tetrahydrofurane (THF), dichloromethane (CH₂Cl₂), chloroform (CHCl₃) and other residual solvents present in the production processes.

Fig. 11: TKX after emptying in December 2000 - solid residues collected from the bottom (source: operator)

- e. long stay (2-3 days) of the BES inside the tank, which facilitated the fermentation. The positioning of the exit nozzle 40 cm above the tank bottom allowed the accumulation of up to 40 cm of solid phase.

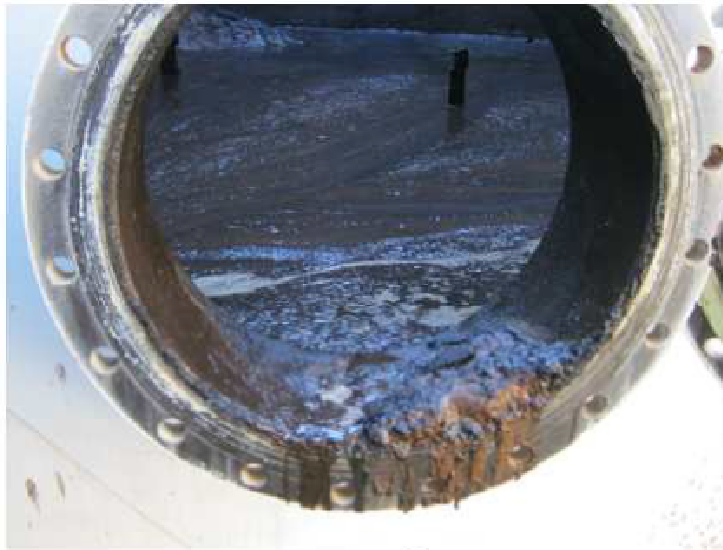
Fig. 12: Solid / paste residues collected from the exit nozzle (source: operator)
