# Massive alumina red sludge release after the failure of a containment dam

4 October 2010

**Kolontár**  
**Hungary**

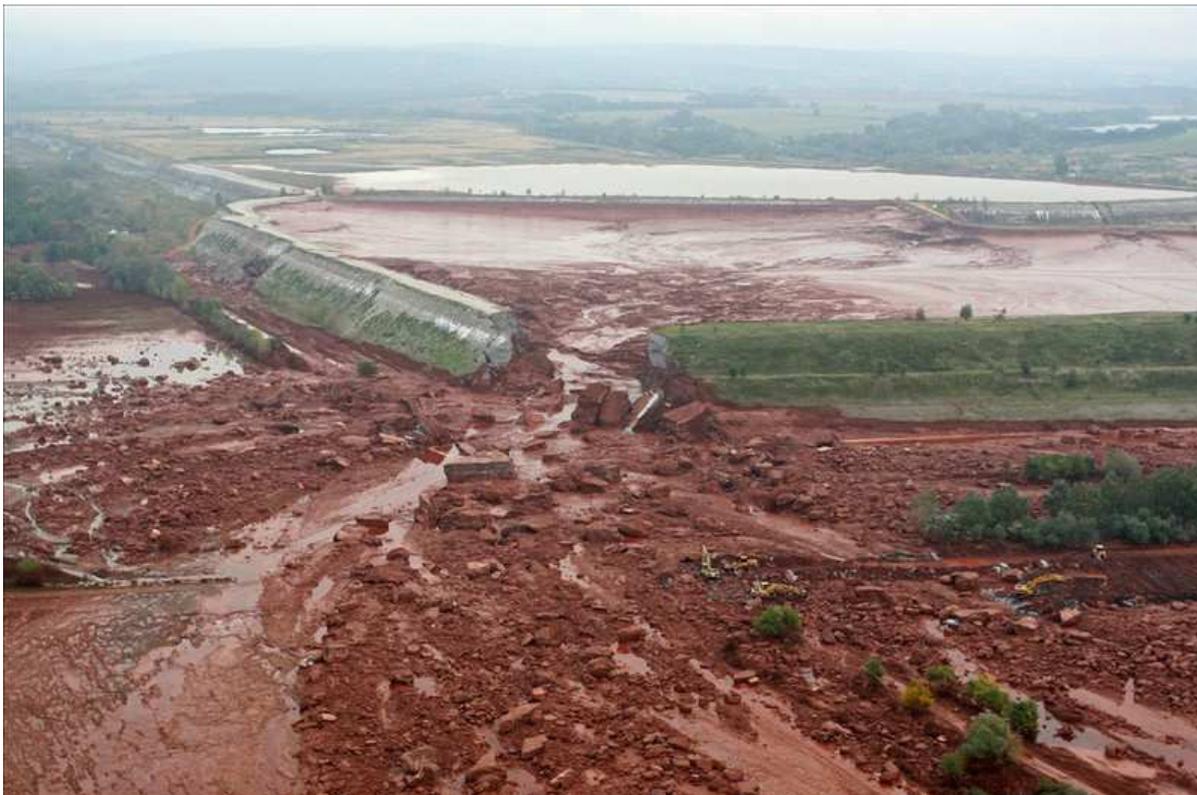
At around midday on 4 October 2010 a breach occurred in the dam wall (app. 50 metres long) holding back red sludge in containment Reservoir 10 of the MAL Inc. The strongly alkaline water produced through the Bayer process for the treatment of bauxite, containing residues of aluminium and toxic metals immediately flooded the village of Kolontár, then Devecsér and other towns. Instant response was necessary to protect lives and property, and to preserve natural assets and agricultural areas.

3. Dike breach

One of the reasons that led to the accident was the extreme amount of rain in the year 2010. It was the source of numerous agricultural and environmental problems all over Hungary in that year. The extreme quantity and the intensity of rain resulted in huge agricultural areas covered with inland waters and caused floods in some areas where it was unprecedented before. The enormous amount of rain that fell on the top of the red sludge in the Reservoir 10 further increased the pressure on the wall of the dam. It worked as a catalyst in the dike's erosion process and finally led to the breach of the wall.

Over the course of four days (9-12 October) teams of construction professionals built a defence dam (Dam Number 1) 620 metres long, 2.75 metres high and 6.8 metres wide near the ruptured sludge container. After constructing the defence dam, hydrological experts began work on temporarily sealing Reservoir 10. The breach has been completely closed with tiered ring dam walls with water outlet capacity. The six cascade basins formed by the ring dams safely drain alkali water from the damaged reservoir, while holding back red sludge.

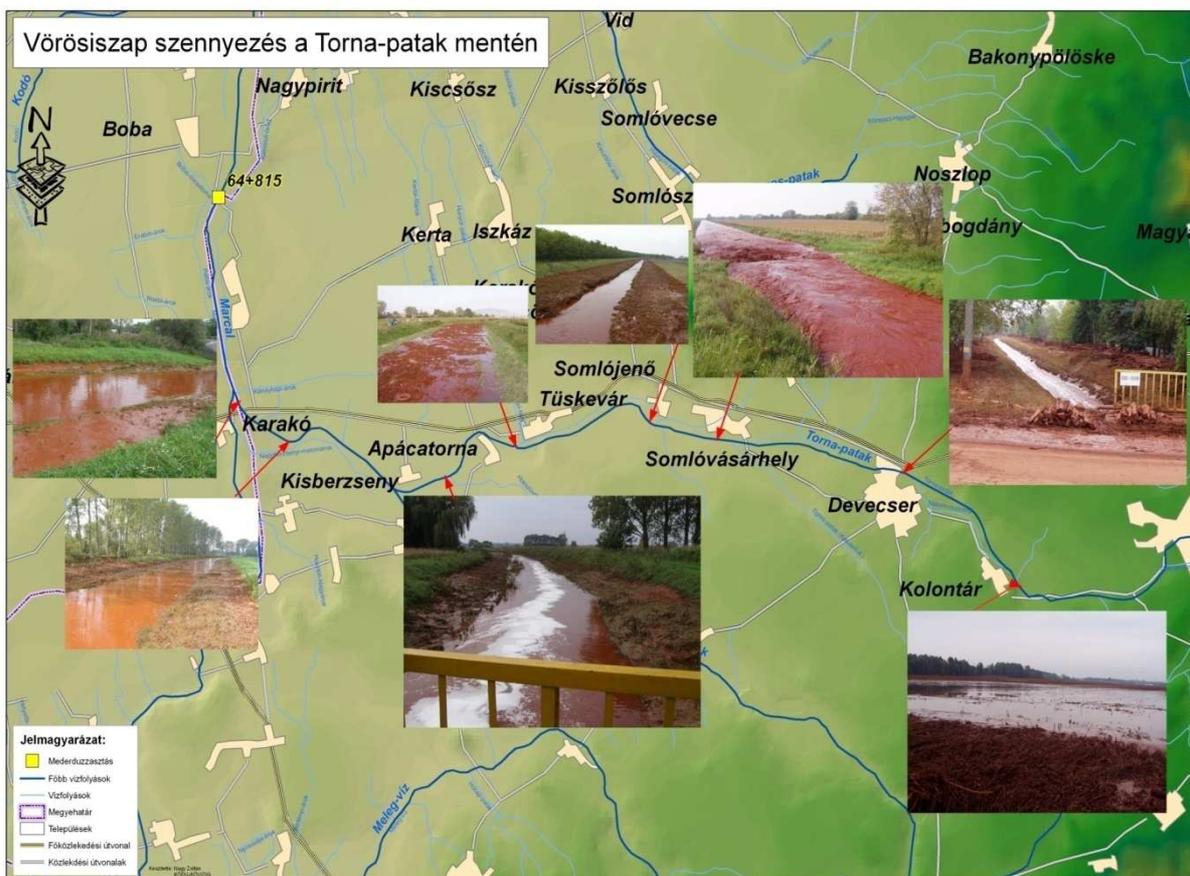
As the result of the rupture of the dam wall, the Torna Creek and its valley were contaminated by the estimated amount of over 1 million m<sup>3</sup> of alkaline red sludge. The pollution plume reached the Marcal River at 6:00 pm on the same day, in which the recent flood wave was already decreasing, therefore the transport of the pollution fortunately slowed down. In the morning of the 5 October a warning message was sent out to the Danube basin countries by Hungarian national centre (PIAC) through the Accident Emergency Warning System (AEWS) of the Danube Protection Convention. The head of the plume passed the village of Mersevár at 3:00 pm on the same day.

4. Contamination along the Torna Creek

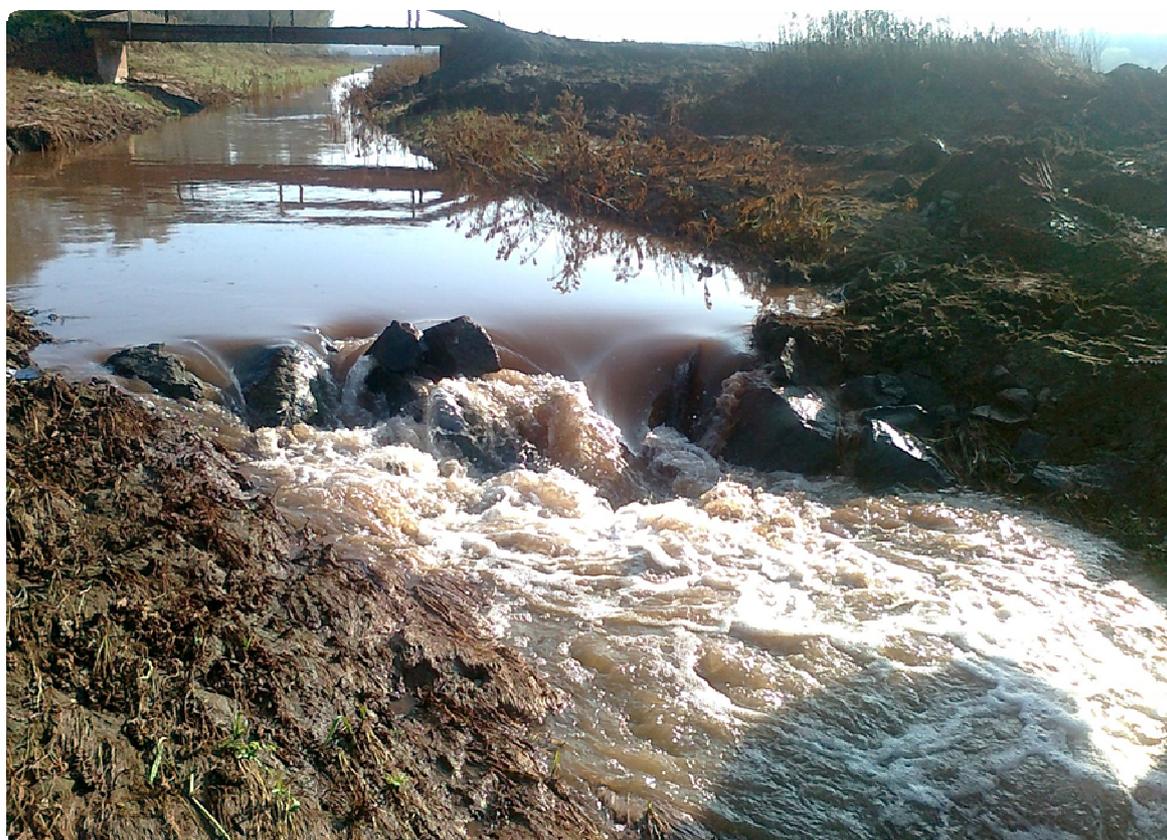
Hungary took intensive measures on the whole length of the Marcal River before the arrival of the pollution plume to settle down the suspended solids possibly contaminated by heavy metals. For this reason decision was made to construct 7 so called “riverbed barriers” (artificially created obstacle under water – on the river bottom - to stop the heavier fractions of contamination (the red mud) in the riverbed).

### 5. Riverbed barrier

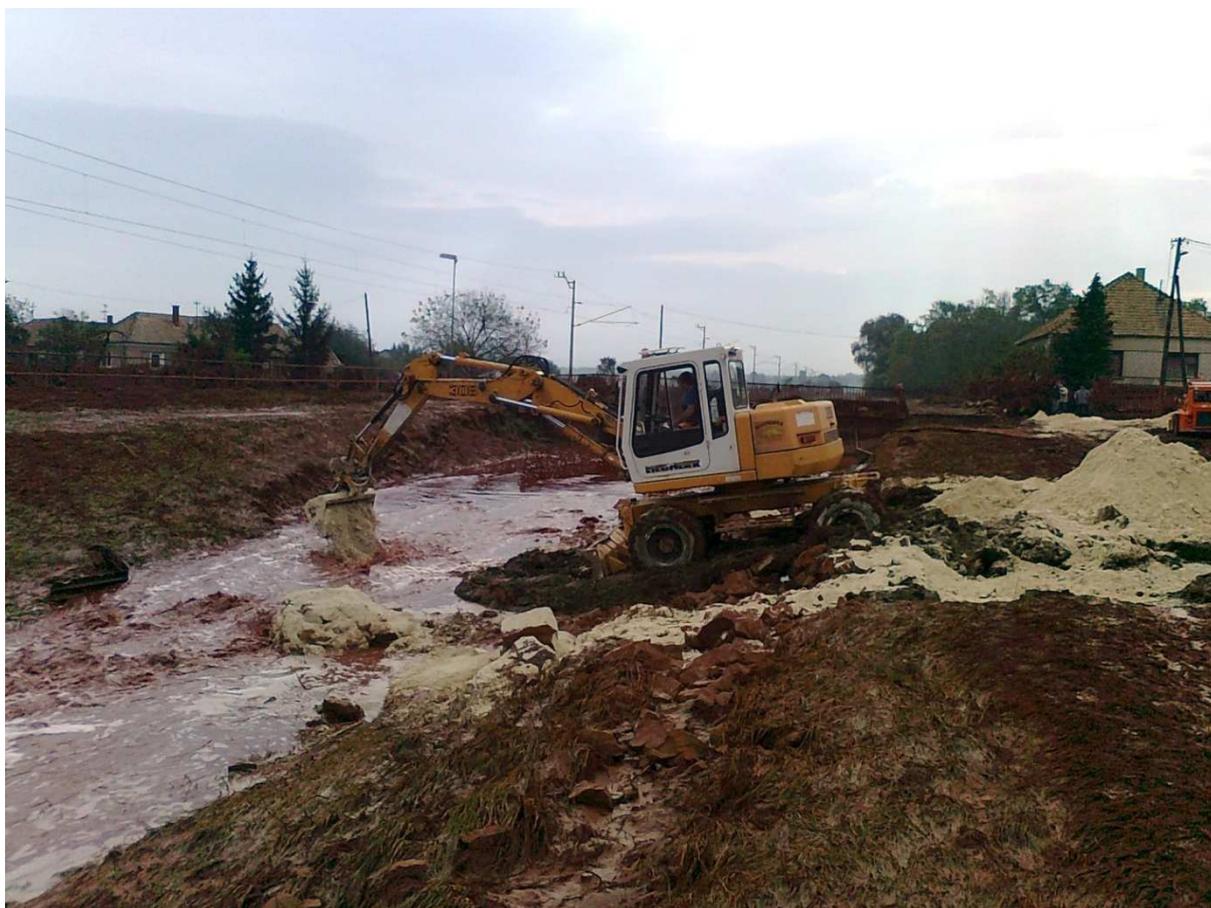
Protection of water quality also demanded immediate action. The most important measures were neutralisation of water and the capture of floating matter containing heavy metals. Gypsum (23,500 tonnes) and acetic acid (cc. 1,800 m<sup>3</sup>) were used to reduce water pH levels. The mixing of gypsum as it began to be applied was aided by the use of high-pressure fire-hoses and aeration equipment. In the settlements involved gypsum was also added directly on affected areas.

### 7. Decontamination (gypsum dispersion, below Kolontár Bridge)
