Natural triggering event: Severe cold spell

Crushing of a butadiene tank at a marshalling yard

27 December 2010

Woippy (57)

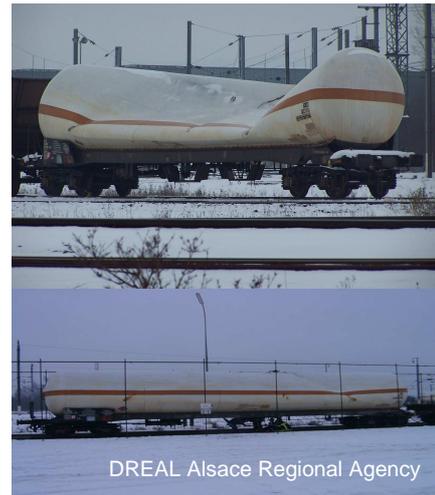
A pressurised liquefied butadiene tank, which had been drained but not yet degassed, collapsed on one of the tracks at the Woippy marshalling yard during a period of intense cold weather (temperatures as low as -17°C). Due to its ensuing deformation, the railcar was no longer in a state to circulate and furthermore caused a micro leak on a tank valve.

Nonetheless, the tank remained heavily damaged and unsuitable for transport (property loss: approx. €200,000).

This drained, yet not degassed, tanker car had contained a residual quantity of some 870 kg of product, which during the winter period was exposed to temperatures below its boiling point (-4.5°C). The butadiene gas, which had formed the car's vapour expansion space, subsequently liquefied, triggering a pressure loss estimated at 0.35 bar (i.e. the tank's lower limit design pressure).

It had not been anticipated therefore that the tank might subsequently be subjected to more severe depressurisation conditions. On 26 December, the ambient temperature dropped to -17°C and exposed the tank to a substantial pressure loss, eventually leading to its collapse.

Prior to being moved, the tanker car first had to be inerted with nitrogen and drained onsite. This step was performed by technicians specially called to the scene as part of the TRANSAID accident response protocol. The entire sequence of steps was carried out under continuous supervision of fire-fighters with the Moselle Departmental Fire Services unit.

At present, the international regulation of such transport for both road and rail modes has set guidelines intended to protect empty tanks having previously transported liquefied gas at low pressure against the risks of deformation, by means, for example, of filling with nitrogen or another inert gas in order to maintain sufficient pressure inside the tank. Such steps are specifically aimed at avoiding the collapse of older tanks that were not designed or built to withstand pressure drops.
