Explosion of a formulation reactor at a chemical plant

January 11th, 2011

Bourgoin-Jallieu (Isère)

Chemical plant
Reactor
Explosion
Inerting
Toluene
Sodium methoxide
Glass equipment
Human factor

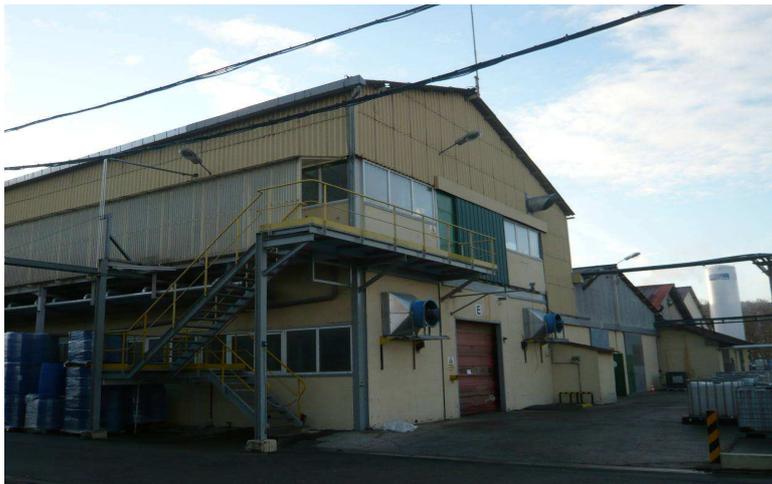
Figure 2: View of the damaged unit (source: Site operator)

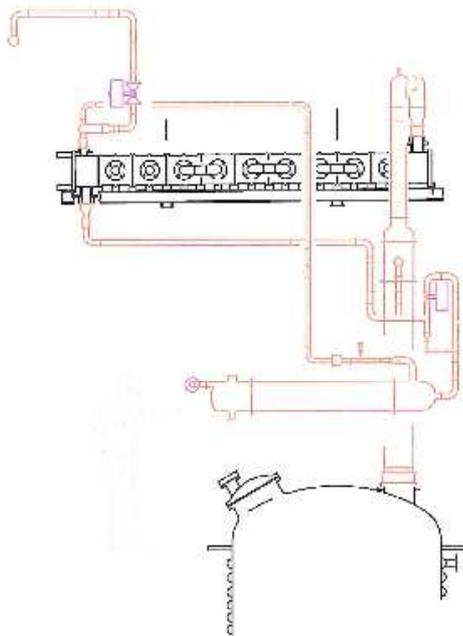
On Tuesday 11th January, 2011 around 1:40 am, an explosion occurred inside the formulation reactor (Fig. 3) once all the camphorsulfonic acid had been loaded into the toluene for dehydration via azeotropic distillation. No chemical reaction ensued, and the mix temperature held constant at 15°C. This operation was conducted under atmospheric pressure with an atmosphere rendered inert by means of nitrogen sweeping.

Figure 3: Diagram of the damaged reactor, with glassworks shown in red and the reactor's enamelled steel housing or exchanger graphite shown in black (source: Site operator)

The site operator's investigation revealed that the column broke subsequent to an internal pressure surge; the glass tubes of this diameter (i.e. DN 300) were not designed to resist static pressure in excess of 1 bar. Both the splitting of the column into many small fragments and the damage recorded (essentially over the upper part of the building) attest to a fast-acting pressure rise phenomenon.

The large quantity of soot in the reactor reflects incomplete toluene combustion due to an insufficient oxygen concentration (i.e. partial reactor inerting) at the time of ignition. A lack of oxygen might also explain why the flame died and why a secondary fire never broke out (toluene is inflammable at room temperature).

- Drafting of specific instructions relative to the inerting of formulation reactors, entitled "Atmospheric measurements inside closed capacities".
- For the targeted process, drafting of an operating procedure specifying continuous oxygen content measurements inside the reactor, along with replacement of the glass column by an enamelled column.

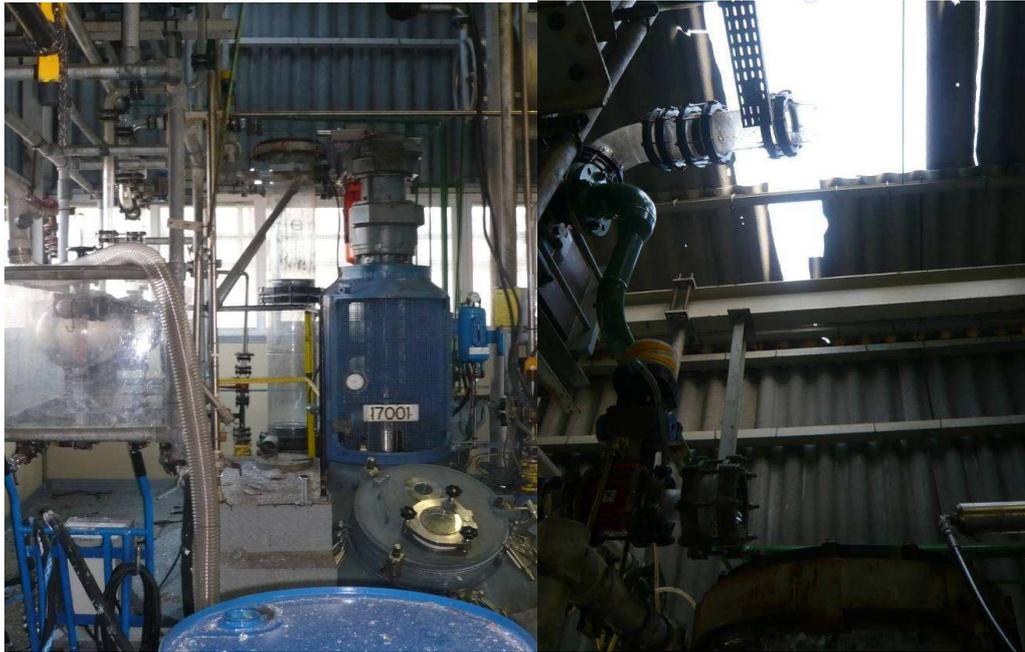
The explosion caused one injury as a result of the direct (blast) effect. It also broke the upper part of the distillation column, damaged the roof (ripping off asbestos-cement plates) and projected debris (mainly pieces of glass) 20 m to 30 m from the production building, while remaining inside the site boundary (Fig. 4).

Figure 4: View of damage sustained by the workshop where the accident occurred (source: Site operator)

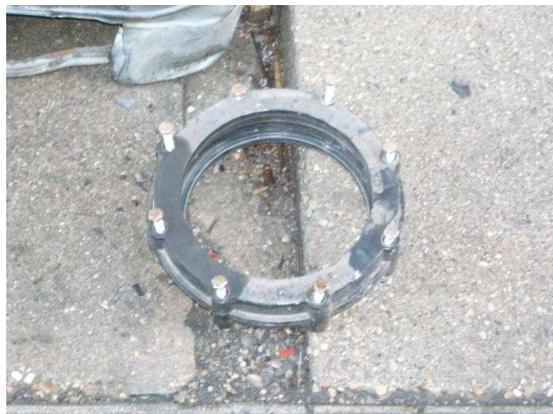
The upper part of the column (DN 300, designed for a max pressure of 1 bar) burst into many small pieces of glass. At the column top, the temperature transmitter was stripped from the power supply cable and eventually found lying on the building roof. A flange (weighing 0.5 - 1 kg) was recovered outside, approx. 20 m from the production building facade, yet still within the site boundary (Fig. 5).

Figure 5: Flange ejected outside the building (source: Site operator)

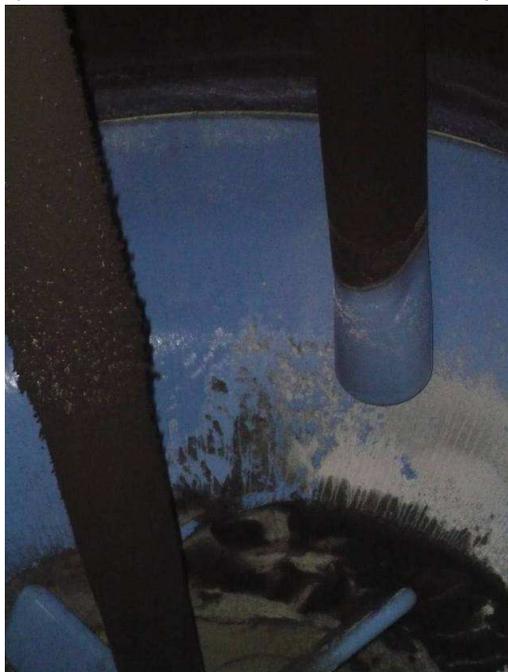
A large quantity of soot was observed on the reactor walls, as well as inside the dome, on the manhole surface and along the agitator shaft (Fig. 6). Traces of soot were also visible in both the glass pipes and the (Florentine type) decanter, thus indicating that the circuits had been open when the explosion was triggered. The valve at the outlet of the Florentine decanter had remained in the closed position.

Figure 6: Traces of soot inside the reactor (Source: Site operator)

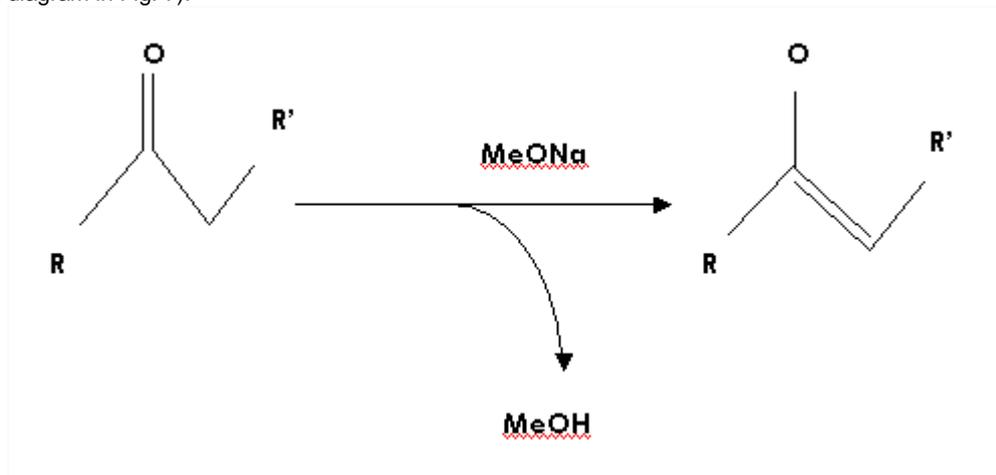
Between two identical product manufacturing runs, the reactor was neither descaled nor rinsed. The end of the reaction was controlled by the change in methanol content stemming from the transformation of sodium methoxide (see reaction diagram in Fig. 7).

Figure 7: Reaction leading to the accident (source: Site operator)

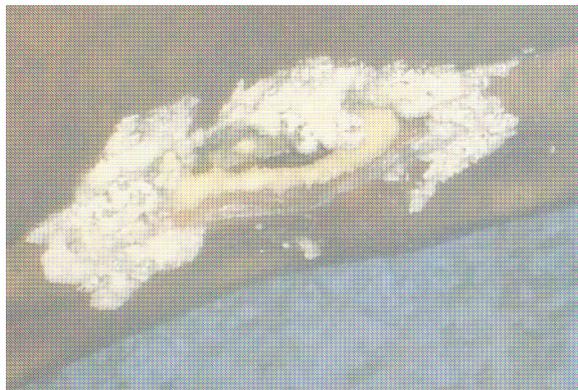
An infrared analysis conducted on a sample by an external laboratory revealed the presence of camphorsulfonic acid (Fig. 8).

Figure 8: Camphorsulfonic acid at the reactor surface (source: Site operator)
