Explosion of a paper pulp storage tank

18 January 2011

Nogent-sur-Seine (Aube)

Explosion
Hydrogen
Paper mill
Victims
Works / modifications

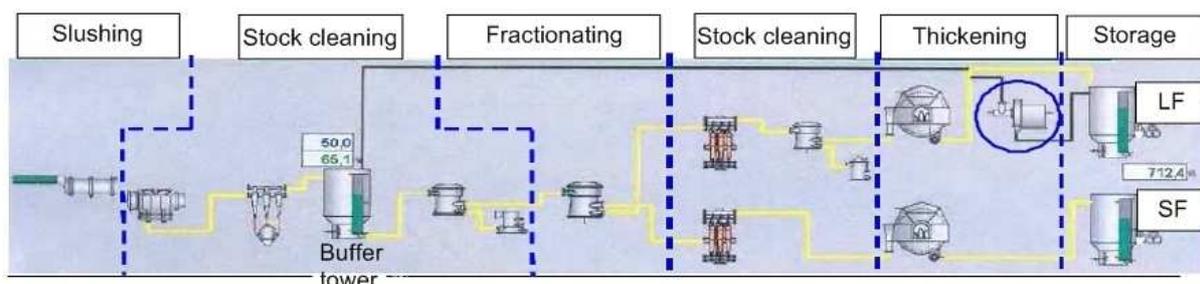
The paper pulp processing path is depicted by the yellow line.

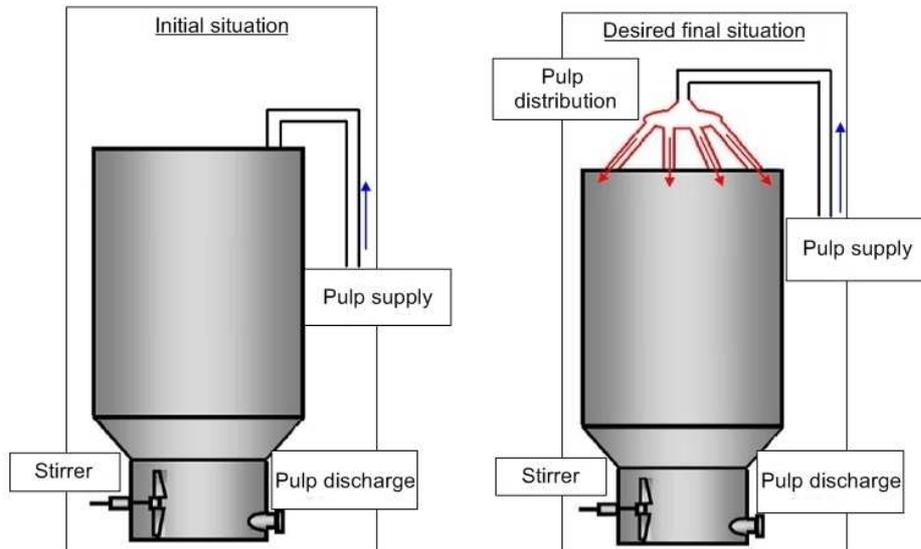
A preliminary transformation completed in December 2010 had included pre-installing a new pulp distribution system on the LF storage tower by replacing the single pipe with one splitting into four tubes (shown in red in the figure below). On the day of the accident, the mission assigned to a subcontractor specialised in sheet metal work entailed connecting the pulp supply pipe to the distribution system.

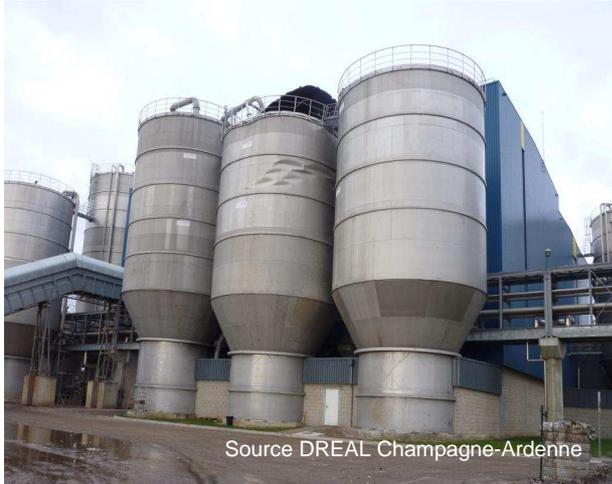
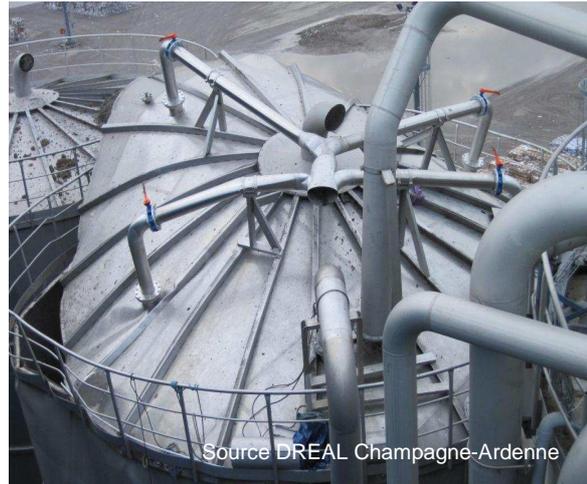
As for property loss, the LF storage tower sustained heavy damage and its use was immediately prohibited by the Inspection Authorities for Classified Facilities. This decision led to a production shutdown, as the tank involved was critical to factory operations.

- paper pulp stored in the tower released hydrogen at a rate such that the lower explosive limit (LEL) could be reached within a few hours,
- the hydrogen then mixed with air present in the tower vapour space to form an explosive atmosphere (ATEX),
- the source of ATEX ignition was a spark generated by the grinder during cutting of the pipe connected to the tower vapour space,
- the pressure surge created by the explosion caused the tower roof to fail at the level of the seam on the tie-in weld with the cylindrical shell.
