Hydrocarbon spill during a transfer operation

17 July 2010

Speyer

Refinery
Hydrocarbons
Unloading
Pipe
Leak
Site clean-up
Procedures

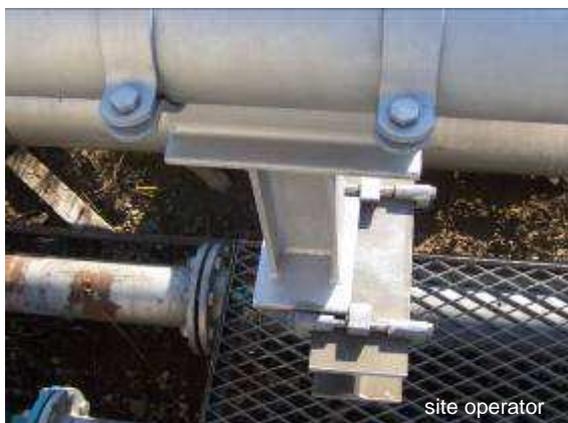
Restarting the boat's pump at high pressure (100 m³/h instead of 50 m³/h) had caused an expansion compensator installed on the pipe to burst. The leak released 120 m³ (i.e. approx. 80 tonnes) of hydrocarbons, which in turn penetrated into the unsealed ground.

Dislodged pipe bracket

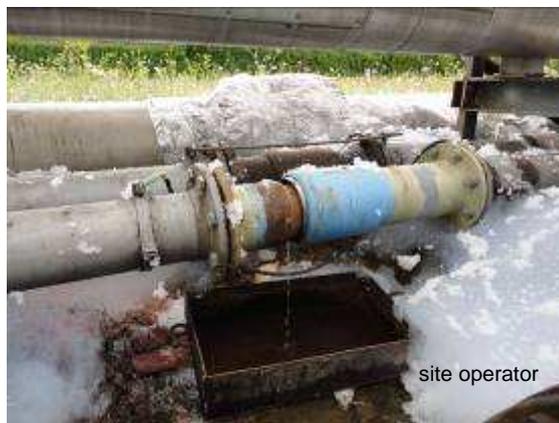
Damaged expansion compensator

The pipe's expansion compensator burst due to the pump's repeated malfunctions and restarting under high pressure. Post-accident investigations revealed that a water hammer phenomenon occurred and was then accentuated by the following technical aspects:

Given the infeasibility of exercising direct authority over a boat's crew or controlling all technical characteristics of their installations, other pump malfunctions are capable of occurring in the future. A system equipped with a vacuum release function was therefore installed to mitigate the ensuing water hammer risks: flow rate measurement equipment around the wharf detected flow rate drops at the outlet and activated a compressible gas (nitrogen) injection, so as to ensure that moving fluid masses would not collide with the static fluid masses in causing peak pressures beyond the pipe's designed strength. Moreover, the number of narrowing cross-sections and expansion compensators was reduced to the bare minimum required. Once the installation had been renovated, just a single pipe was responsible for conveying product between the port and on-site tanks.

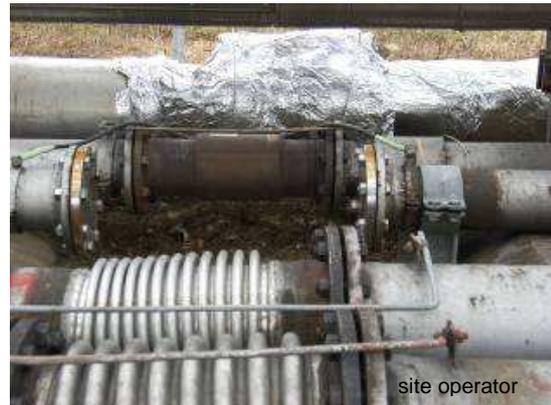
- The 450 m long pipe could not be positioned along a constant incline due to both geographic constraints and the site layout.
- Repeated pump malfunctions led to its cavitation, triggering the formation of cavitation bubbles.
- Pump start-up under more strenuous operating conditions led to a pressure surge that exceeded the pipe design pressure (16 bar).
- The narrowing cross-section (a nominal diameter drop of 150 to 80), combined with improperly placed support systems and the expansion compensator design, was responsible for leading to the breaking point.

Expansion compensator taken apart after the accident

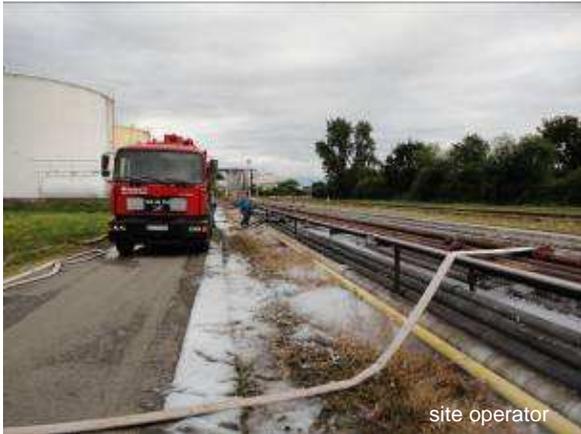
Place of the accident the day after

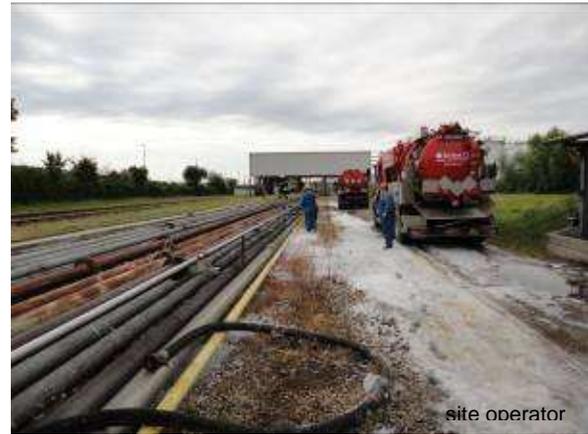
The puddle was subsequently pumped by a specialised subcontractor.

Hydrocarbons pumping

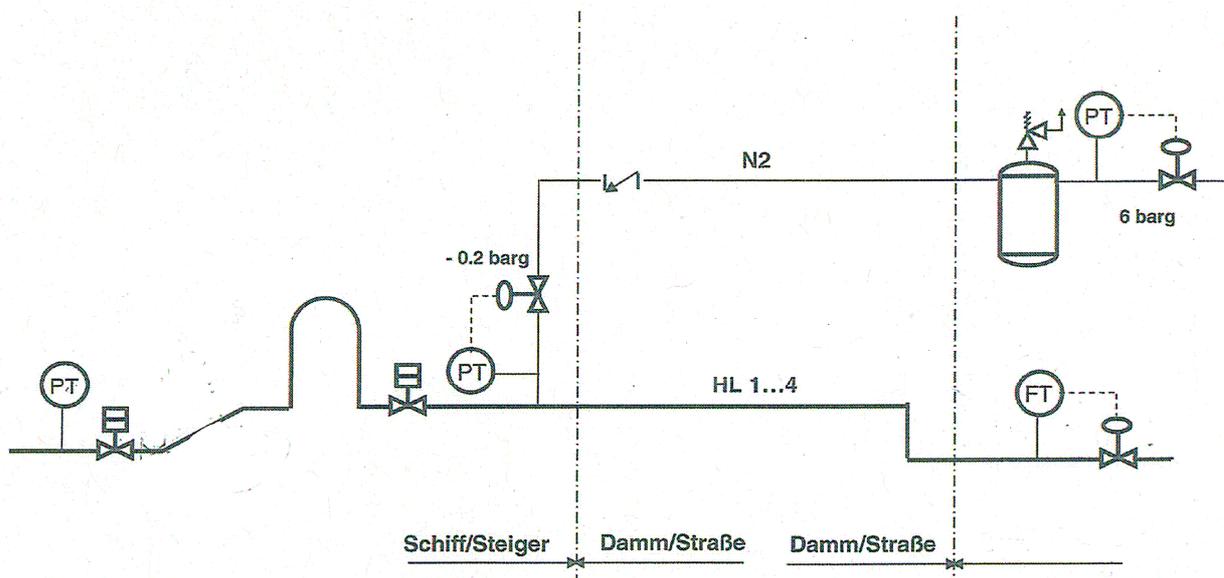
Planned installation and instrumentation layout
