# Explosion in a chlor-alkali plant due to a voltage dip

23 July 2009

Ibbenbüren  
Germany

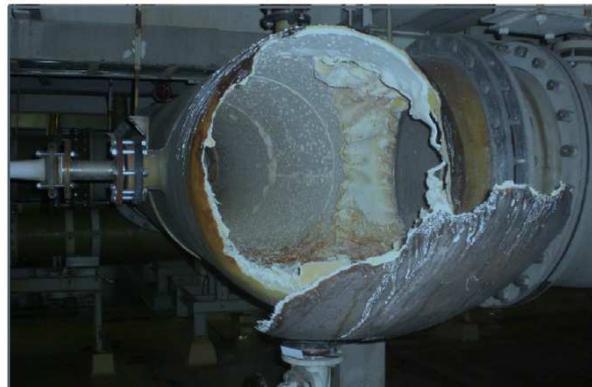
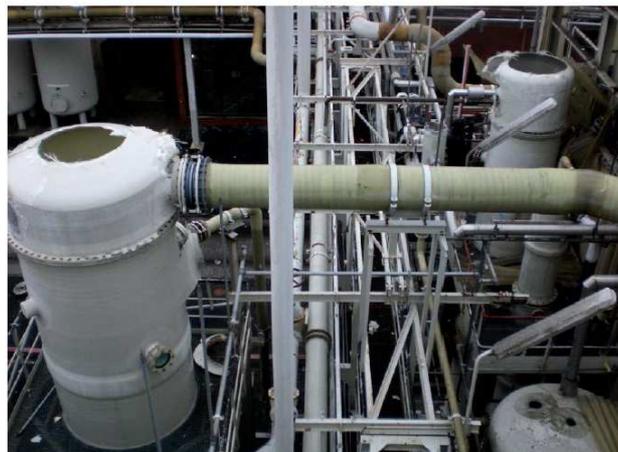
The whole low-pressure system of the chlorine processing was destroyed. The photos below show the damage to the chlorine-collecting pipe below the cell room and to two cooling towers and a demister.

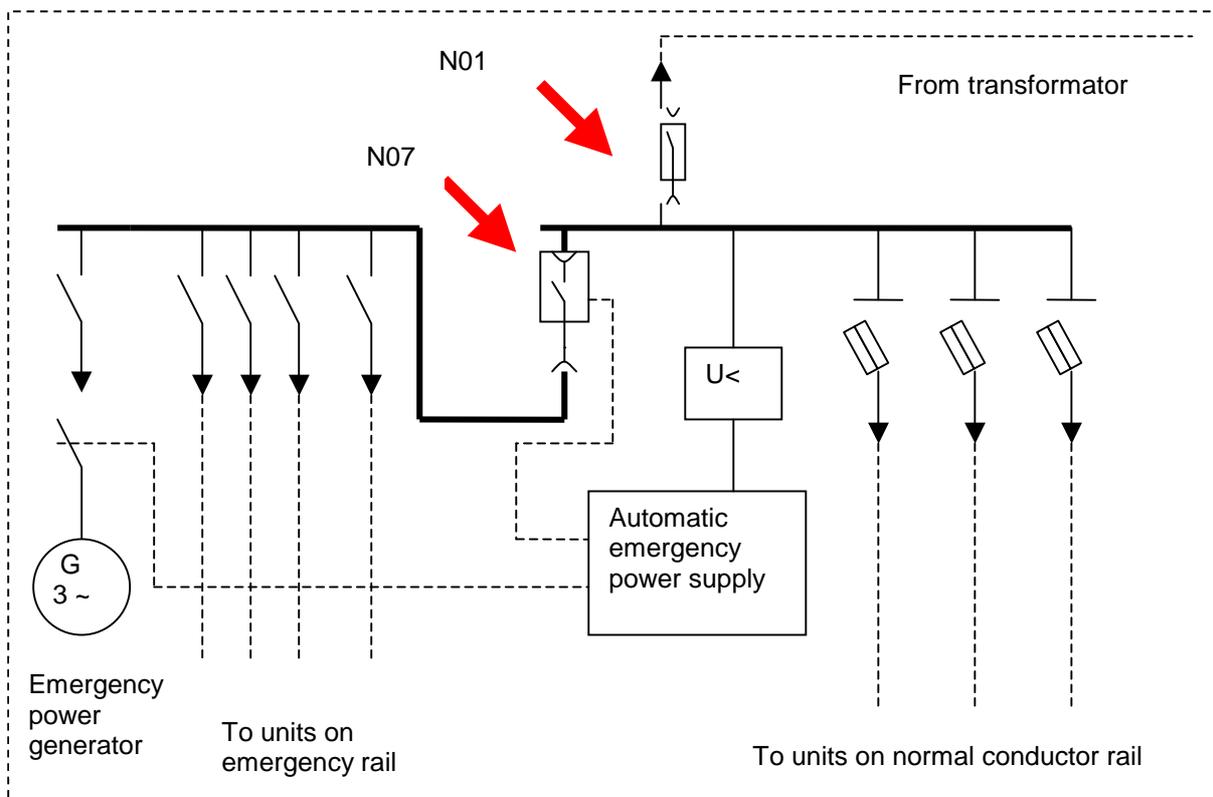
During normal operation the emergency conductor rail is supported by the internal power distribution, the switches N01 and N07 are closed. If the network monitoring registers a voltage dip and classifies the dip as failure, the N07 will open and the emergency power generator is started. On matching the connection conditions, the emergency power generator connects to the emergency conductor rail and supports the units with power.

On 23 July 2009, this happened: the voltage dip was registered by the network monitoring, the switch N07 was opened and the generator was started. But the emergency power generator was not connected to the emergency conductor rail, as the internal net had already returned. The opened switch N07 could not be closed, as the contradictory commands caused a blockade. The whole emergency conductor rail had no power, while the internal net was available.

1. Optimisation of the control technology for the emergency supply in order to exclude blockades.
2. Design of the emergency power supply insuring a safety integrity level (SIL) 2 according to EN IEC 61508/61511.

- Alternative 1: a redundant stand by set with a monitoring device in SIL 2 quality
  - Alternative 2: abandonment of emergency power supply in the safety policyActions taken: the design of the emergency power supply in SIL 2 quality was not realizable. Instead, the redundant stand by set was implemented. Additionally the lack of emergency power supply is regularly regarded in the risk analysis.
