## Rupture of a black liquor tank

8 July 2011

### Saillat-sur-Vienne (Haute-Vienne)

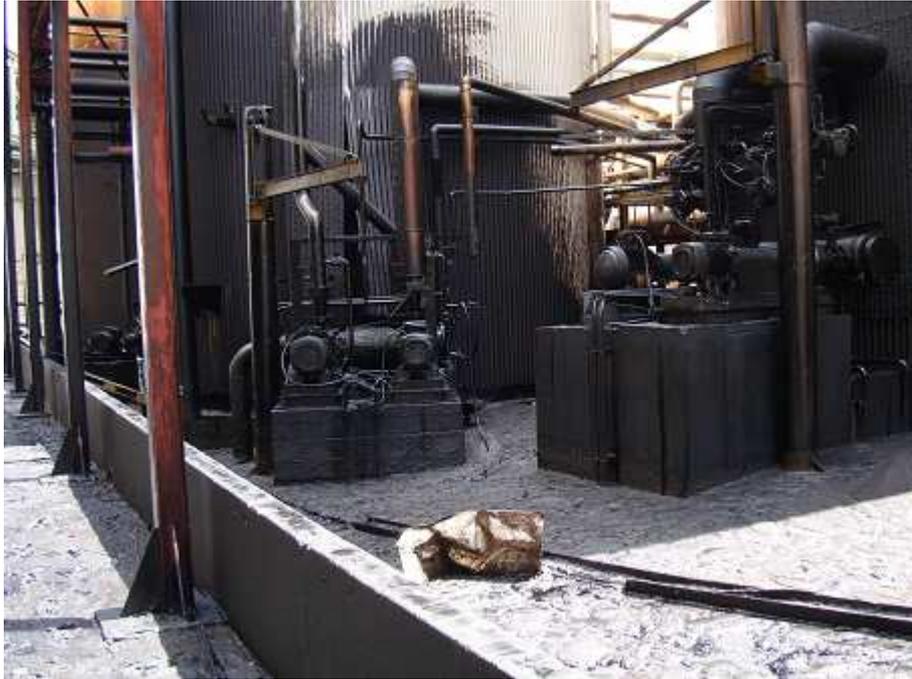
Low wall on the tank TB7 retention basin - Source: DREAL Limousin (Regional Environmental Agency)

Moreover, the raised and outlying position of the TB7 tank retention basin, coupled with its 21-m height and sudden rupture of its cone-shaped bottom, caused the tank to be blasted outside the retention structure (due to the wave effect).

Beyond the mere presence of retention basins, their operational efficiency needs to be examined. For this accident, the magnitude of the wave effect, correlated with tank configuration and location (placed near the low retention wall), exceeded the capacity to retain the entire quantity of black liquor. As such, the mill operator was requested to evaluate the efficiency of existing retention basins to identify potential improvements and undertake remedial actions.

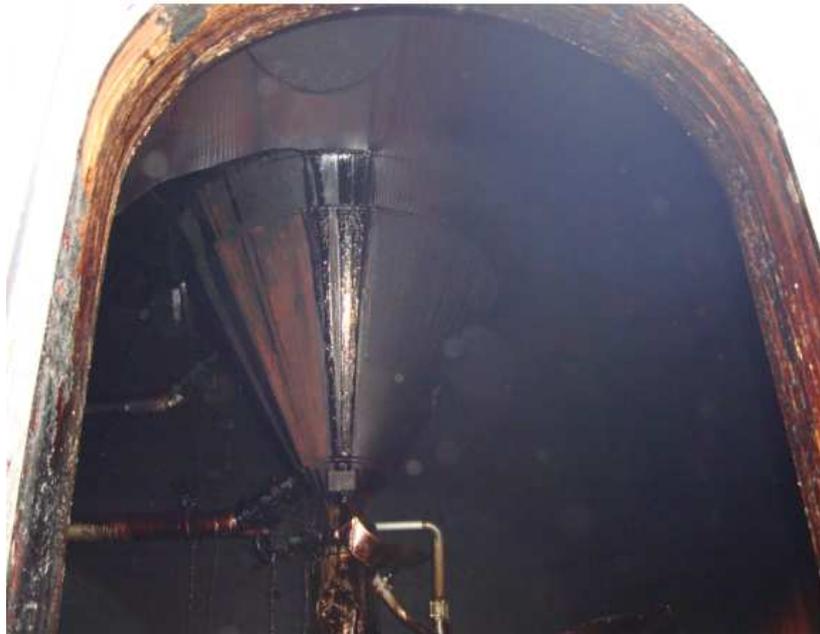
Cone-shaped bottom of tank TB7, as seen from the opening of its shell - Source: DREAL Limousin

Rupture of the cone-shaped bottom on the tank where black liquor was being extracted occurred as a result of gradual wear due to the effects of corrosion/erosion.

Based on expert appraisal, it turned out that the black liquor had infiltrated between the original plates and reinforcement plates following repairs. This infiltration served to substantially accelerate plate corrosion phenomena while continuing to corrode the original tank wall.

- scheduling of inspections, especially in-depth internal controls (tank TB7 had been scheduled for August 2011);
- more in-depth inspections, in light of the fact that no early warning sign had drawn attention to the possibility the TB7 tank would break;
- the choice of repair methods in the event of corrosion or structural defects.

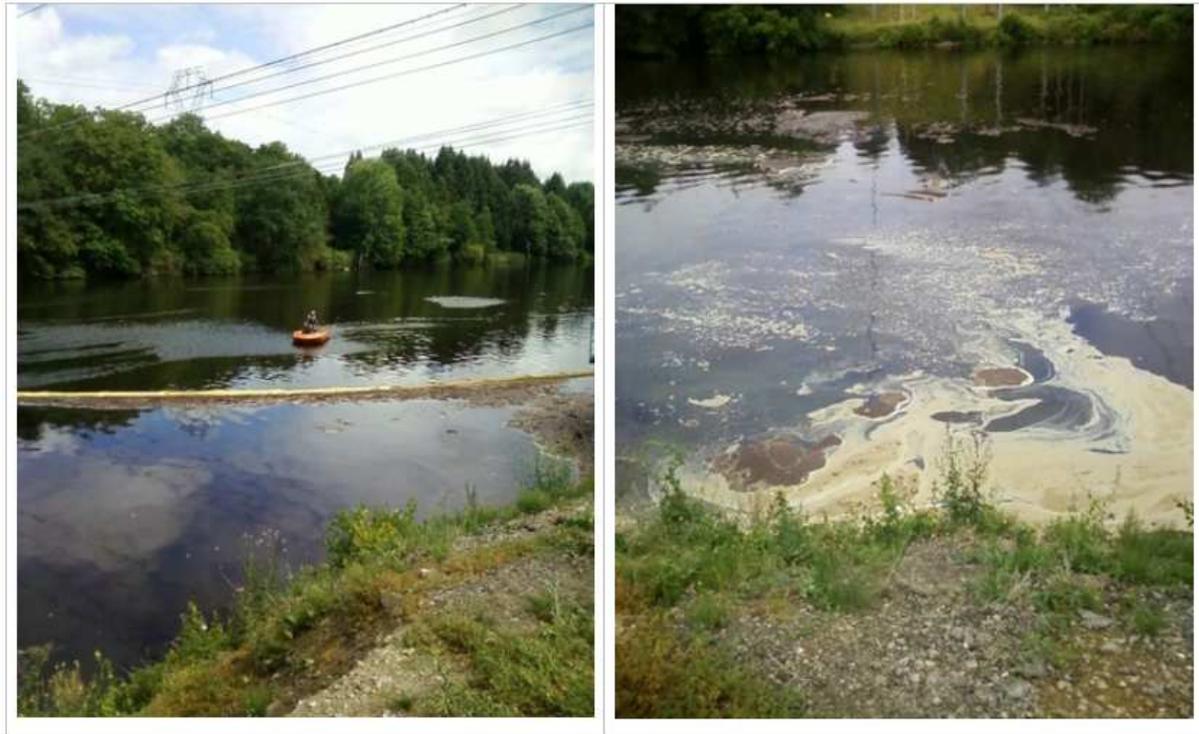
- 9:30 am: Fire-fighters installed floating booms. The efficiency of these devices was limited given the high level of miscibility of black liquor in water. Nonetheless surface foam could be partially retained.

Floating boom set into place and Vienne River pollution - Source: Departmental Fire Services

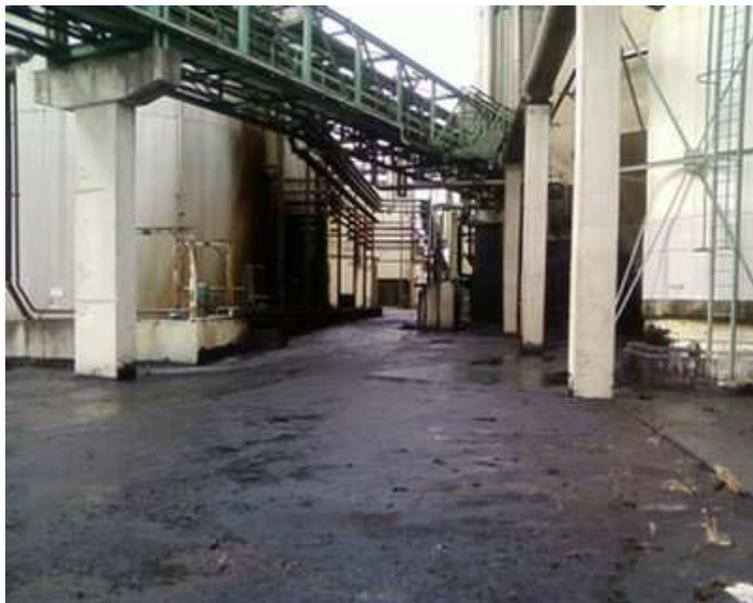
No human consequences were reported. The mill's equipment, outside of tank TB7, sustained practically no damage. Outside the site, more than 80 m<sup>3</sup> of black liquor spilled into the Vienne without killing any fish.

Condition of installations after the accident - Source: County Fire Services
