Explosion of a VOC recovery pipeline at a petrochemical plant

October 21st, 2011

**Loon-Plage (Nord-Pas-de-Calais)
France**

Explosion
Hydrocarbons
VOC
Management of change
Design
Risk analysis

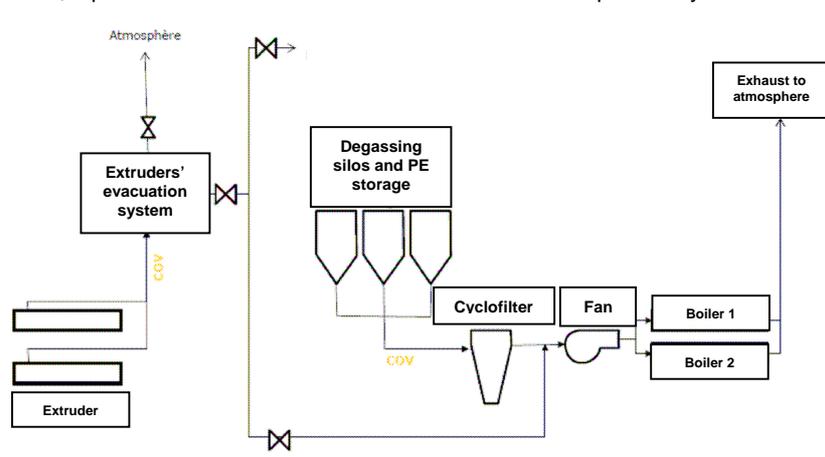
Figure 3: Diagram of the VOC recovery system on the polyethylene production line (source: Site operator)

As part of the LDPE unit remodelling project, the operator decided to improve the VOC emissions collection process in order to keep up with applicable regulatory changes. More specifically, a collection device was installed at the level of the extruders. This flux is thus channelled to the fan suction station via a collection pipe, where it then mixes inside the duct with the flux originating from the degassing silos (see Fig. 3).

- Presence of liquid containing hydrocarbons in the extruders' VOC recovery pipes (a mix of water / vinyl acetate / solvent);
- Forced flow of the liquid towards the silos' VOC recovery duct;
- Creation of a flammable atmosphere by evaporation of the liquid inside the connection duct, thereby leading to an explosion at the level of Boiler no. 2 and then in the vicinity of the fan.

- **Partial condensation of hydrocarbons:** The expert appraisals performed after the incident confirmed the possibility of VOC condensation in the form of liquid hydrocarbon, with accumulation in the extruders' VOC recovery pipes;
- **Forced flow of liquid into the recovery pipes via both the extruders' VOC recovery evacuation system and accumulation:** The hypothesis of driving hydrocarbon liquid via the evacuation system cannot be excluded. The initial safety studies for this process, conducted between 2008 and 2010 by a group of experts, had not addressed the possibility of a change in VOC state (condensation of the VOC gaseous phase into liquid hydrocarbon) nor for that matter the risk of such a liquid entering into this particular line.

The operator also decided to build a new system for reprocessing the VOC emitted by operating the EVA configuration polymerisation unit, making it independent of the recovery system for VOC emitted by polyethylene bead storage and degassing silos. The independence of this system relative to other production units (boilers, steam-crackers) thereby increases the level of installation safety and eliminates the possibility of accident recurrence.

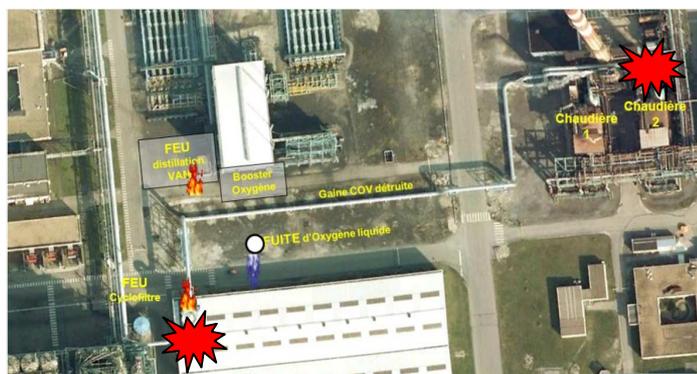
At 3:40 pm, an initial explosion occurred at the outer part of the air supply pipe feeding steam production to Boiler no. 2. Twenty to thirty seconds later, a second explosion destroyed the VOC recovery pipeline, spewing debris in all directions.

The VOC duct explosion was followed by an outbreak of fire on a 1,000-litre bag-in-box of vinyl acetate (an easily flammable product) at the base of a column intended for product distillation, along with the break of a pipe connected to a 1-m³ oxygen (O₂) tank whose contents then emptied into the atmosphere. Another fire broke out on the dome of the cyclofilter upstream of the VOC duct (Fig. 4).

Figure 4: Location of the explosions and their domino effects (source: Site Operator)

The two pipelines that exploded were exposed to atmospheric air. The damaged boilers could not be restarted while maintaining the required safety measures. The VOC recovery duct was destroyed over a length of 200 m.
