Overflow of a gasoline tank inside a refinery

22 October 2011

Reichstett (Bas-Rhin)

Oil depot
Hydrocarbons
Automatism
Sensor
Test periodicity
Material failure

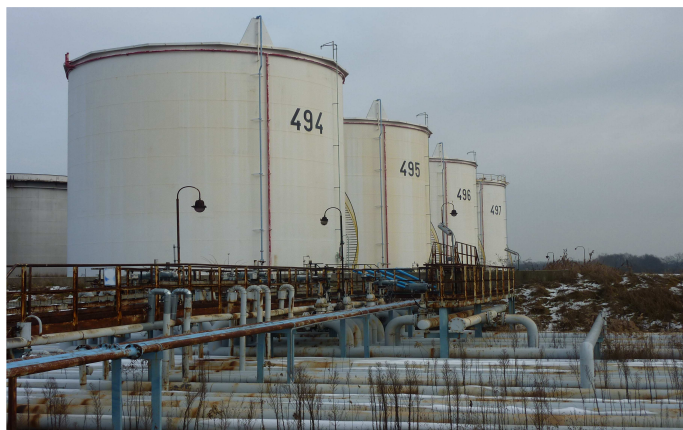
Figure 2: View of the storage tanks
(source: DREAL Environmental Agency, Alsace)

Tank T 495 - 17 m in diameter and 18 m high - had been fitted with a floating roof, a radar-based operating level measurement installed in a vertical shaft, and a safety high-level measurement system (independent of the operating level and also performed in a vertical shaft, Fig. 2).

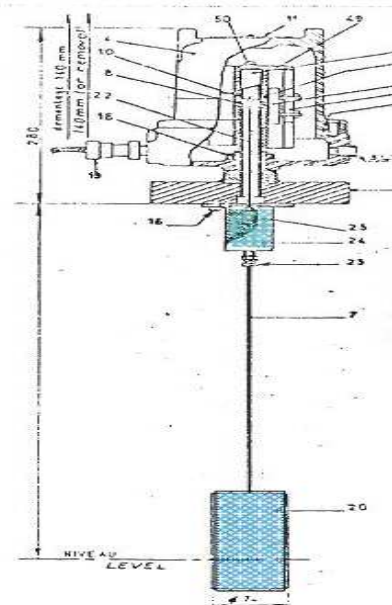
The high-high level safety measurement relied upon a system called MIP (for Marine Instrument Petroleum) that operates according to a different principle than the radar-based level measurement (Fig. 3). This system comprised a plunger hooked up to a hose connector and a spring, plus a vertical shaft connected to both the spring and a mercury bulb switch. With this set-up, the switch activation triggered a high-high level signal visible in the control room, thus initiating immediate shutdown of the transfer operation.

Figure 3: MIP operating diagram
(source: Site operator)

Due to its malfunction, the second "MIP" system failed to sound the high-high level alarm. The tank overflowed and gasoline spread towards the tank's outer ring, eventually reaching the oily water network, since the purge valve had remained open. This open valve position was a measure practiced during periods of heavy rainfall in order to avoid clogging the outer ring and to ensure good working order of the drain on tanks fitted with a floating roof.

- assessing the causes of malfunction experienced with the mechanical device for the high-high level (MIP) control. The site's MIP systems were tested: all activated normally, except for one installed on a crude tank, as the plunger system was unable to return to the rest position on its own and needed to be pulled down mechanically. Some slight seizing could be observed;

- revise MIP test conditions to include floater or scale type mechanical systems in order to ensure no defects under actual operating conditions. More specifically, testing of the floater-based MIP entails disassembly and an external test protocol. The device spring, subject to wear, is a known weakness of this level measurement technology;

- change the control device test periodicity within the operating range by using an environment more representative of actual conditions: *in situ* testing of the MIP in a liquid medium (gasoline or crude);

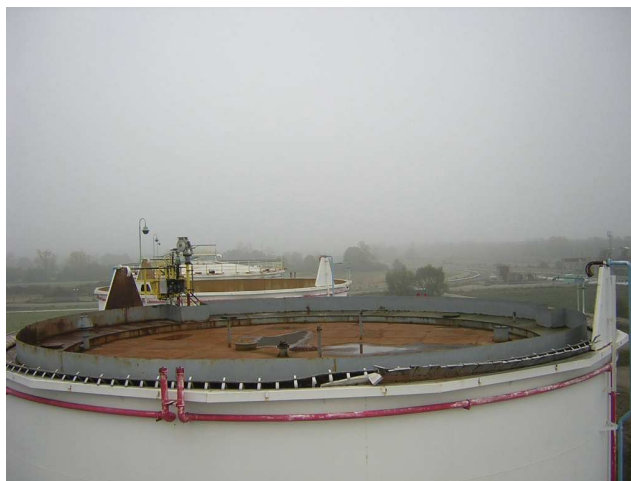
- the presence of gasoline in the outer ring of tank T495;
- a gasoline flow in the oily water sewer system via the drain line, which had remained open;
- the absence of gasoline in the retention basin due to the fact that the oily water purge valve had been left open;
- the floating roof, thrust by the gasoline, had bumped the upper edge of the tank structure.

No victims were reported from this accident. Property damage was limited to the floating roof, which remained stuck to the upper edge of the tank shell. After several hours of investigation, the gasoline loss could be evaluated at approx. 20 m³. The gasoline was eventually recovered and routed to a slop tank (i.e. containing liquid residue) for treatment.

Figure 4: View of the tank's floating roof after the overflow (source: Site operator)

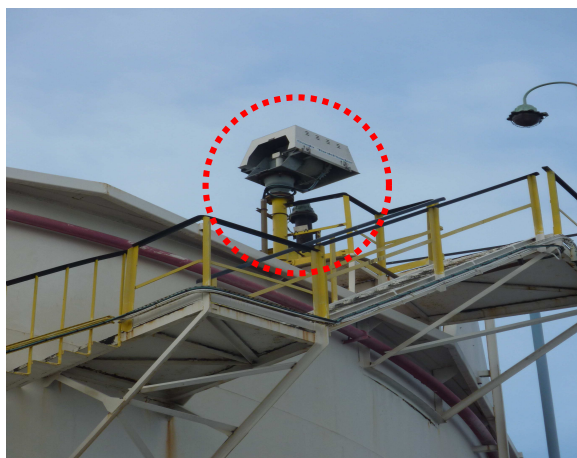
The ullage of tank T 495 (i.e. gasoline height in the tank) was relayed to the control room console by a radar-type, high-level sensor indicating gasoline height in the vertical shaft (see Fig. 5).

The control operator, stationed in the control room, could visualise on a screen the gasoline level inside the tank. Relayed by radar, the reading displayed on his screen provided a measured gasoline level in the vertical shaft but not the actual gasoline level inside the tank. Water present at the bottom of the tank could rise into the vertical shaft as a result of the thrust generated by gasoline movement in the tank during this transfer process. Therefore, a height difference could occur between the gasoline level in the tank and its corresponding level in the vertical shaft.

Figure 5: View of the radar device on tank T 495
(source: DREAL-ALSACE)

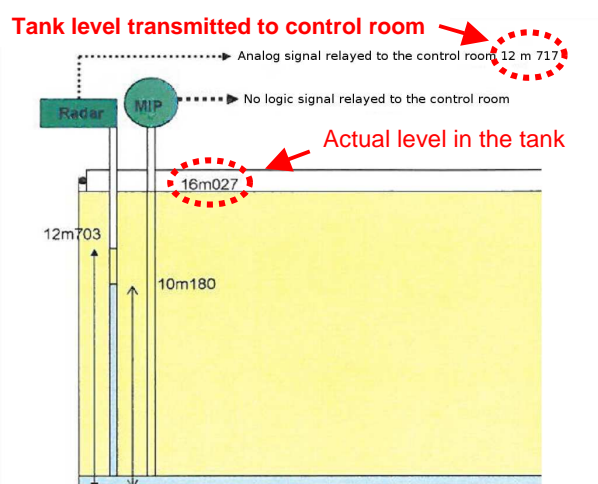
The radar-based control system appeared to be operating normally with no preliminary indication observable by the control operator that the height being read by the radar was lower than the actual gasoline level in the tank (Fig. 6). During tank overflow, the height difference between the radar reading and the actual gasoline level in the tank was 3.3 m: the level reached inside the vertical shaft from the radar reading, as displayed on the control room screen, was just below the operating height whereas the actual liquid level had reached tank height.

- The vertical shaft on the radar-based system for verifying operating levels (Fig. 6) was not equipped over its height with orifices to allow for unrestricted flow of gasoline into the tube. This shortcoming led to a false reading of gasoline level in the tank due to the presence of heavier water; the level read by the control operator in the control room was therefore actually lower;
- The high-high level barrier (MIP system) was inoperable despite recent verification. The vertical measurement shaft on this sensor contained orifices over the longitudinal generatrix, allowing gasoline to pass and thereby eliminating any risk of false reading due to the presence of water heavier than the product.

Figure 6: Presence of water in the control shaft of tank T495, observed after lowering the floating roof to 16 m during accident investigations
(source: Site operator)

- improve the quality of information available on the control operator's console, including a more refined representation of ongoing transfer processes capable of alerting the technician of a deteriorating situation. Given the change in tank use patterns, operating conditions needed to be modified: no more tank-to-tank pouring and regularly scheduled purges due to the use of vapour (as was the case when the depot had been jointly run within the refinery complex);
- replace the 7 distinct MIP mechanical systems using a plunger to control operating levels by MIP systems based on a floaters or mechanical scale device, deemed more reliable and easier to test. Moreover, the plunger
