Accidental release of phosgene

14 May 2012

Le Pont-de-Claix (Isère)

Chemistry
Phosgene
Leaks
Heat exchangers
Corrosion
Confinement enclosure
Organisation / Human
factor

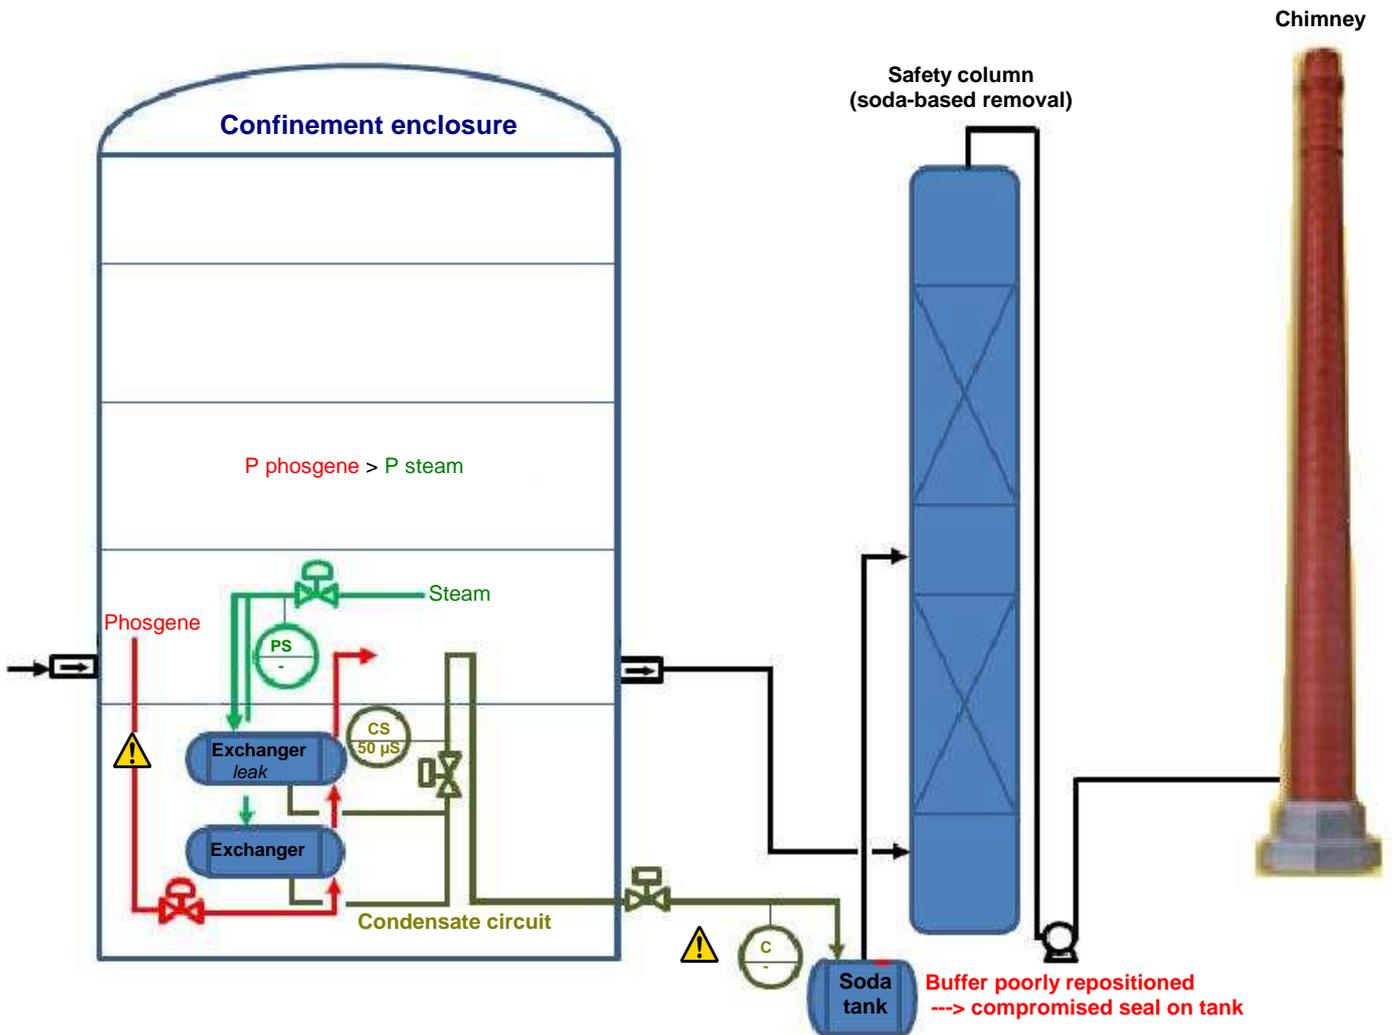
Simplified diagram of a portion of the HDI (isocyanate) workshop process
(State of the installation on the day of the accident)

- Sensor measuring condensate conductivity with a safety action programmed at 50 µS → isolation of the condensate circuit and shutdown of the phosgene pump
- Sensor measuring condensate conductivity without triggering any safety action
not operational on the day of the accident
- Sensor measuring the condensate circuit pressure with programmed safety action → isolation of the condensate circuit and shutdown of the phosgene pump

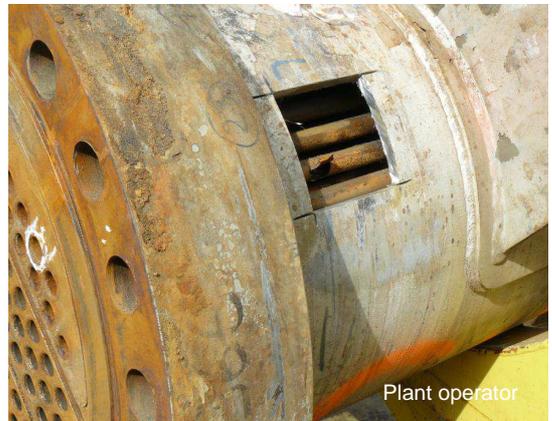
- Corrosion at the level of the tube where the leak was initiated was such that the tube's residual thickness was no longer sufficient to resist the pressure. The tube ripped open abruptly, with a large quantity of phosgene instantaneously flowing into the steam circuit, whose pressure then suddenly jumped. Once the pressure threshold had been reached, the safety controller isolated (as was programmed) the condensate circuit and turned off the phosgene solution supply pump → activation of the 2nd and final technical safety barrier.

- As a result of this pressure surge in the condensate circuit and the sudden valve closure, a "water hammer" phenomenon broke one of the bleed valves at the base of the exchanger.

- The released quantity of phosgene immediately flowed into the confinement enclosure, causing a loss of depressurisation in the enclosure and subsequent closure of its check valves.

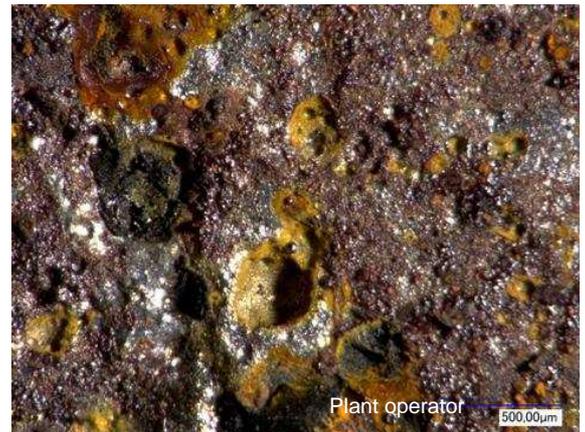
- Phosgene / steam contact followed the internal corrosion of a tube, which caused a "pinhead"-sized hole (diameter: 0.5 mm);
- This phenomenon likely happened due to the presence of deposits that had become corrosive after insufficient cleaning of the exchanger and then "activated" once the three following conditions had occurred:
 - presence of phosgene under the deposits during exchanger downtime;
 - partial elimination of deposits at the time of cleaning;
 - water retention under the deposits despite completion of a drying step (nitrogen flushing) after cleaning.

The presence of phosgene and residual water under the deposits led to the formation of hydrochloric acid.

- and of an organisational nature:
 - modification of the exchanger cleaning procedure and establishment of criteria for evaluating the quality of exchanger drying;

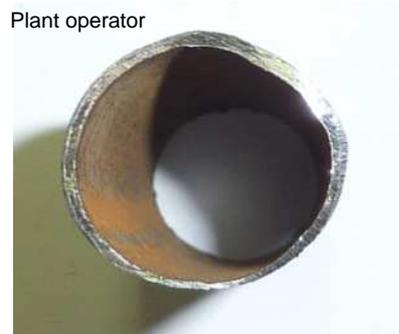
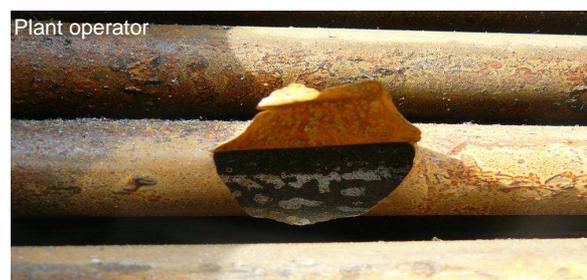
The phosgene release in the direction of the exchanger's tubular shell subsequently induced external corrosion on the tube that eventually leaked and, to a lesser extent, on adjacent tubes. For the originating tube, the level of corrosion was such that the residual steel thickness was no longer adequate to resist the differential pressure, which in turn caused the tube to burst and a major release of phosgene within the shell.
