Failure of a black liquor tank in a paper mill

5 July 2012

Biganos (Gironde)

France

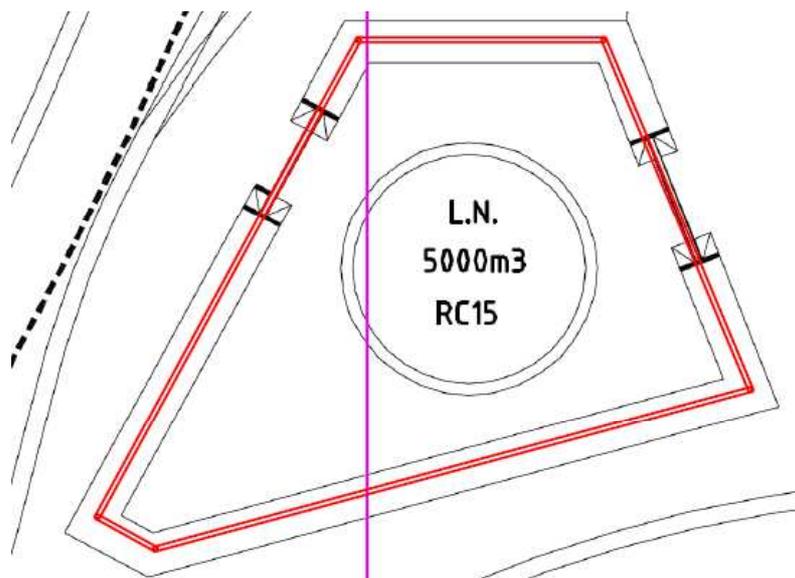
The tank and the retention basin

The wave effect of this sudden spill caused the collapse of most of the retaining bund walls. This wave, which started out 10 m high, spread across the site destroying installations, yet without triggering a secondary accident.

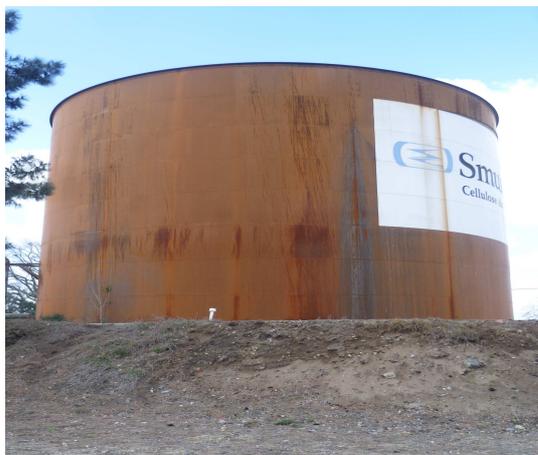
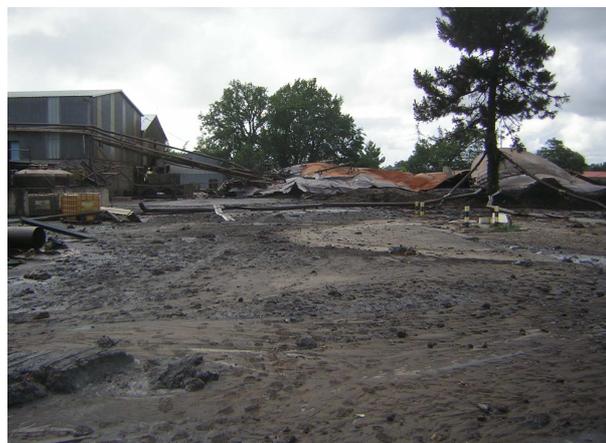
Photographs of the tank taken before and after the accident - Source: DREAL Aquitaine (Environmental Agency)

On 5 July 2012 at 2:28 pm, a complete rupture on the RC15 tank sidewall (a vertical zip tear) as well as on both the top joint (beneath the lid) and bottom joint (base of the chest) caused 4,100 m³ of black liquor to spill at approx. 80°C inside the site boundary. A portion of this discharge reached the Lacanau stream and ultimately the Leyre River.

The expert commissioned by the factory operator reported that an instantaneous pressure surge caused an immediate opening of the tank at both the top and bottom, along with a "vertical zip" type of tear. This instantaneous pressure surge would have been triggered by a shockwave whose origin has yet to be determined.

An initial metallurgical appraisal of the damaged tank was assigned to the Classified Facilities Inspectorate by the gendarmerie. The content of this appraisal mainly focused on openings with crack lips observed on the tank. The break was exhibited by a "vertical zip-like" tear crossing metal sheets without following any weld lines, offset in a step-like pattern between each sheet. The appraisal also uncovered local buckling and the presence of a lower-quality steel.

The operator has undertaken works to replace both 5,000-m³ black liquor tanks according to the following layout:

- ✦ reduction of storage volumes to 3,250 m³ and 3,275 m³ respectively, for a 35% decrease;
- ✦ use of stainless steel to improve corrosion resistance;
- ✦ introduction of corrosion test samples to identify any type of degradation;
- ✦ a shared reinforced concrete retention basin: with a volume corresponding to that of the tank with the largest capacity; designed from the operator's perspective to resist the wave effect; and fitted with an "anti-spill" rim to contain the product in case the shell-bottom joint breaks.
