Oil spill from a sub-surface connection pipeline

28 February 2012

**Wesseling
Germany**

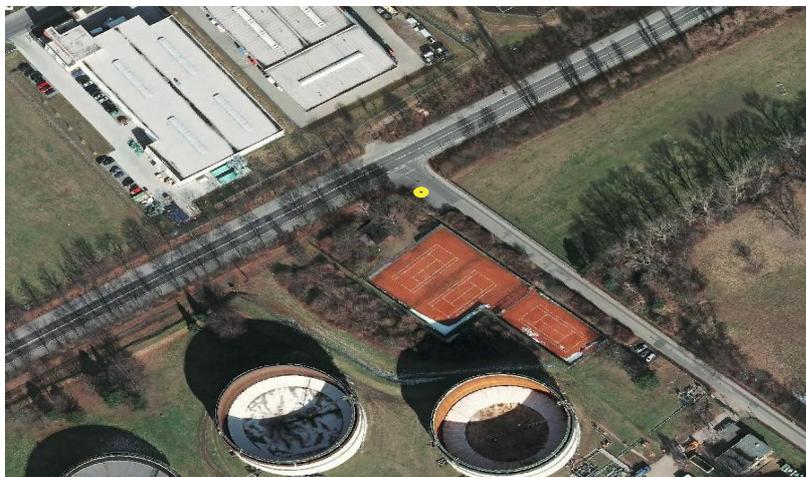
On Saturday 25 February 2012, obvious changes of the filling level of two tanks at the Wesseling site of the refinery were observed. As cause a leakage of the connecting pipeline number 7 was assumed and verified by pressure and leakage checks. The pipeline was blocked on 26 February and discharged on 28 February. The location of the leakage outside of the tank field and the refinery was identified by noise emission analysis and verified by digging up (Figure 2). It was shown by later calculations that, over a time period of 28 days, 846 tons (or 1057 m³) of kerosene were emitted into the soil. The leakage rate was below 2 m³/h (0,5 l/s) and could not be detected by the installed leakage detection system because it was only able to detect a minimum flow rate of 5 m³/h (1,4 l/s).

Figure 2: Location of the leakage (yellow dot)

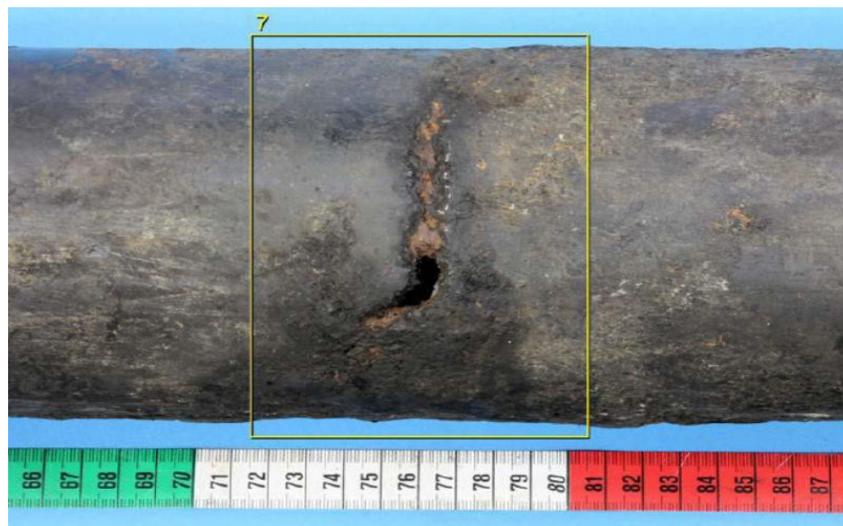
Figure 3: Hole in the steel kerosene pipeline stemming from outside corrosion (copyright: operator)

After the loss of kerosene and the detection of the leakage location the damaged part of the pipeline was brought to a laboratory for further investigation. The outside bitumen layer had been “washed” away by the kerosene flow. A hole in the steel pipe with an area of about 70 mm² caused by outside corrosion was found (figure 3). There were only minor signs of inside corrosion stemming probably from former more corrosive fluids transported in the pipeline but they had no effect on the integrity of steel construction.

Because of the tiny hole in the steel pipeline (about 70 mm², Figure 3) caused by electrochemical corrosion, the low temperature and discontinuous kerosene transport processes the leakage was only detected after 4 weeks. Calculations of the leakage rates under pressure during the transport of kerosene to the tank field and under standstill conditions are shown in table 1. Unfortunately the pipeline was not blocked at times of stand still with the consequence that at these times there was a big contribution to the kerosene pollution of the soil.

As the interference of the steel kerosene pipeline with the steel water pipe was main reason for the leakage, the operator changed the steel water pipe into a plastic pipe. To improve the cathodic corrosion, prevention the system was disconnected. The part in the vicinity of the tank field was connected to the electrochemical system of the tank field and electrically isolated from the other part of the pipelines corridor. In addition, the map containing all pipelines was reviewed to identify all pipeline crossings. An intensive measurement was carried out to identify all locations with disturbances of the electrochemical potential. At these locations the soil was removed and the bitumen coating renewed where necessary.
