Hydrochloric acid (HCl) vapour emissions

13th May, 1993

Port de Bouc (Bouches-du-Rhône)

France

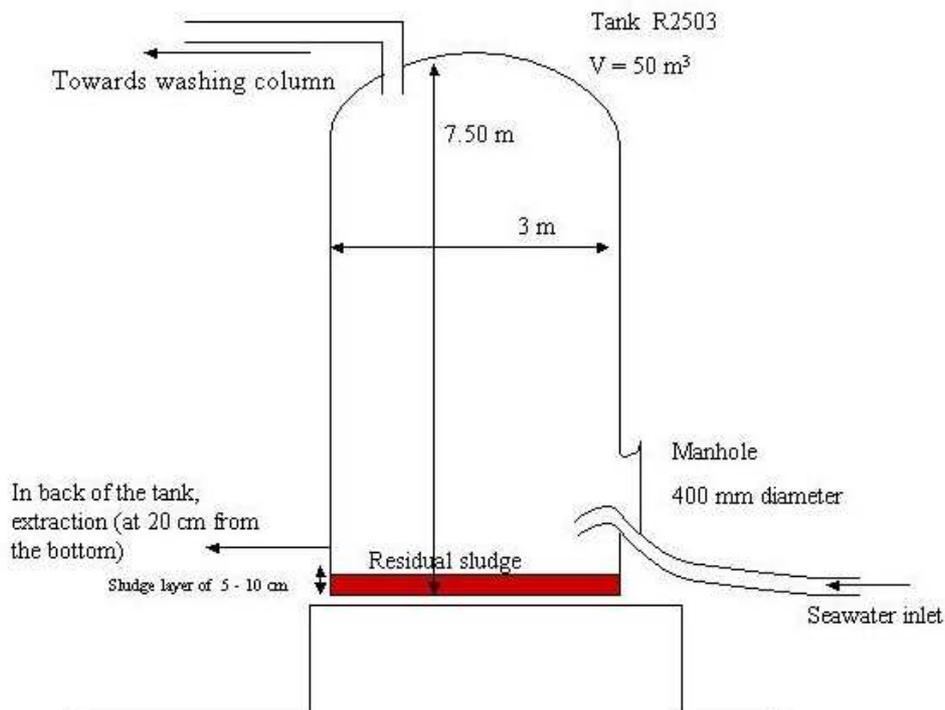
The onset of cracking on the shell-bottom junction weld was detected on Reservoir R 25.03. A regular maintenance call had been scheduled; these works required preliminary drainage of the tank.

However, a relatively compact sludge with 60-mm average thickness still remained at the bottom of the device. This sludge contained corrosive products, 50% sulphur monochloride and miscellaneous other impurities.
