Rupture of a crude oil pipeline

26 May 2014

St-Vigor-d'Ymonville (Seine-Maritime)

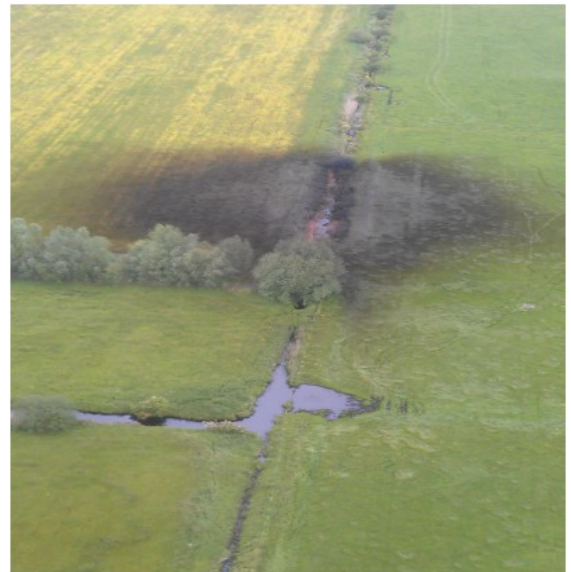
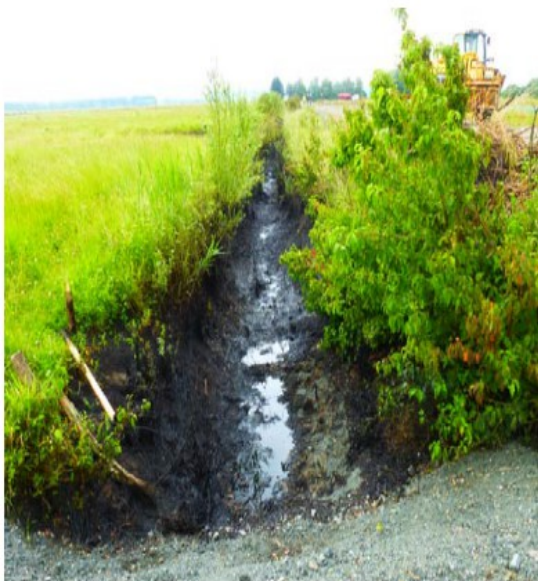
The oil spread and fouled 820 meters of trenches (submerged at the time), with the oil pooling at the bottom over 650 meters of this length. Both flora and fauna were immediately affected by oil at the surface.

The oil geyser resulted in a falling oil spray that stuck very tightly to parts of plants above ground. 14,000 m² of meadow, used mainly for the production of animal feed and beef cattle grazing, were adversely affected by the oil spill. Some 48,000 m² of surface were sprayed by oil (micro-droplets on the above-ground parts of plant life).

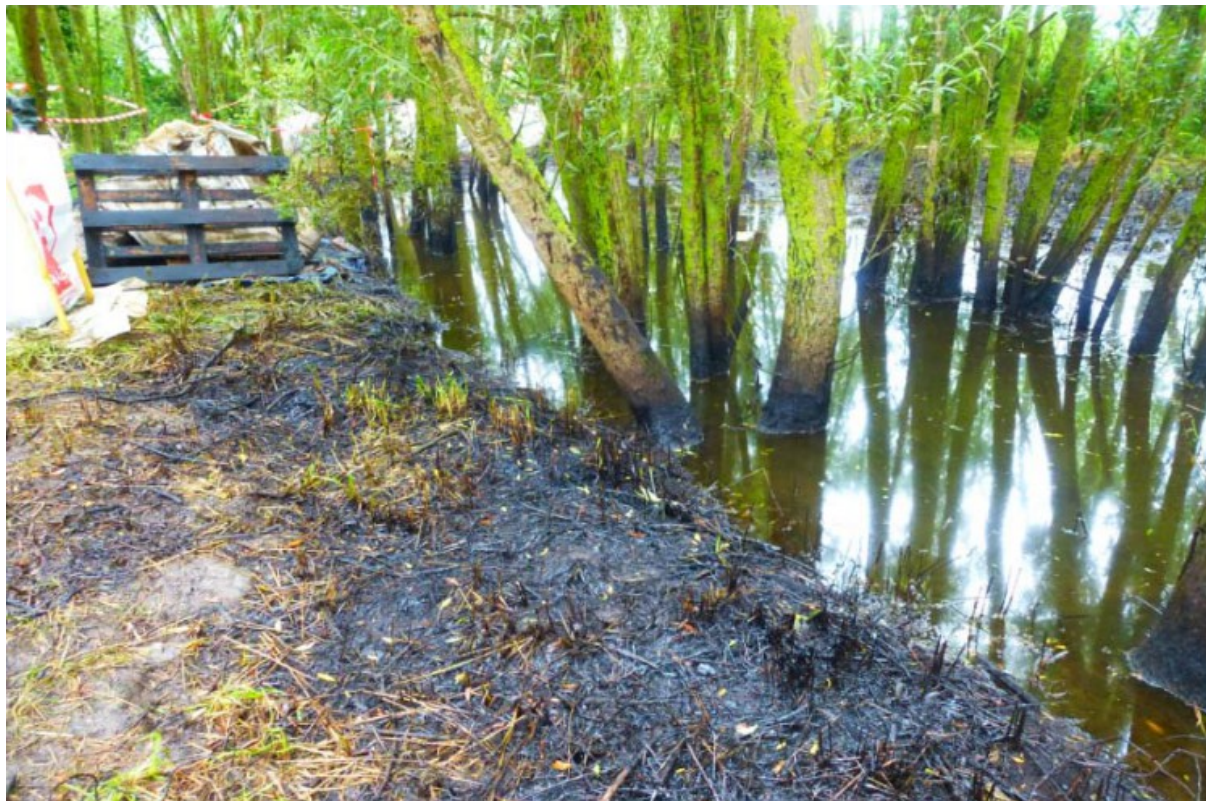
Via a trench, the oil also spilled into a willow plantation.

To clean the willow plantation, the FOST (Fast Oil Spill Team) unit was contacted for assistance. This unit is a Marseille based skills centre affiliated with the oil company; it offers trained response teams along with a ready supply of equipment for eliminating hydrocarbon pollution.

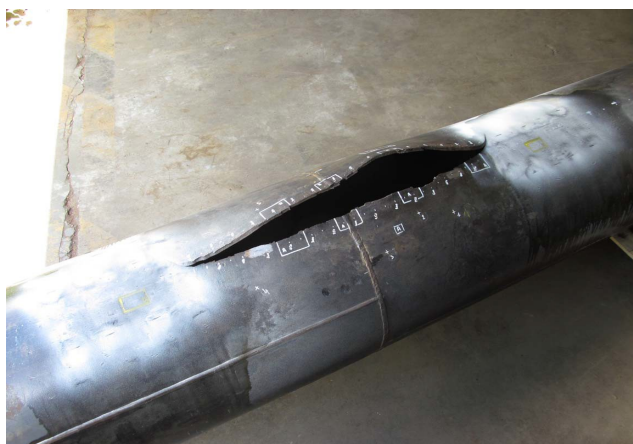
The oil leak occurred subsequent to the widening of an 87 cm long opening positioned along the upper generatrix of the pipeline on both sides of a circular coupling weld between two rolled-welded tubes. The longitudinal welds on this pair of tubes were located away from the rupture zone. An approx. 4 meter length of pipeline was removed and appraised by an expert. The section of burst pipeline displayed along its upper generatrix many signs of shock, dents and scratches as well as macroscopic deformation in the form of flattening and ripples. The outer surface of the circular coupling weld was also damaged, thus indicating that the damage occurred after installing and welding the tubes.

The morphology and location of this external damage reveal that it was probably caused by heavy equipment, subjected to a scraping effect from a power shovel and/or a track roller crossing over the ground.

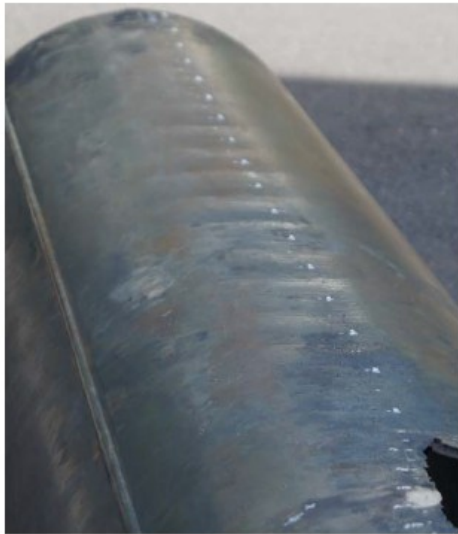
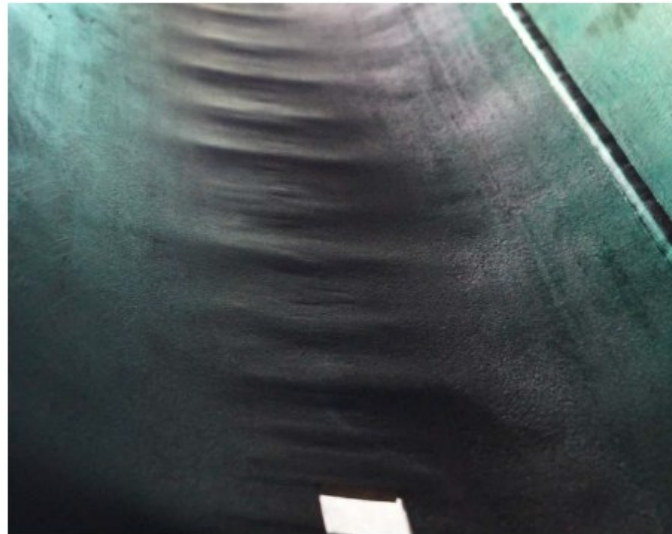
The tube appraisal conducted by an inspection body established that the sudden pipeline break, followed by gradual development of multiple longitudinal corrosion cracks due to stress, was initiated from the outer skin of the pipeline, in the strain-hardened zone with mechanical deformation.

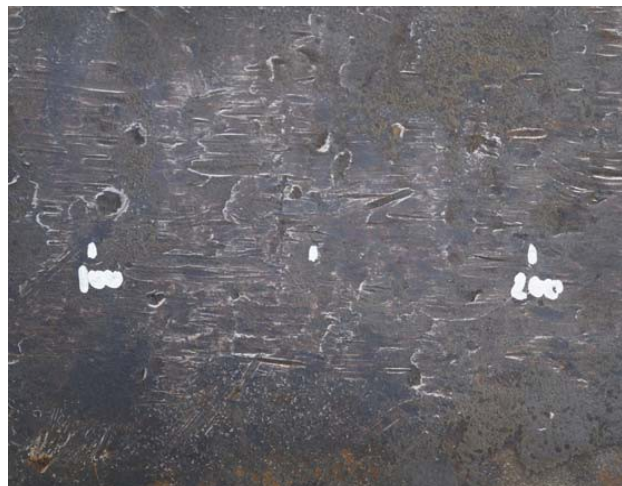
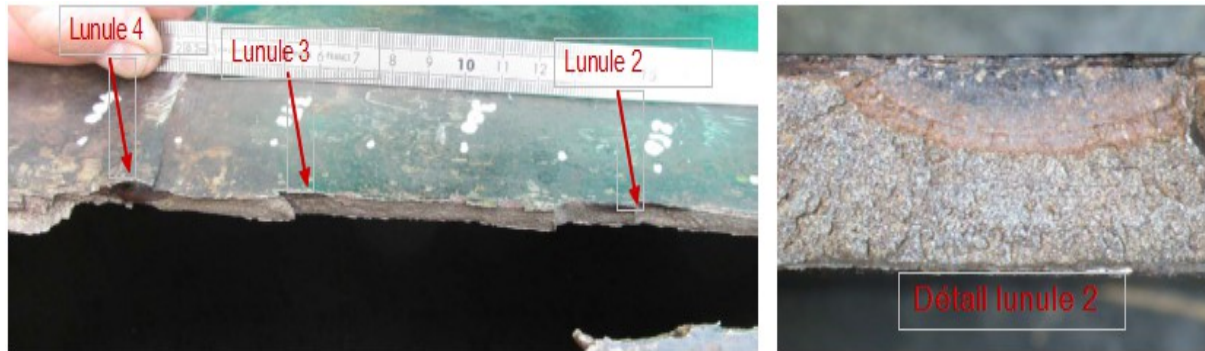
Inside the rupture zone, six lunula corresponding to pre-existing longitudinal cracks representing some 35% to 50% of the wall thickness could be identified. These lunula were characterised by an advanced state of oxidation, or even corrosion, that did not match the ultimate rupture zones and moreover proved that they predated the actual rupture. The presence of radiating bands from the external surface suggested crack onset from this surface. The remainder of the pipeline surface offered a clean appearance without any loss of thickness due to corrosion. Furthermore, no corrosion on the tube's internal surface could be detected.

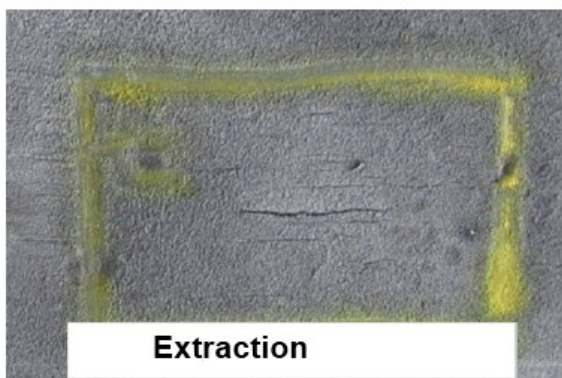
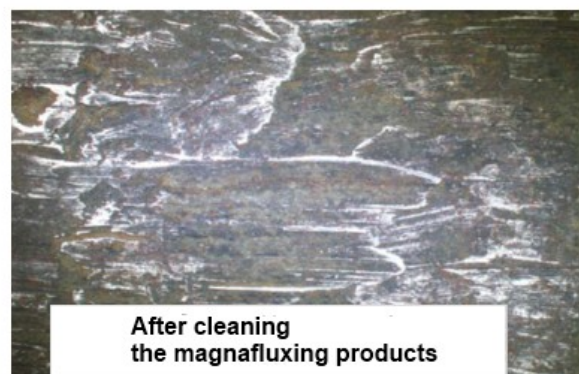
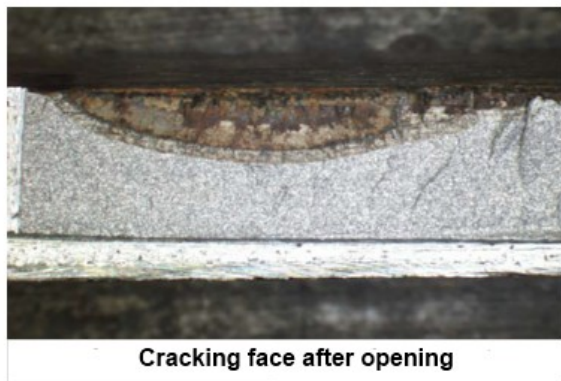
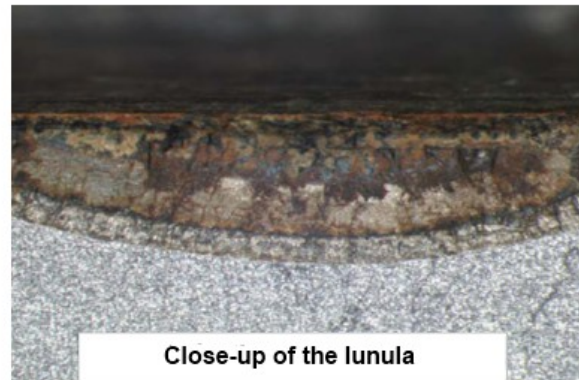
Outside the rupture zone, on the outer surface of the liner and along the upper generatrix, the magnetic particle inspection evaluation revealed the presence of crack-type anomalies associated with the identified mechanical damage that had strain-hardened the metal and caused the tube to flatten over its upper generatrix. Mechanical stresses at the level of the connection with the non-flattened zone had thus formed.
