Water / molten metal explosion in a foundry

21 January 2015

Feurs (Loire)

Explosion
Water / molten metal
Metallurgy
Control

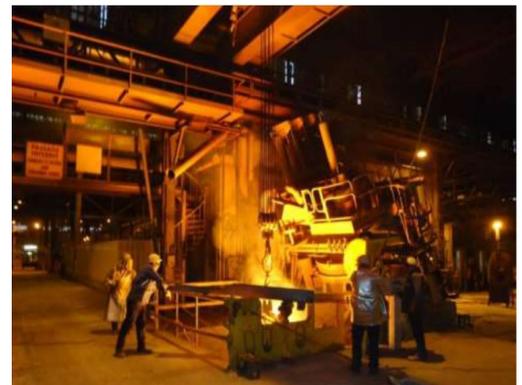
Furnace No. 4, © Site operator

The source of this accident was the contact initiated between molten metal and water or humidity that had accumulated at the bottom of casting pit 4. During the process of pouring metal into the foundry ladle, some 400 kg of molten metal accidentally fell into the pit. The abnormal presence of water at the pit bottom triggered both an explosion, in the form of a dry expansion (yet without spraying any metal), and the release of a large plume of dust. The blast resulting from the explosion, funnelled by the pit walls, damaged the roof made of asbestos cement sheets, which acted like a fuse vent (many sheets landed on the floor or were displaced). No other structural damage to the building was observed.

- Expert appraisals of the furnace 4 pit, following the accident on Wednesday 21 January 2015, revealed the absence of a drainage film on at least one of the pit walls.

The entire array of proposed active and passive technical systems brought the final risk level to 10⁻⁸. The various RMM dedicated to works and machinery were introduced in order to prevent any recurrence of such an accident (double casing, moisture meters, level probes in the sumps, etc.).
