**H₂S leakage
during the transfer
of effluents
7 July 1993
Grasse (06)
France**

Chemistry
Hydrogen sulphide
Tanks
Tanker trucks
Effluent transfer
Organisation / procedure /
supervision
Victim

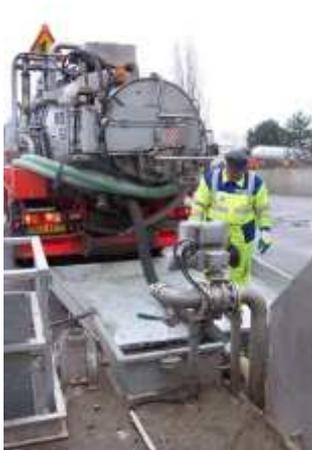
On Wednesday the 7 July around 9.30 am, the truck driver of the sub-contracting company in charge of transporting the liquid industrial waste to an incineration centre arrived at the reception area of the plant. His badge gave him access to the storage site of the concentrated effluents. This was the second time that his company worked in this facility as back-up to the company that usually collects the concentrated effluents.

The operation started and involved the transfer of concentrated effluents contained in tank 11 to two of the four 10 m³ compartments of the tanker truck. At the end of the transfer (~ 20 m³), the alarm was sounded. The driver who was with the security guard for 45 min got down from the tank. He stopped the alarm near the control panel of the vacuum pump at the right of the vehicle. While the security guard drained the cargo hose used for the transfer, the driver closed the outlet gate to seal the compartments of the tanker truck. He then walked over to the left of the truck, passing by the driver's cab to cut off the vacuum pump and make it rotate. He then returned to the other side

to carry on with the remaining operations (stop the pump) and fell unconscious near the driver's cab without before completing them.

The security guard still near the tank 11 saw this and rushed to help the driver. When he arrived near the driver, he felt uneasy as well. He left the spot before losing consciousness for a short duration. He then came to and returned to rescue the driver while holding his breath and move him about 15 metres away from the spot. He then asked a technician driving a power lift truck to call an ambulance and bring oxygen and prohibited other employees from entering the dangerous zone. He then put on a self-contained breathing apparatus to stop the truck's motor that was still running. When he returned, the paramedics had arrived who called a second ambulance on seeing his condition. The first ambulance transported the driver who died soon after.
