Two hydrocarbon tanks ablaze subsequent to a malicious act

14 July 2015 (French national holiday)

Berre-l'Étang (Bouches-du-Rhône)

Malicious intent
Hydrocarbons
Fires
Pollution
SEVESO facility

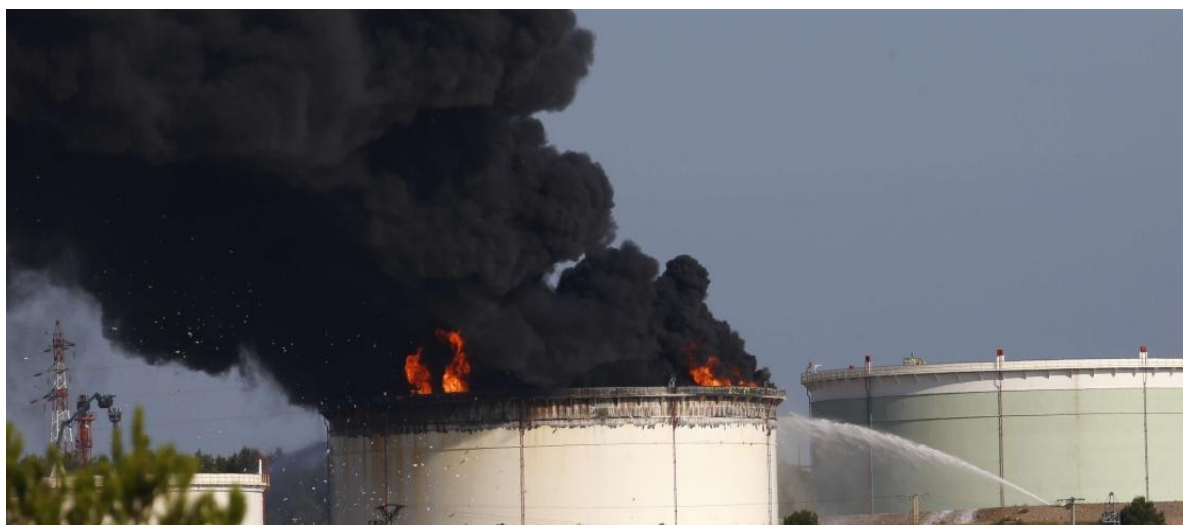
Priority was assigned to extinguishing the 1st gasoline tank. This fire was put out at 4:35 am following a foam assault by the on-site crew. A foam blanket was kept in place until noon. Extinction of the 2nd (naphthalene) tank got underway at 6:20 am and ended by 11:15 am, with the foam blanket being maintained until 3 pm. The floating roof collapsed 48 hours later. Both tanks remained structurally intact. External responders left the scene around 8:30 pm. In all, 170 m³ of foam were sprayed.

The second tank on fire – © Press
