Leak of pressurised flammable gas within a petrochemical complex

17 October 2015

Gonfreville-l'Orcher (Seine-Maritime)
France

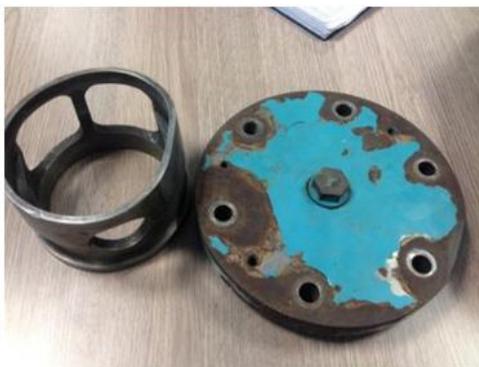
This leak was caused by ejection of the hatch on one of the check valves fitted onto compressor 1. This valve was found lying 6 metres from the compressor.

Expertise pointed a poor clamping of the studs, exacerbated by the beating of the valve joint given that this joint had not been annealed at the time of assembly, in violation of procedure. This condition, combined with a damping error of the dowel already close to the plastic deformation, caused a beating of the check valve-lamp-lid stacking sequence, plus the failure of a stud and ejection of the stack. The compressor showed no signs of operating anomalies prior to this incident.

The compressor was completely refurbished by replacing all the studs (all check valves) and reassembling the fastenings on all main linings, plus the cylinder spacer, housing spacer and brackets. The unit was placed back into service on 23 December 2015. The revised maintenance task list was shared with the subcontractor assigned to maintain the compressor. A review and update of task lists on the other compressors at the facility were also undertaken. During the month following the incident, the connection of both the isolation actuation and the automatic compressor security actuation upon gas detection were performed. A reminder to teams was issued pertaining to the functionality of systems in place for securing the compressors.
