Explosion of a tank undergoing transfer in an oil product depot

15 October 1993

Cusset - [Allier]

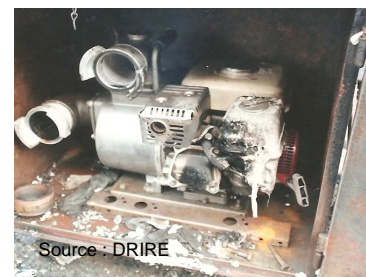
The transfer was done using the tanker's motor pump (30 m³/h) placed in a metal box and powered by a gasoline engine whose exhaust was not fitted with a flame arrestor. The entire transfer circuit was 80 mm in diameter. The cargo hose connecting the suction hole of the pump to the 5 valve manifold of the tanker is owned by the (distance 1.20 m) carrier company and is part of the on-board equipment. The cargo hose connecting the pump discharge and the fixed supply tube belongs to the depot and remains connected to the building. The trailer is earthed by the supporting metal coils of the cargo hose.

Tank motor pump

The inspection authorities of classified facilities support the theory of a leakage in the pressure port of the cargo hose or at the coupling leading to the formation of a hydrocarbon "fog" that was ignited by the pump exhaust. According to the driver, the motor pump exhaust is often red hot at the end of the transfer. Moreover, the gasoline engine of the pump was not fitted with a flame arrester while the magnetic drive device of the latter generated sparks.

The absence of flame arrestor on the pump was also a violation of the law on transportation of dangerous materials.

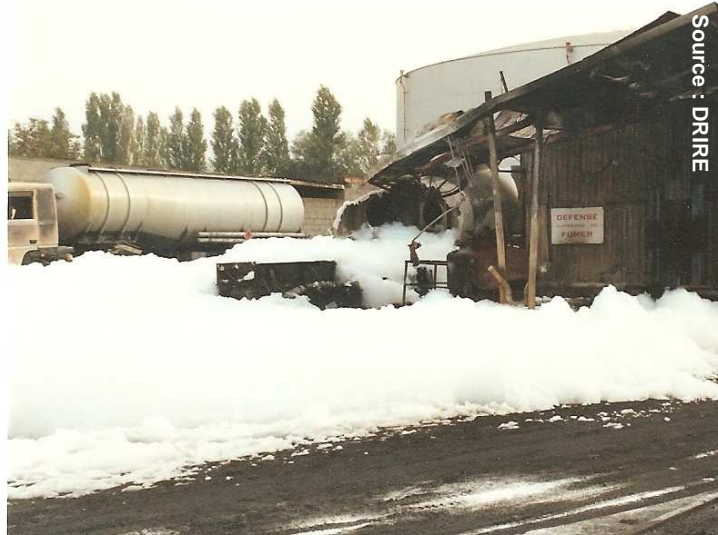
The destroyed tanker truck and the remaining foam on the morning of 16 October

- one tanker truck was destroyed
- two tractors were damaged
- the tanker truck filling station was destroyed

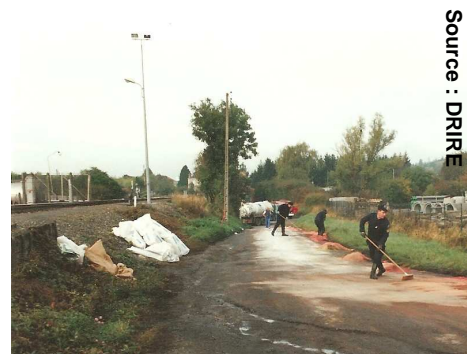
Hydrocarbons transported inside the depot by the water sprayed by the fire-fighters spread and seeped into the soil. Despite setting up cut-off sand barriers and spreading absorbing material, a part of the hydrocarbons spread to the outside polluting the pit on the public way.

Cleaning operations after the accident

As part of rehabilitating the site, at least a surface of 500 m² representing 850 m³ of land in terms of volume is treated by in situ biodegradation.
