Flooding of a glassworks factory

30 May 2016

Bagneaux-sur-Loing (Seine-et-Marne)

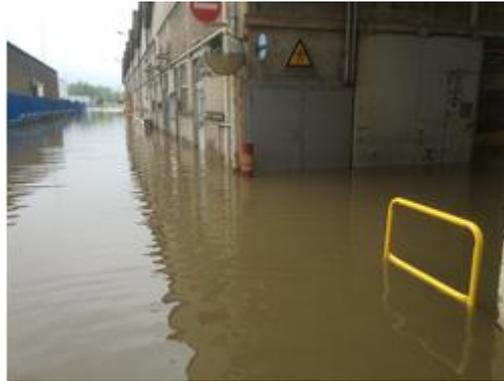
at 8:00 a.m.: Flood peak. The maximum height reached to the site's lowest point was approximately a metre in the site's southern area (construction site base camp area). Water reached a maximum height of approximately 40 cm in the lower levels of the kilns, 30 cm in the arsenic storage cases and 20 to 30 cm in the composition workshop.

The flooded installation - source: operator

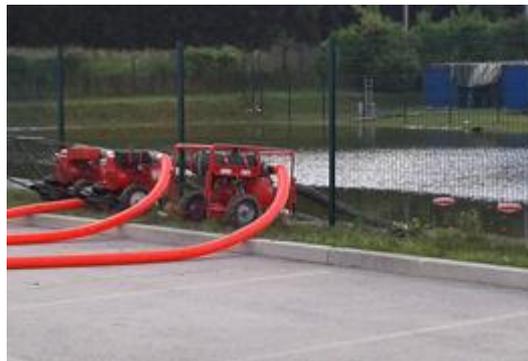
A significant amount of water was still present in southern part of the site. Special means were brought in (motor-driven pumps) by the civil defence services. Pumping operations were completed in the late afternoon and traffic was suspended in order to pass the drain lines over the roadway.

Water pumping operations - source: operator

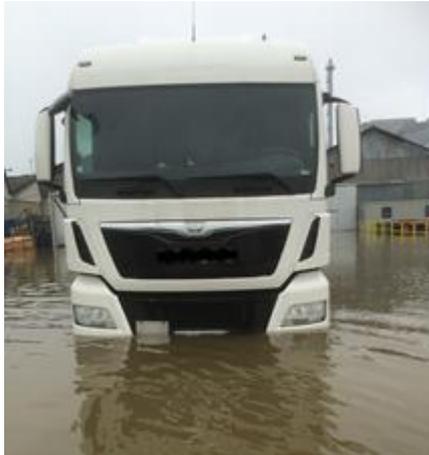
were inoperative. Physical access to the facilities was complicated at some locations due to the water levels (1 m at the base camp in the site's southern area, between 10 cm and 50 cm of water in the basements of kiln buildings);

Water level reached on the site - source: operator
