Release of a chlorinated organic chemical

2 June 2017

Mazingarbe (Pas-de-Calais) France

Chemicals
PVC
Polymerisation
Runaway of an exothermic reaction

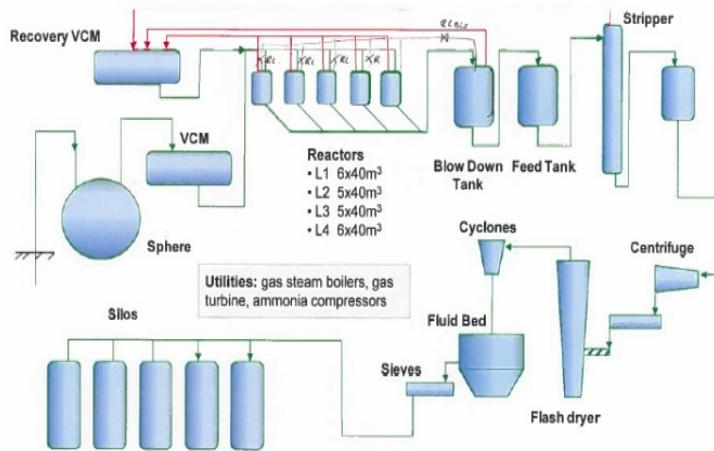
Simplified diagram of the PVC manufacturing process
