Fire in a hydrocarbon depot at the Édouard Herriot port

2 and 3 June 1987

Lyon [Rhône]

France

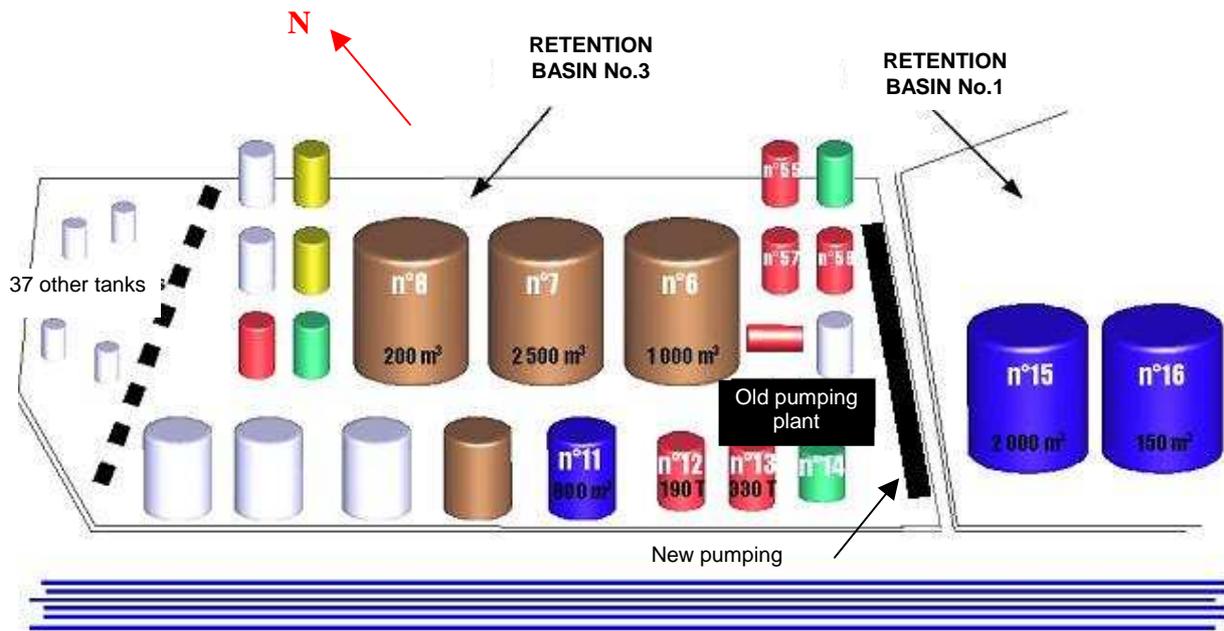
Figure 1 - Diagram of the main facilities

- Tanks with limited capacity (see figure 1) are potentially a greater hazard in the event of retention basin fires. Their quick heating may be aggravated by a low storage factor. The internal vapour pressure increases rapidly causing the product to evaporate and the gas inside or outside the tank to ignite causing the tank to rupture under pressure. Post-accident studies carried out by the operator revealed that when the metal sheet comprising the walls of the tank is exposed to fire, a temperature of 500°C can be attained in 2 min by the portion below the liquid level.

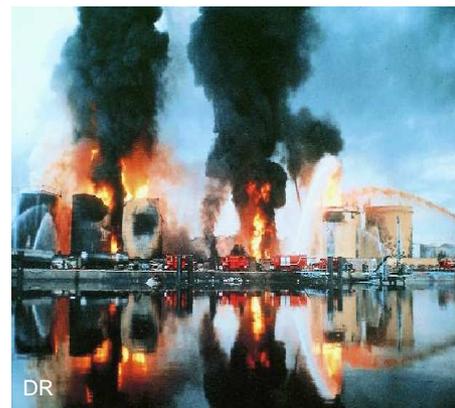
Figure 2 – Fire in the retention basin No. 3

- At 2.30 pm: Faced with the spreading fire, the Rhône prefecture triggered the PPI (external emergency plan).
- Until 5.00 pm, the fire continued to spread to the entire retention basin even though the waters in the facilities were cooled.

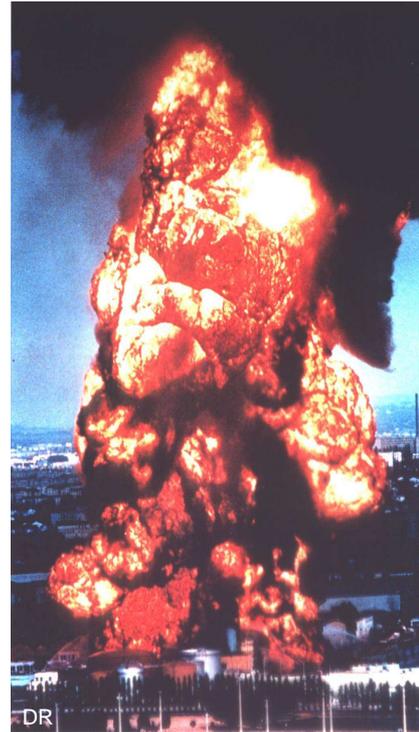
Figure 3 – Sight of the fire ball developed above the retention basin No. 3

- At 6.32 pm (according to the emergency team on site): When the rescue workers took shelter behind an adjacent building, tank 6 containing 1 000 m³ of gas fuel literally exploded forming a 300 m high fireball with a 200 m diameter for about 15 seconds. It collapsed partly outside the retention basin.

Contrary to what was assumed for a long time, the fire ball of the non-insulated tank no. 6 with a welded design was not a "boil over" phenomenon. In fact, tests performed by an expert revealed that a "standard boil over"¹ was not possible in a diesel fuel tank and the phenomenon of "thin-layer boil over"¹ involving this fuel would have had a lesser impact and a clearly smaller fire ball.

Strident hissing sounds were heard from tank no. 6 a few seconds before the roof reputed to be frangible, and the shell ruptured releasing the fire ball. Witnesses reported a 20 m flare on tank no. 7 containing 2500 m³ of diesel fuel located adjacent to tank 6 and having the same dimensions. At the time of the incident, the 2,900 m³ tank no. 6 filled to one-thirds of its capacity, i.e. 1 000 m³ of product thus contained 2,000 m³ of pressurised gas. This explosion could consequently have resulted from the pressurisation of the tank or a similar phenomenon assuming that the valves set at 175 mbar failed to evacuate the excess pressure resulting from the vaporisation of the product. The expansion and ignition of the gaseous atmosphere under pressure and the dispersion of the overheated liquid (thermodynamic flash and carry-over of droplets) triggered by decompression subsequent to the rupture of the tank may have contributed to the formation of such a fire ball.

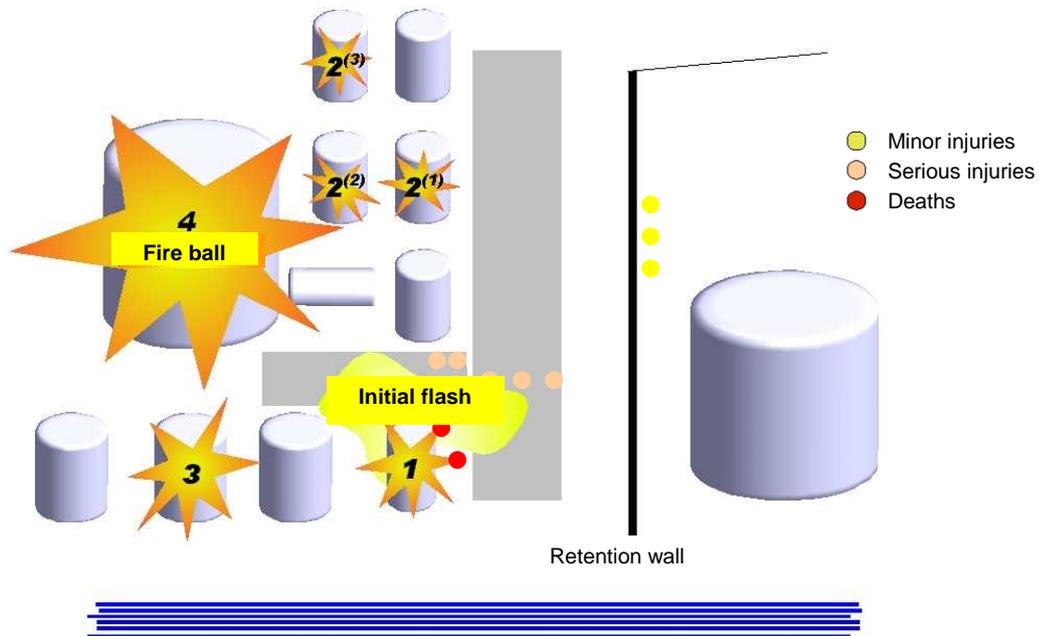
Figure 4 - Site and order of appearance of various explosions during the accident – Localisation of victims

The 2 technicians present near tank no. 14 during the initial flash and then trapped by the fire died. The flash also burnt 8 other technicians including 5 seriously. Three of the technicians were on the framework of the new pumping plant under construction at heights, while the two others were beside the control panel of the pumping plant in service. The technicians in retention basin 1, protected by the retention wall only sustained mild injuries (see figure 4). Six fire fighters were reported to have sustained mild injuries during the explosion of tank 6.

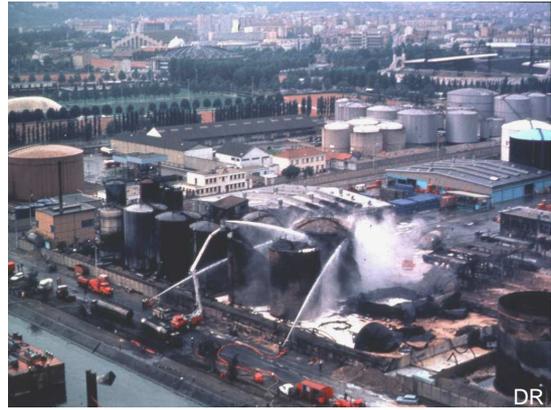
Figure 5 – Final intervention with foam in morning of 3 June

- From 6.30 am the following day: Several types of fire fighting equipment were used in the final attack on the blaze with foam. Two flares escaped from tank 7 without any damage to its shell. However, the emergency workers feared an explosion similar to that of tank 6. The blaze on tank 15 and 16 was put out first. A sharp decrease in the fire was finally observed around 11.00 am.

Moreover, the foam liquid used by the fire fighters was adapted to hydrocarbon fires but not to polar compounds also present in the retention basins. These compounds destroyed the foam layer built by the emergency services.

- ✓ Promote the use of polyvalent foam compounds or store products requiring different foam compounds in separate retention basins.

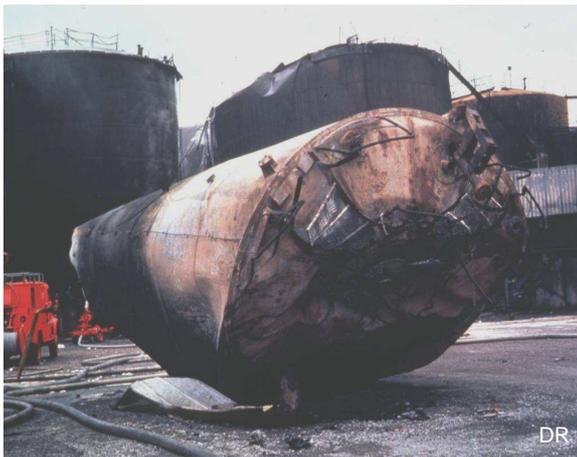
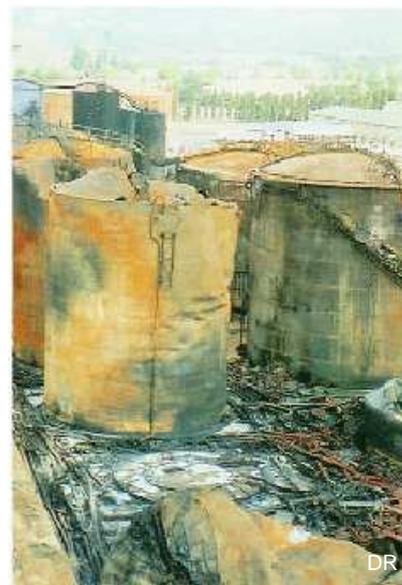
Figures 6a & 6b – Tank « blown » by the 'explosion (above)
And tanks damaged by the fire (right)

- The depot was operational at the time of the fire: the valves at the base of the tanks that were manual were opened and thus leading the fiery pool to be fuelled by pipelines destroyed by thermal flows (see photo 6b). Moreover, the loss of products from the foot of the tank favoured the flow of oxygen to the gaseous atmosphere above the tanks creating conditions conducive for explosion.

- ✓ Install automatic remote controlled devices to shut the valves on the foot of tanks in the event of fires such as flap valves² to avoid feeding the blaze in the retention basin in the event of rupture of pipelines during a fire.

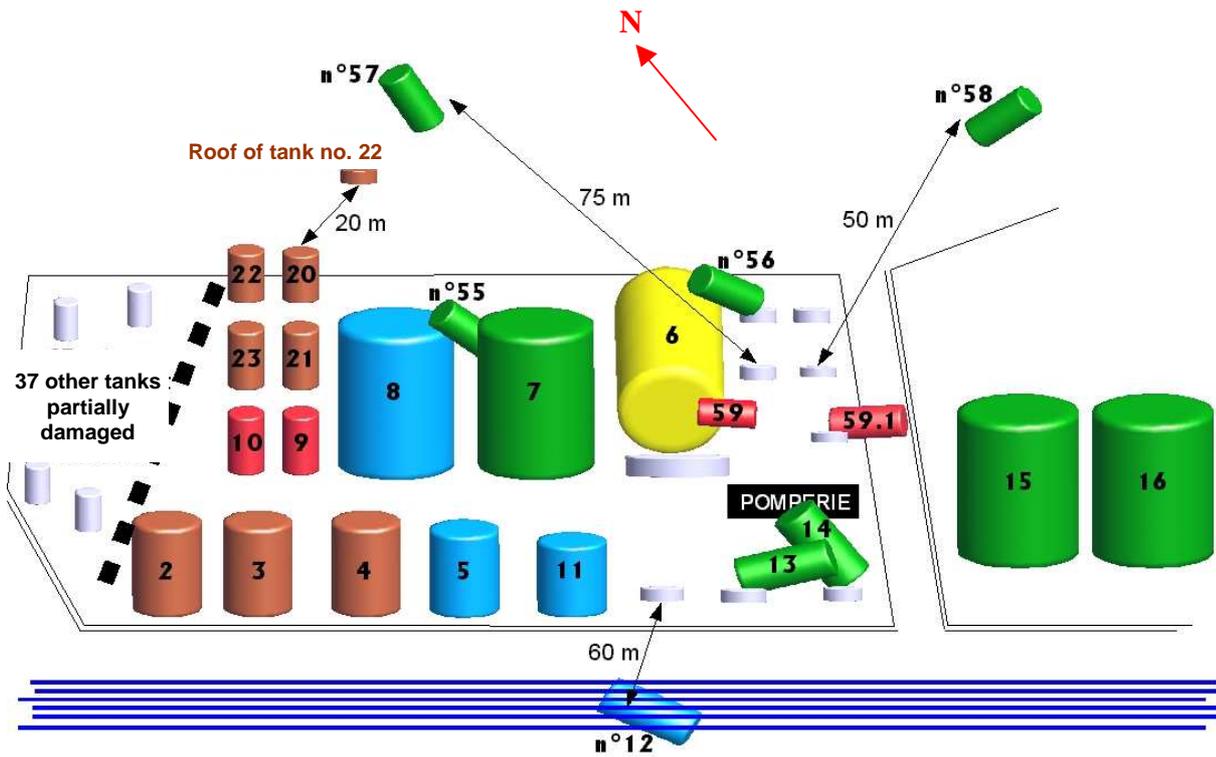
Figure 7 – Material damage on facilities and typical falling distances

The accident resulted in significant material damage. Almost all tanks contained in the retention basins 1 and 3 were either destroyed (tanks no. 6, 12, 14, 55, 56, 57, 58, 59, 59.1, 20 and 22) or suffered considerable damage and could not be re-commissioned. In all, 14 tanks and around 4 km of pipelines were impacted. The loading stations, offices, packaging workshops and the neighbouring construction site equipment were also destroyed.

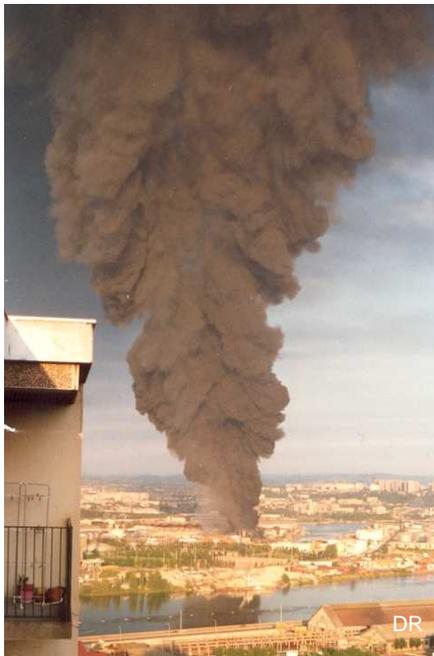
Figure 8 - Cloud of smoke above Lyon

Weather conditions (light wind in the eastern sector at the start of the fire followed by a long calm period during the night) helped the smoke cloud rise vertically above the site. The atmospheric emissions mainly included dust in the form of unburnt products, sulphur dioxide, lead compounds, and vapours and breakdown products of basic chemicals used in manufacturing additives. Despite the huge quantities of dust released into the atmosphere during the accident, the concentrations measured in the environment do not show a marked variation in the concentration of pollutants in the Lyon region during the accident. It is possible that a part of the pollutants were transported beyond the surveillance perimeter of the region.
