Fire in a fertiliser warehouse

October 29th 1987

Nantes – [Loire-Atlantique]

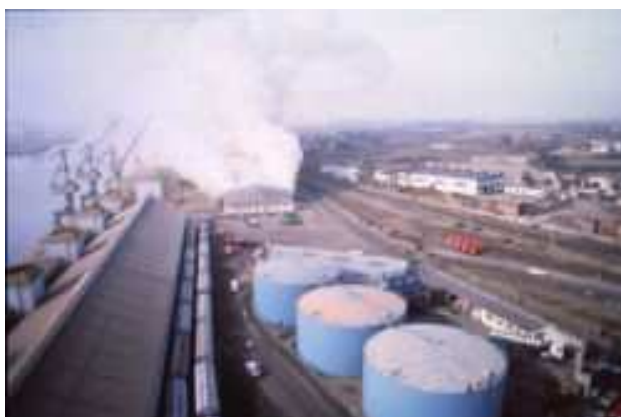
Source : DR

At 11:15, the first confinement measures were taken in a radius of 1 km around the site ; 73,000 people were involved. Instructions were broadcast on FM radio stations and by loudspeaker vehicles driving around the zone.
