Large-scale fire in a wood chip storage facility

21 August 2017

Gasville-Oisème (Eure-et-Loir County) France

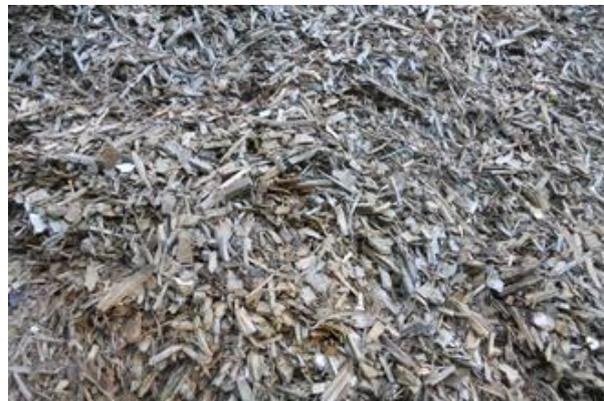
On 21 August 2017, at around 3 a.m., a deep-seated fire broke out in an outdoor recovered facility. The storage area, of about 50,000 m³, consisted of a single stack roughly 24 m high, 100 m long and 40 m wide. This mound of chips was located on the facility's property line. The burning portion was located at the back of the pile which filled up both sides of the storage area. White smoke was emitted, but there was no flame.

Woodchips (source: SDIS 28)

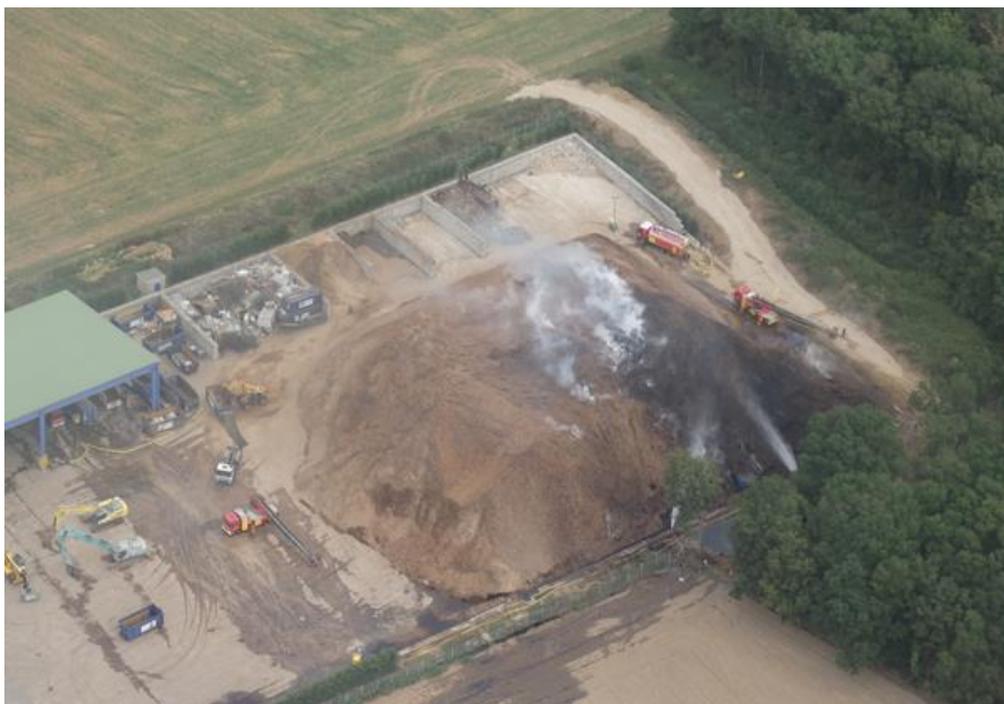
On 22 August, gusts of wind caused the fire to flare up on the surface of the heap, and flames were visible. The entire pile of chips was rapidly affected.

Aerial view of the pile of chips (source: SDIS 28)

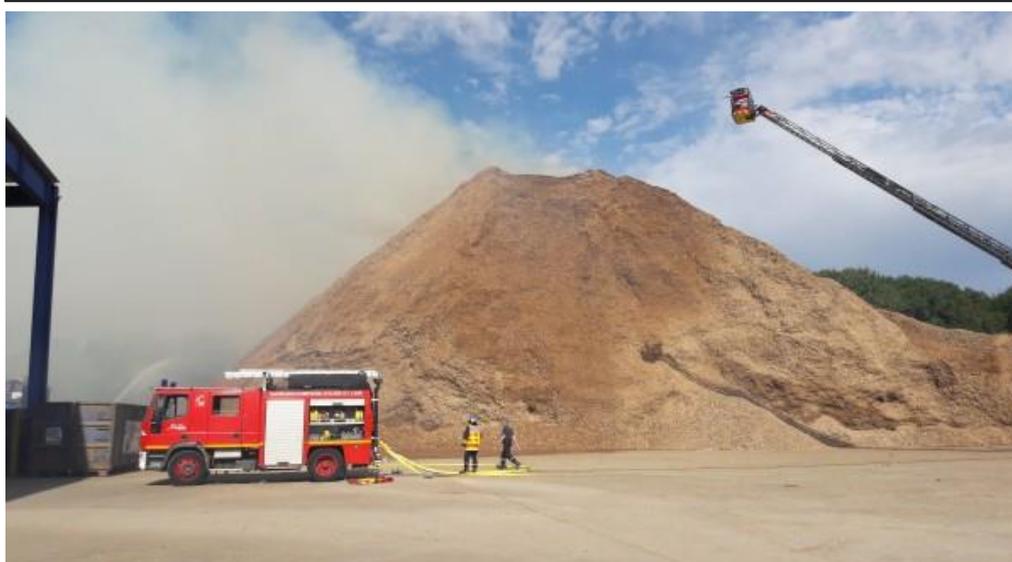
Pile of chips and intervention equipment (source: DREAL Centre Val-de-Loire)

The strategy adopted was to gradually flatten and spread the mound and water it down. The operations had to be undertaken carefully to avoid collapsing the perimeter walls. The chips collected were then transported and unloaded on a vacant 4-hectare site located 3 km from the previously prepared and secured site. A geomembrane was installed to create a waterproofing layer, as well as a bed of gravel to receive the chips. Runoff water was collected at the lower part of the slightly sloping land.

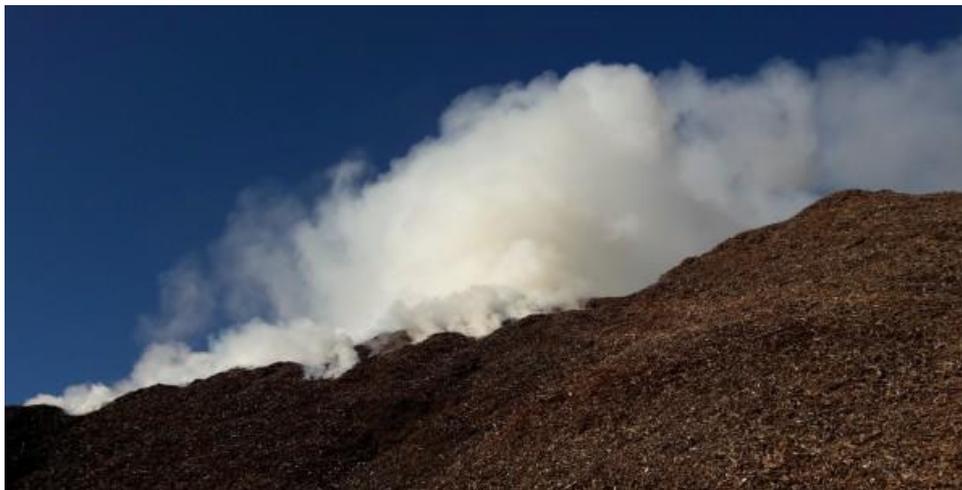
A significant amount of smoke was visible over the urban area and the A11 motorway. The smell of burnt wood was also noticeable. Comments appeared on social networks.

Billowing white smoke (source: SDIS 28)

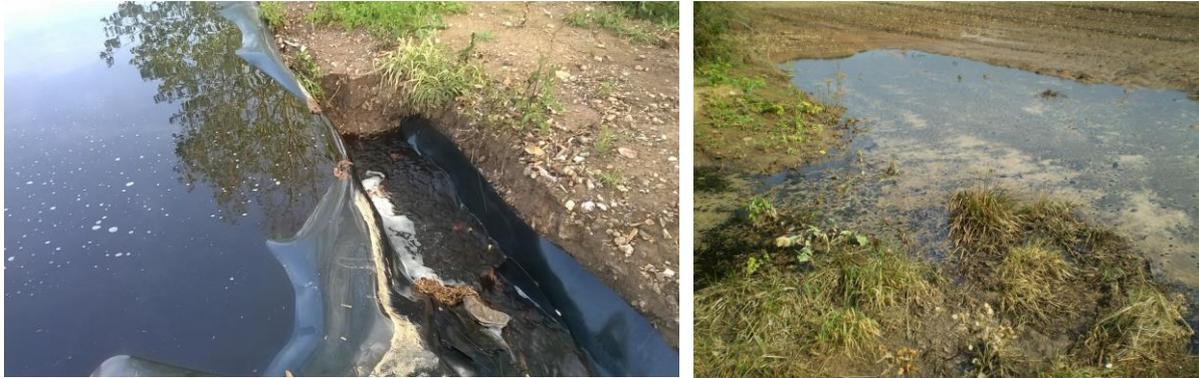
The water supply problem quickly overlapped with the extinguishing water retention problem. The site's 1,000 m³ retention basin rapidly filled to capacity. On 26 August, this retention basin overflowed into the natural environment (flowing into a ditch and the field near the site).

Overflow of the retention basin and flooding into the neighbouring field
(source: DREAL Centre Val-de-Loire)

Six semi-trailers were used to drain the polluted water and transport it to a former WWTP facility in the area. In addition, three flexible tarps were installed to increase the retention capacity by an additional 1,050 m³.
