Phosgene discharges in a chemical plant

12 August 2017

Le-Pont-de-Claix (Isère)

SEVESO
Isocyanates and
by-products
Chemical
manufacturing
Subcontracting

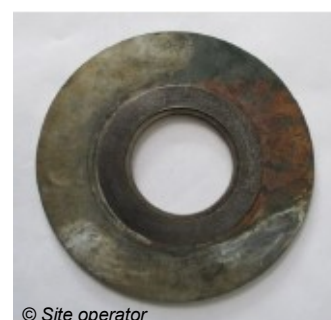
The initial leak inside the containment was caused by a leak on the pressure sensor of a pump and a leak on a flange's seal upline of a flow meter connected to this pump. The flange's seal had been replaced by a subcontractor called to assist an other subcontractor shortly before the accident. However, it had been incorrectly fitted. Seal installations are supposed to be inspected and inspected seals have to be identified with a label. As no label was on the valve in question, there was no way of knowing if an inspection had indeed been performed.

It was not clear who was responsible for performing inspections (the contractor, its subcontractor, or the operator). In addition, the subcontractor called as additional help had only been recently trained in the fitting of seals. Perhaps they lacked sufficient knowledge about the risks related to incorrect fitting, the inspections to be conducted, and the consequences of leaks on the facility. Lastly, a number of operating procedures for sensitive equipment were not written out.

© Site operator
Flange's seal upline of the flow meter

A helium leak test conducted before the facility was restarted did not reveal these leaks. The operator called into doubt the reliability of the helium leak test for this type of equipment, pointing out in particular technicians' inexperience due to training issues and the choice of material used.

After the accident, the operator replaced all its defective equipment and began implementing corrective measures, particularly on the tracking and coordination of maintenance tasks among the various maintenance crews.

- redefine inspection rules;
- clarify inspection responsibilities;
- introduce sealing checklists;
- establish rules of communication with the contractor.
