# Dust explosion in a port-based silo

## 23 February 2018

### Grande Synthe (59)

Silos  
Explosions  
Dust  
Wood  
Cereals

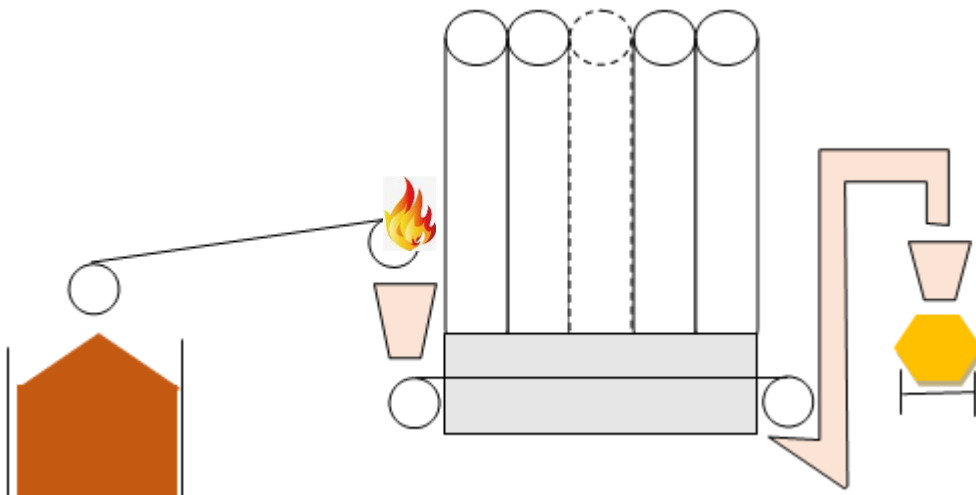
Type of alarm	Interpretation by the operators	What was actually happening
Conveyor belt offset alarms	Conveyor jamming in progress.	Outbreak of fire at the conveyor head which triggered the alarm
The alarm stops a few moments later	They assume that the system has returned to normal.	The fire would have burnt the electrical wiring; the alarms were fail-safe.

1. The fire that had started on the motor at the head of the conveyor, above the hopper, spread to both the overhead conveyor and the hopper.
2. Embers were carried along by the conveyor in the sub-cell gallery.
3. These embers then fell into the handling tower's bucket elevator.
4. Some of the embers were able to reach the loading facility before the first explosion occurred at the bucket elevator.

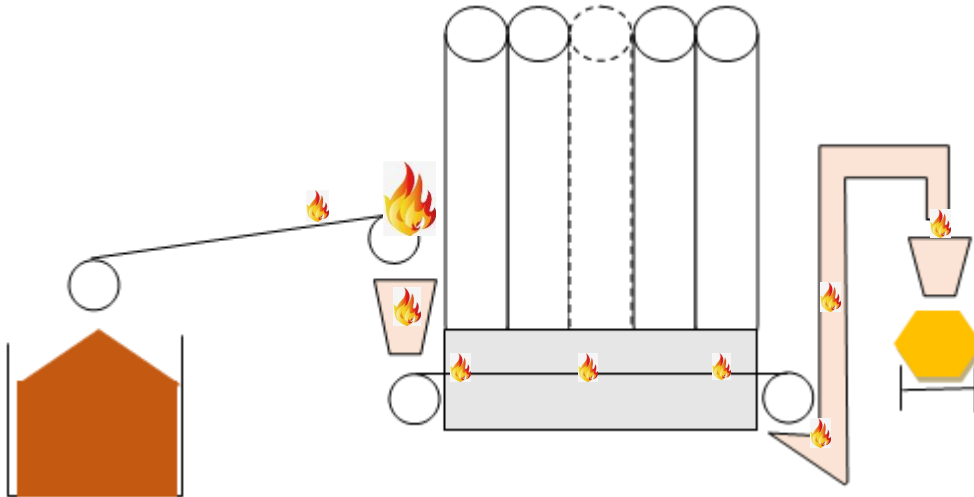
First explosion:

The first explosion was caused by embers falling into the elevator. The **dusty atmosphere** inside the elevator created an ATEX atmosphere. The embers thus provided the ignition source for the dust explosion in this elevator.

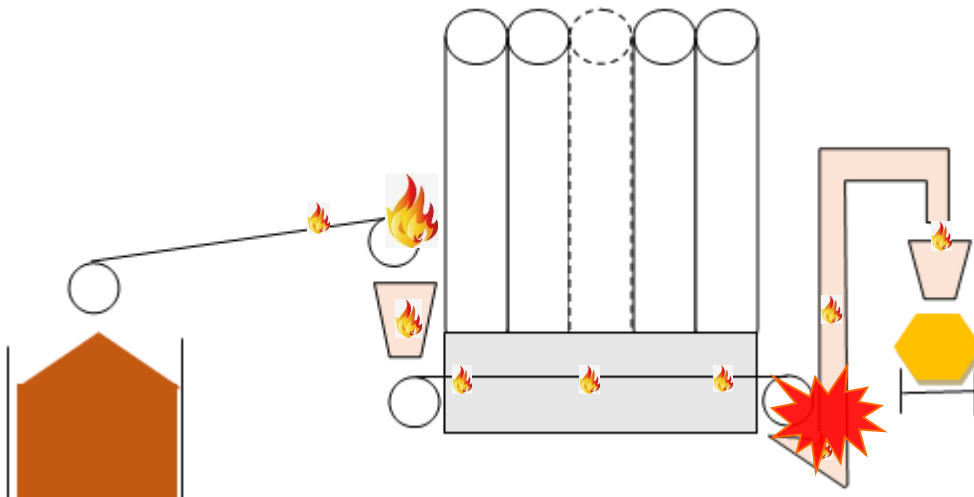
### Second explosion:

The explosion generated a flame front and a pressure wave that travelled to the handling tower and to the sub-cell gallery. The dust dispersed by the shock wave and the flame front created the conditions for the secondary, more violent explosion.

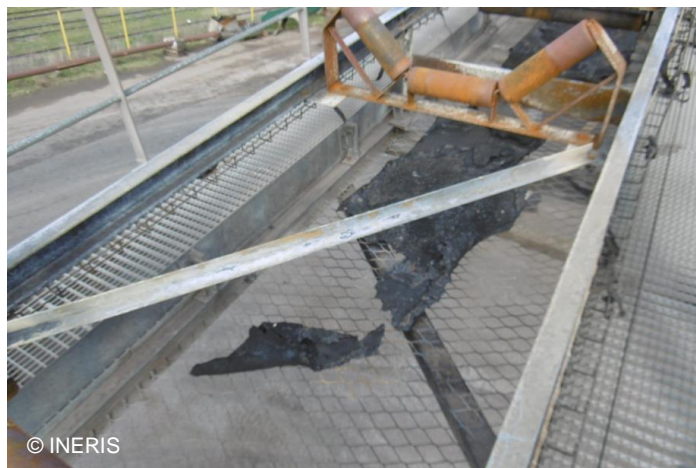
Overhead conveyor belt

- The covered conveyor belt was destroyed by fire. The belt, which had been replaced in 2002, was ISO 340-compliant. The shelter covering the belt created a tunnel effect that promoted the belt's combustion;
- The filter and hopper showed significant traces of combustion. Charred pieces of wood.

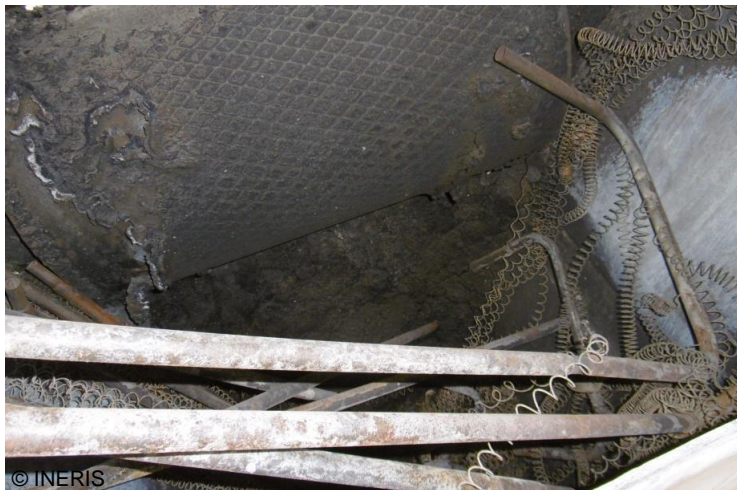
*Upper part of the hopper*

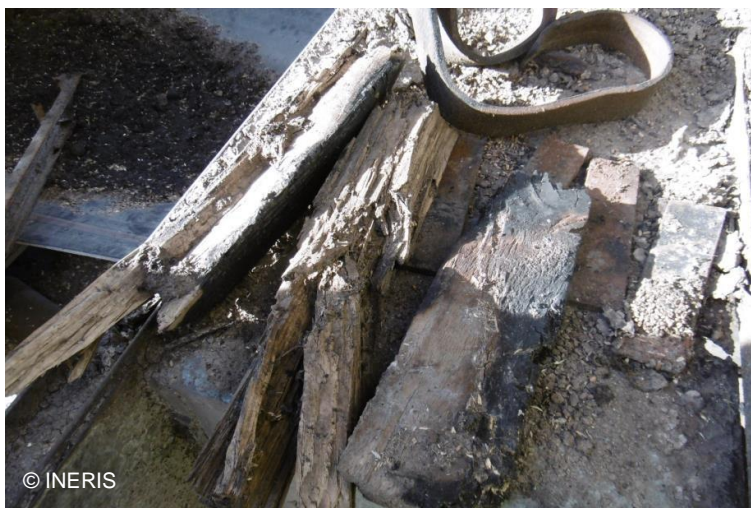
*Pieces of wood trapped in the hopper*

A pile of combustible materials, such as large pieces of wood, was found near the dislocated bearing rollers. The silo had not been authorised to store wood pellets, and no information about this new activity was provided to the inspection services.

- equip all its receiving areas with a screening system (40/40 mesh) to avoid storing materials having noncompliant dimensions which could generate heat;
- design softer transitions with shock absorbers at product discharge points to avoid materials being placed in suspension;
- draft a new cleaning procedure and assign an additional person to this task.

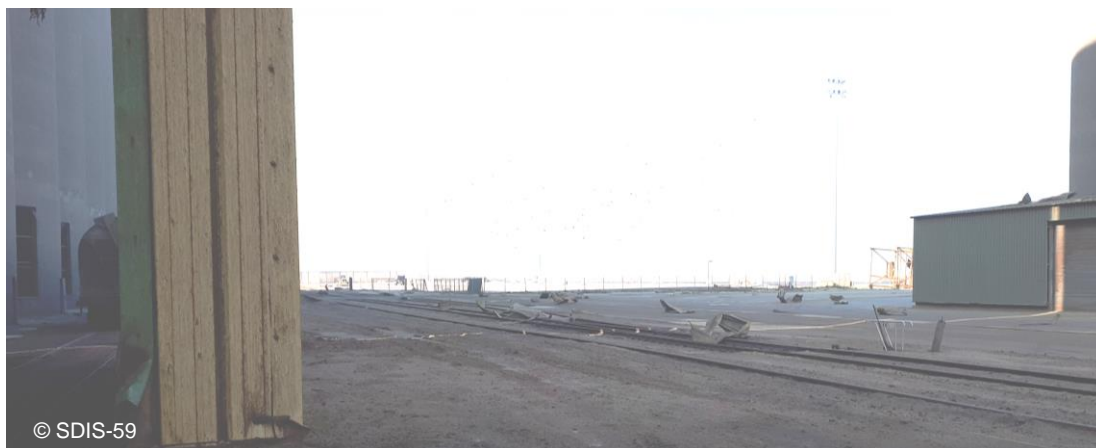
- the gallery's 16 blast panels were thrown more than 50 m away;
- traces of combustion were visible inside the gallery. These traces become increasingly evident closer to the handling tower.

*Projected doors*

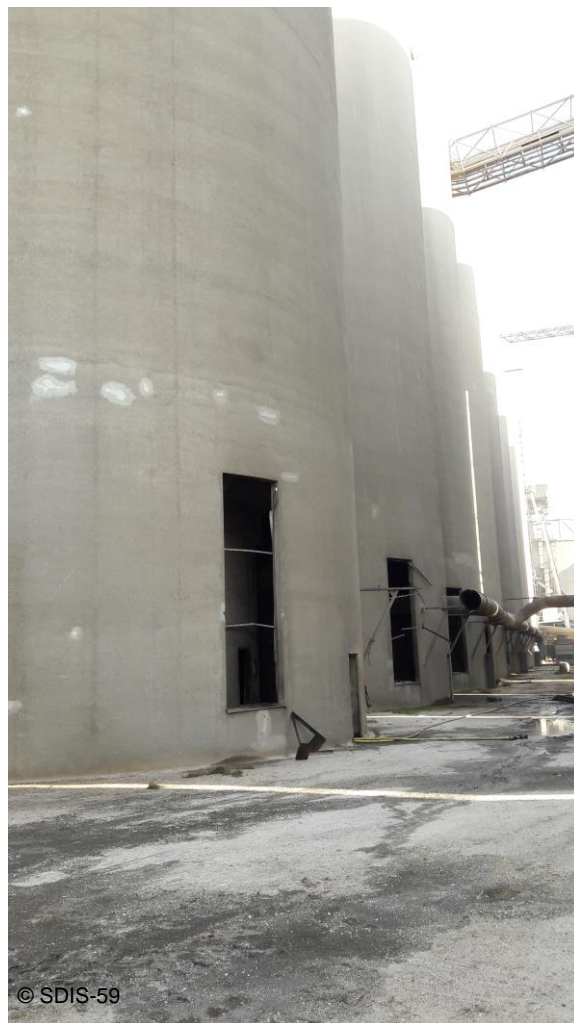
*Doors torn from the sub-cell gallery*

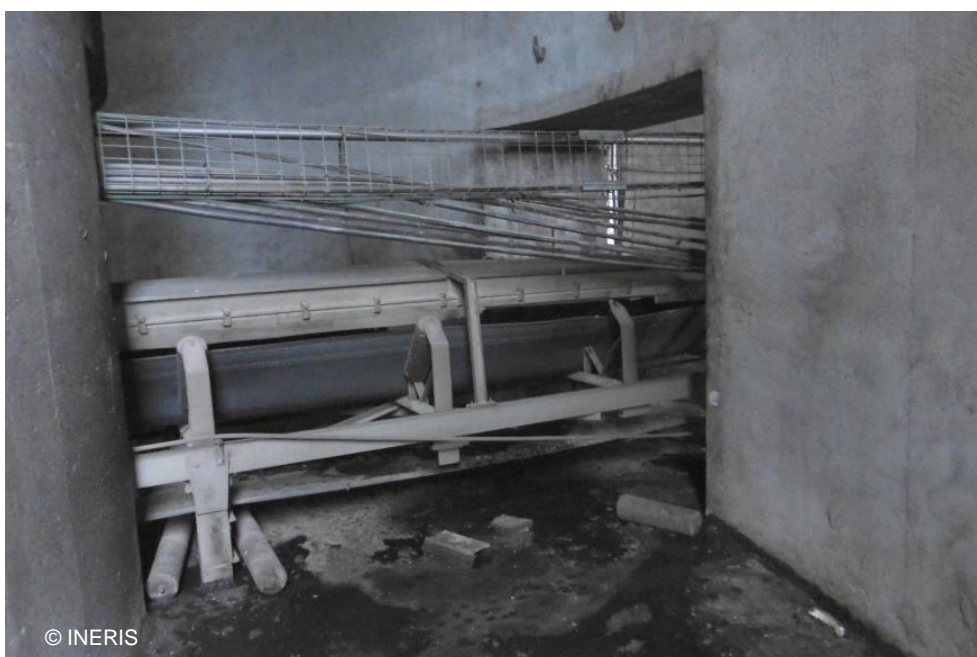
*Traces of combustion in the sub-cell gallery*

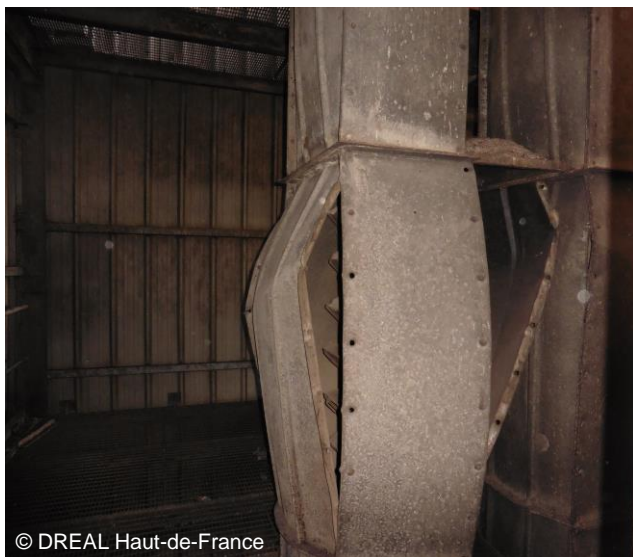
- Numerous structural steel elements on the closed side were deformed.
- Only the bucket elevator used for the operation in progress showed signs of combustion.

*Elevator on the 2<sup>nd</sup> level*

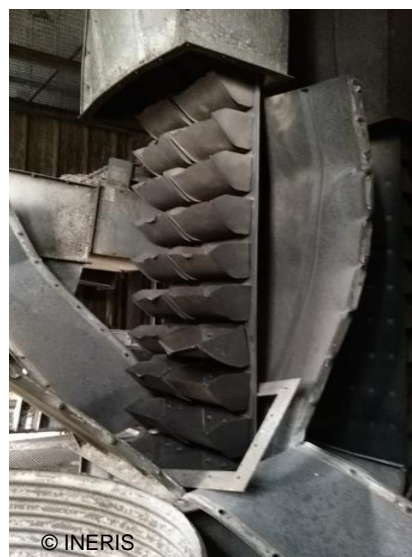
*Elevator on the 1<sup>st</sup> level*

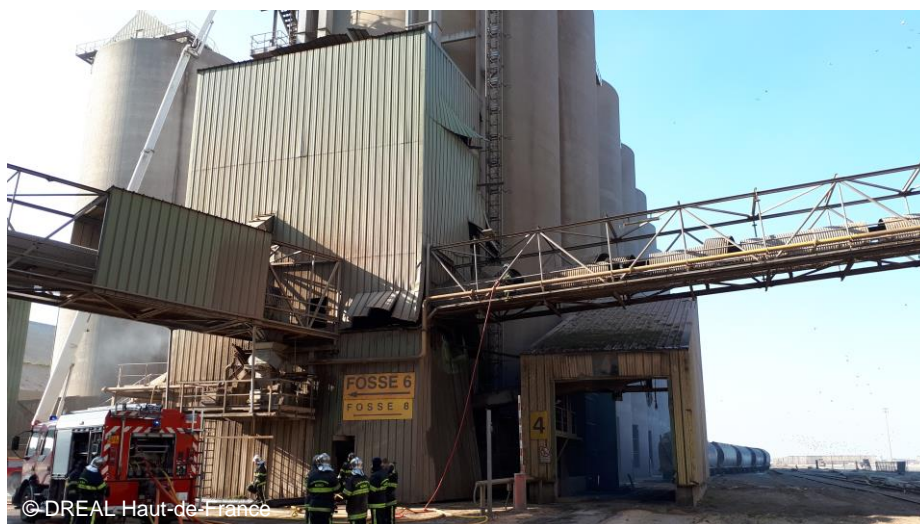
*Handling tower and railcar loading facility*

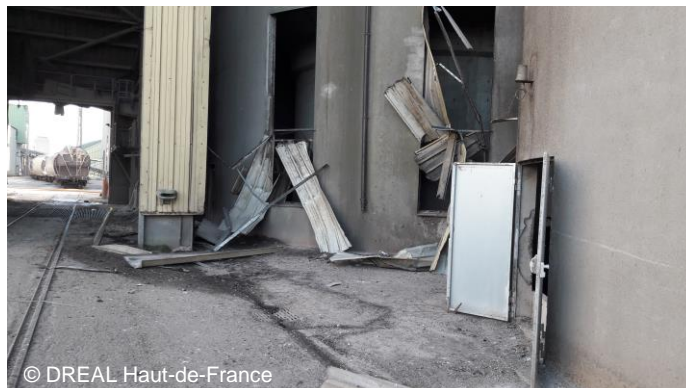
*Railcar loading facility*

- siding deformed.

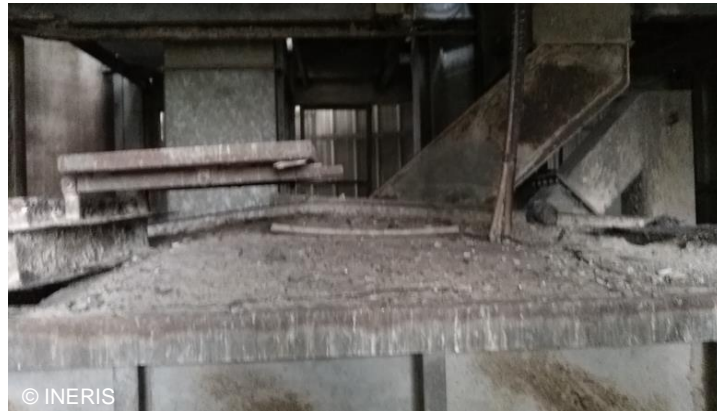
*Weighing room*

- The upper sheeting had expanded and the hatch was open.

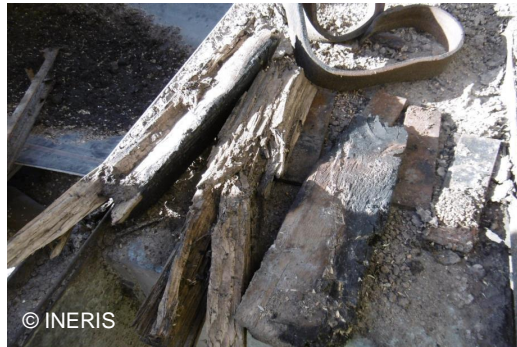
*Pieces of wood trapped in the hopper*

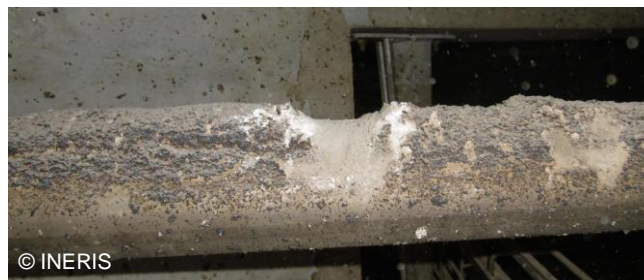
According to the inspection authorities, the site was quite dusty, and the targets at ground level are regularly covered with dust. The condition of the installations was confirmed by the post-accident analysis. The sub-cell gallery is cleaned every 45 days by connecting a suction system. According to the operator, the last cleaning operation on the sub-cell gallery had been performed 15 days before the accident.

*Example of dust accumulation in the sub-cell gallery*
