# Leak of sulphur containing gases in a refinery

## 1 march 2018

### Grandpuits (Seine-et-Marne)

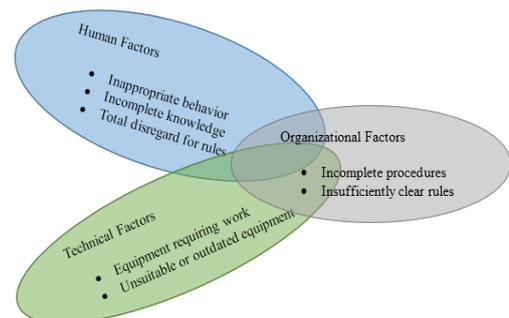
Lastly, the investigation showed that technicians inadequately understood basic safety rules despite thinking that they were following them and that technicians continued performing operations even if they did not go as planned (fear of being singled out as responsible for abnormal situations and for losses in site efficiency). In addition, half the refinery’s technicians stated that they preferred to keep silent about safety incidents out of fear of being punished. Employees no longer gave managers feedback because they feared bothering them and, because of a lack of responsiveness and pragmatism, have little motivation to take part in the process.

© Site operator  
 Characterisation of the root cause behind various incidents

Following this assessment, a programme was launched to improve the safety culture at the refinery, focused on human and organisational factors. Using feedback from employees, the refinery’s management committee proposed four areas of improvement:
