# Loss of control of a chemical reaction in a pharmaceutical plant

19 September 2017

Aramon (Gard)

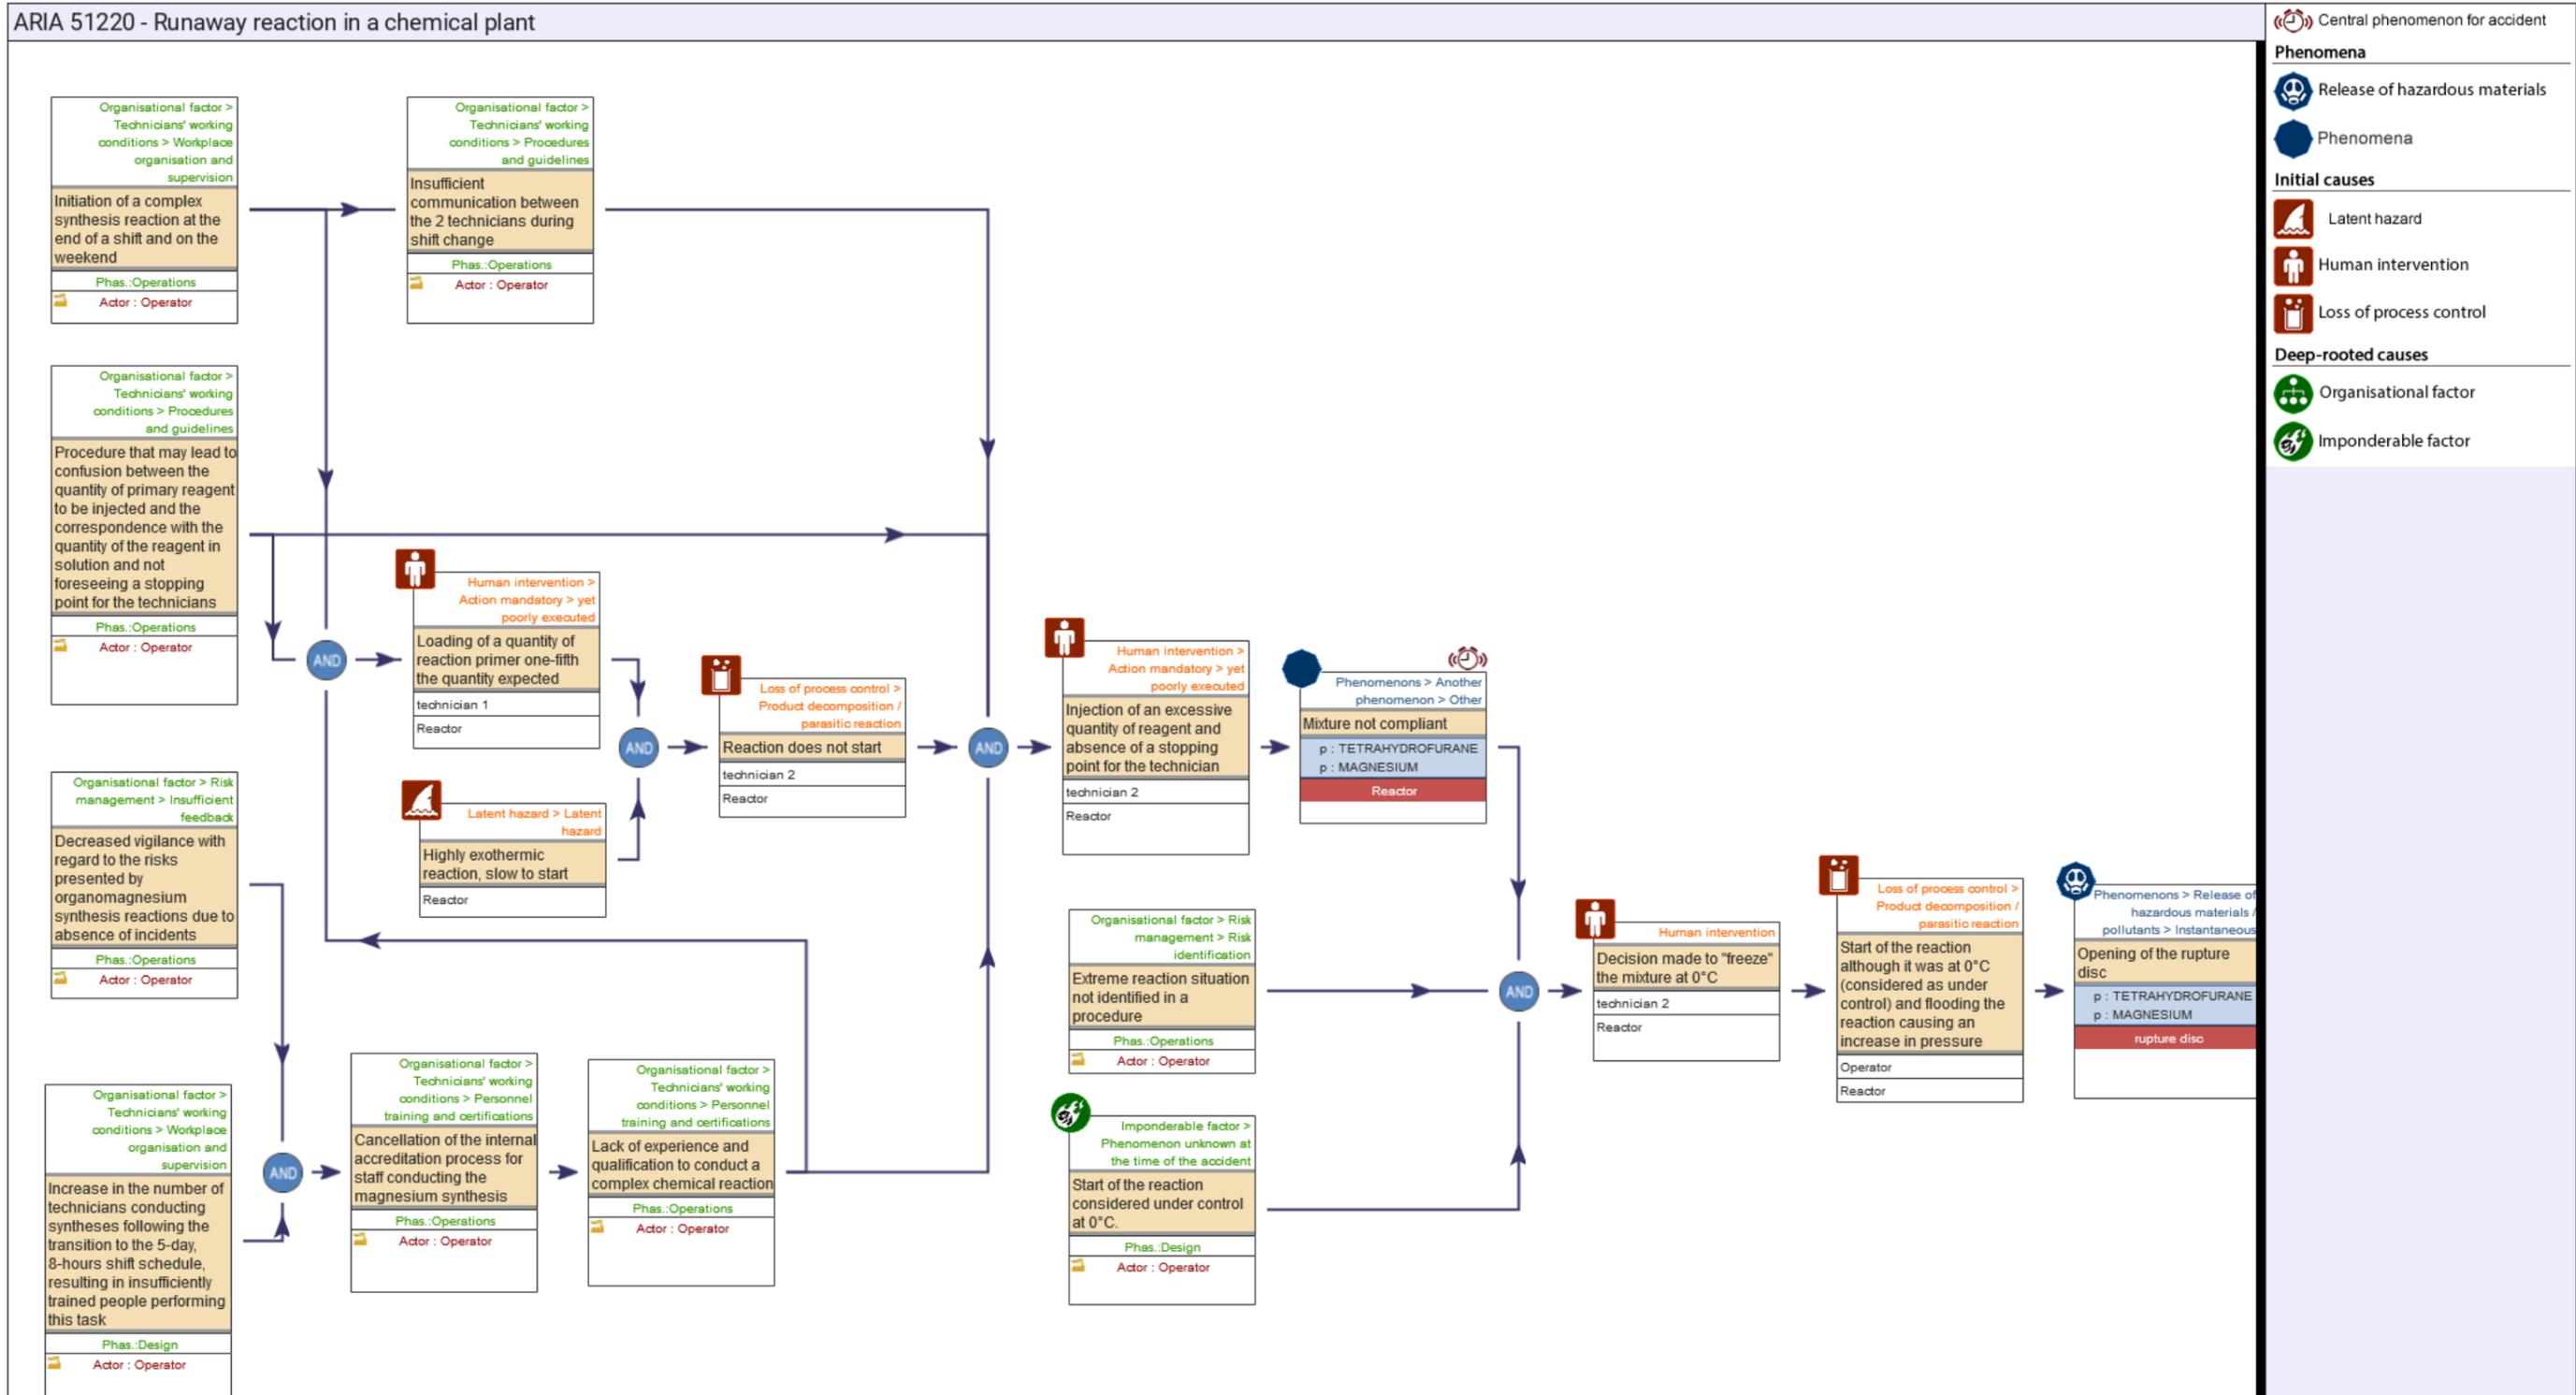
Appendix, detailed sheet: modelling of disturbances and causes which led to rupture of the bursting disc

According to the operator, the highly exothermic reaction had occurred 72 hours after having "frozen" the mixture, as the reagents (primer + PBDMA) were present in the mixture and eventually reacted together. The cooling effect generated by the glycol-water in the dual-wall of the reactor was intended to stop the reaction that eventually took place. The start of the reaction caused the temperature to rise rapidly.

At a temperature above 35°C, the flooding of the reactor with water caused a hydrolysis reaction. The organomagnesium decomposed into magnesium hydroxide and bromine hydroxide with a high accumulation of energy and heat, which caused the pressure to rise and the reactor disc to rupture.

The modelling of the disturbances and causes leading up to the incident is available in the appendix.
