# Explosion under a bridge deck following a fire which caused a gas leak

13/05/2018

Albertville (SAVOIE)

Piping / Distribution systems  
Explosion  
Victims  
Property damage  
Malicious intent

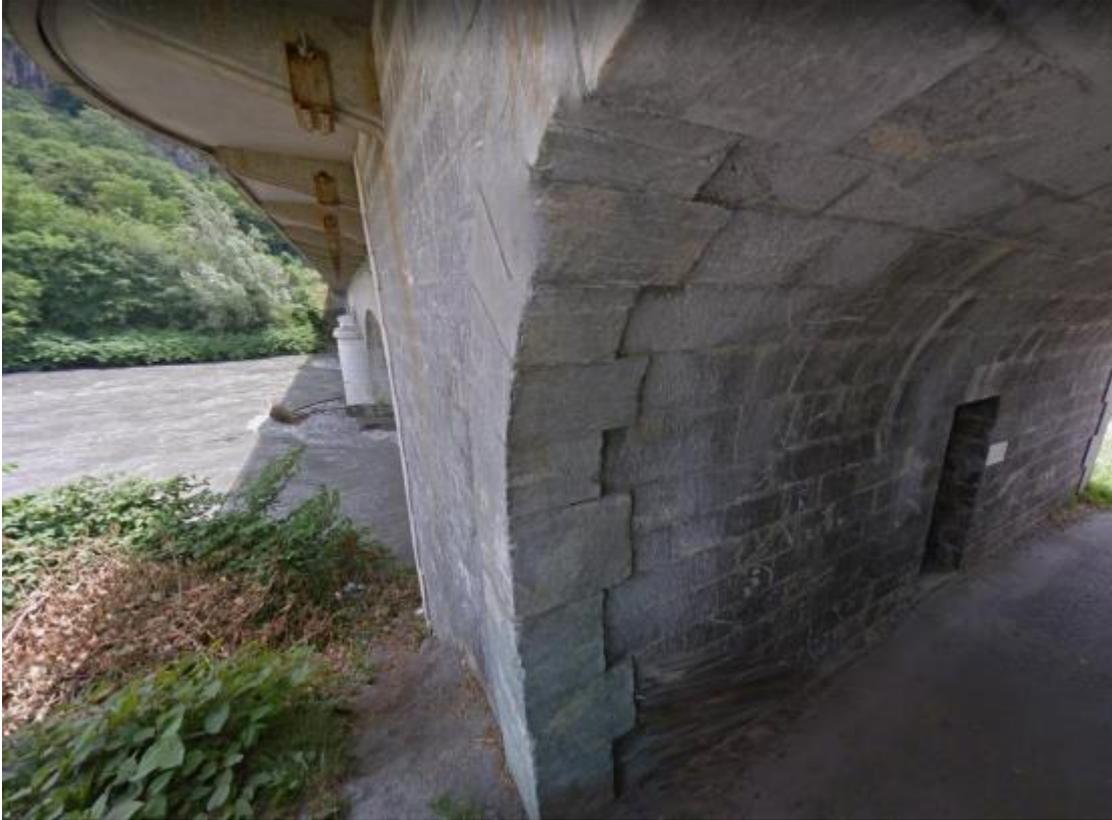
A maintenance room giving access to the technical duct networks is located inside a support pier on the right bank of the bridge (Albertville side). The maintenance room, occupied by squatters despite complaints from local residents, contains “inappropriate” equipment given the proximity of the networks: gas cylinders, gas cooker, etc.

Entrance to the technical room occupied by squatters (view from the parking area: V1)

Following the accident, the public authority in charge of managing the bridge secured the room, closing it to prevent access (safety measures, ongoing administrative and judicial investigations).

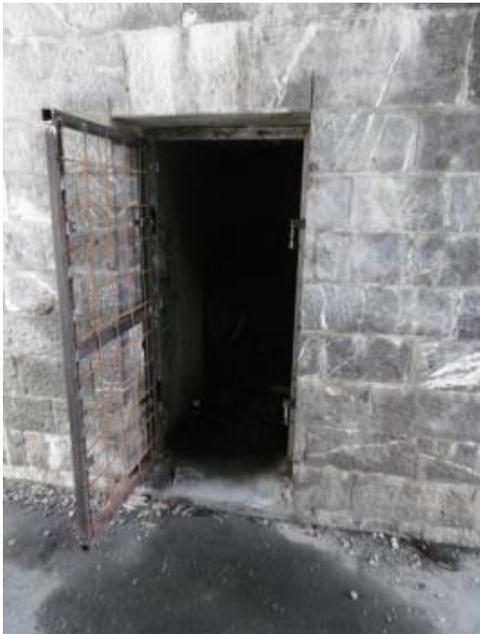
Entrance door of the technical room added following the accident (© DREAL ARA)

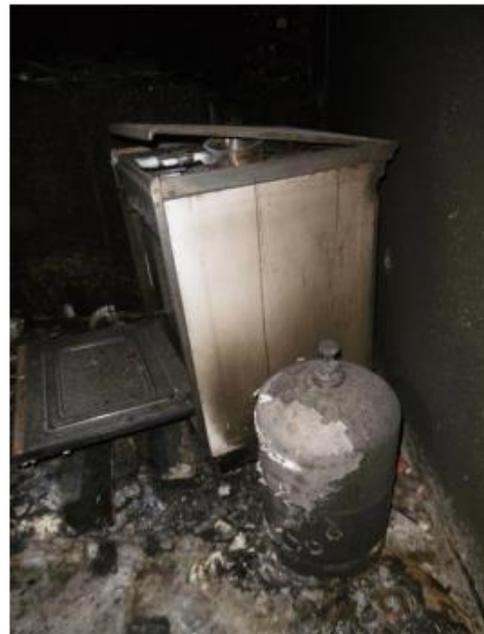
Inside the occupied room (© DREAL ARA)

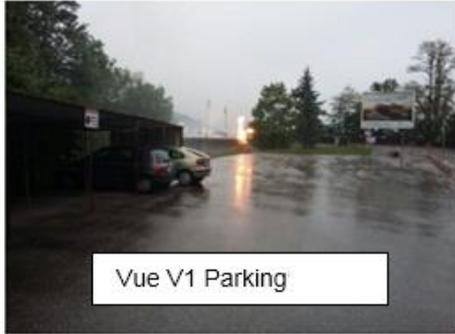
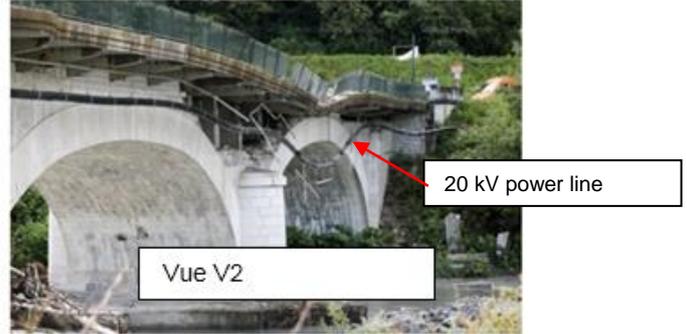
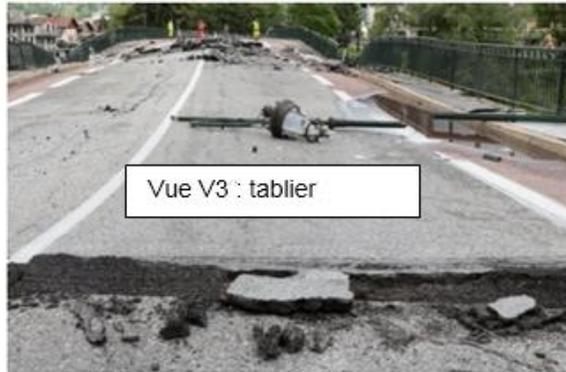
8:55 p.m.: an explosion occurred as the result of a gas leak, leaving the Albertin Bridge completely gutted. The gas utility services were able to close the shut-off valves on both sides of the bridge in an effort to stop the leak of natural gas.

Ignited gas leak (photo top left) and the collapsed bridge after the accident (© DREAL ARA)

The Albertin Bridge was severely damaged and the reconstruction cost was estimated at 4 million euros. Traffic was prohibited across the bridge pending its repair.

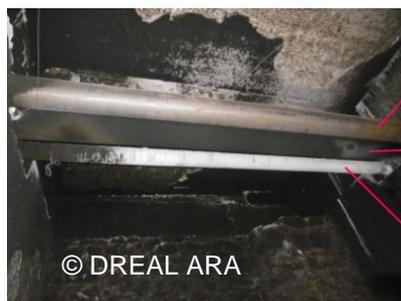
Inside the pylon - Under the Albertin Bridge deck

Stainless steel sleeve containing optical fibres

Stainless steel sleeve containing a PE MPB 125 gas pipe

Steel DN 114 gas pipe

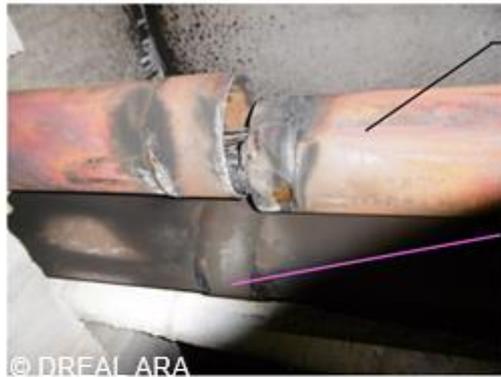
Protective stainless steel sleeve for the optical fibre consisting of fitted tubes that separated due to the explosion

Traces of 'drippings' from the polyethylene gas pipe in the sleeve at the tube junction

The most likely scenario explaining the explosion is that natural gas leaked inside the stainless steel sleeve after fusion of the polyethylene pipe. The gas migrated through the sheath into the confined structures located under the deck of the bridge, then escaped from the sheath through the tube junctions to form an explosive cloud around the 2<sup>nd</sup> pier.

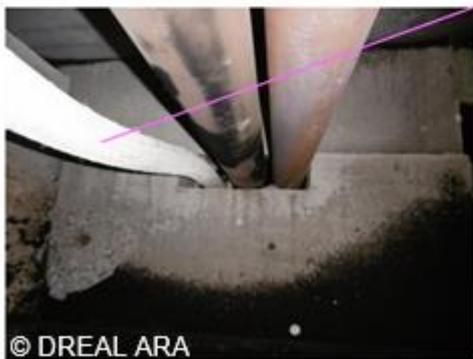
Deflection of the steel gas pipe (deformation)

The heated section suffered deformation under its own weight

A temperature of 600 °C was reached in the bridge pier

The gas distributor conducted a leak test at 6 bar which showed that the steel pipe was free of leaks, unlike the polyethylene pipe which had completely melted.

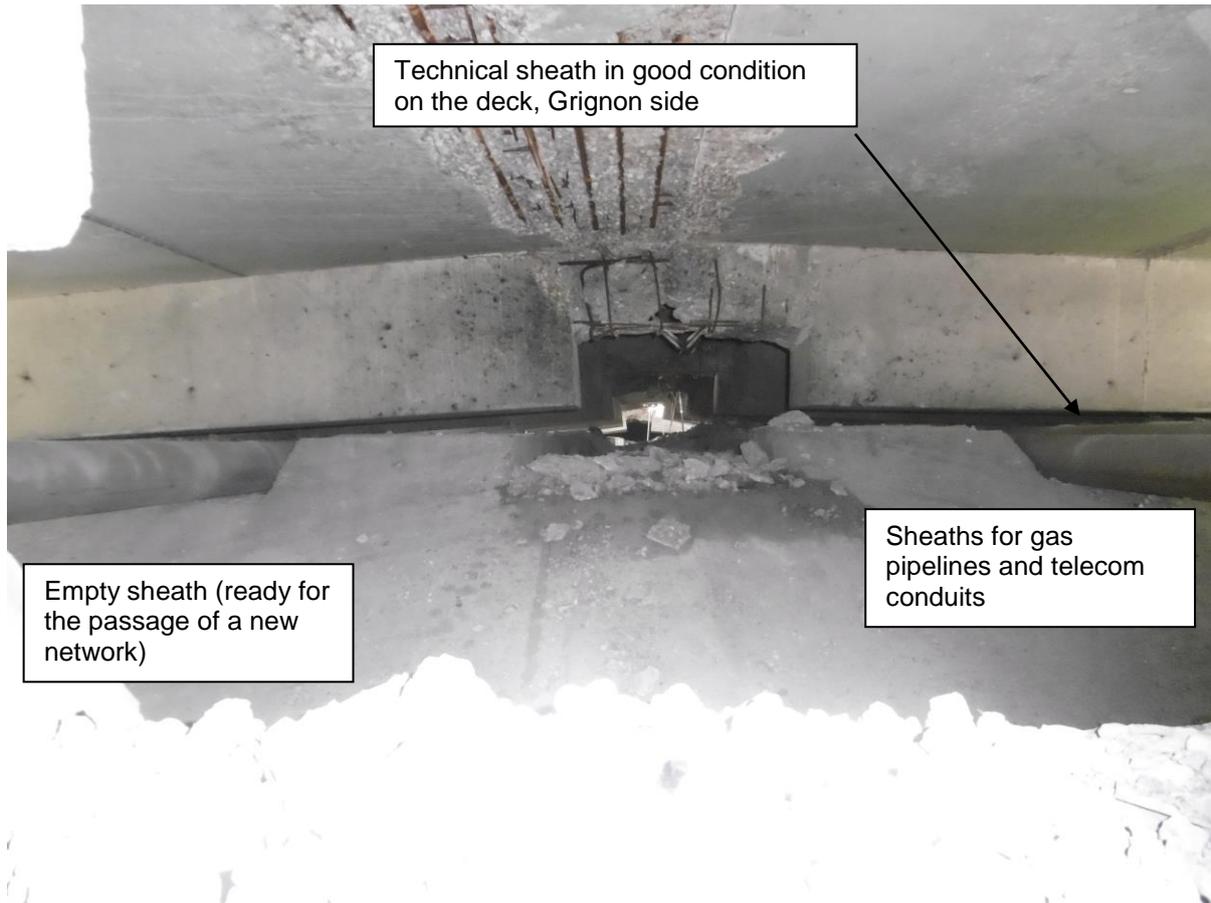
A fire broke out in a room occupied by squatters in a bridge support pier located on the right bank. The heat fluxes released caused deflection to occur on the steel pipe and caused the polyethylene pipe to become fused inside its sheath. Significant damage visible on the bridge's 2nd pier (view V2) was indicative of a strong explosion in this location that no doubt caused damage to the bridge deck on the Grignon side (view V3). The damage appeared to have been caused by the explosion. The pipes routed at this level did not seem to be damaged (leaks), as shown in the picture below.

Bridge deck and piping/conduit sleeves in good condition (view V3) © DREAL ARA
