## Explosions occurring in a bituminous materials depot

May 3, 1994

Portet-sur-Garonne (Haute Garonne)  
France

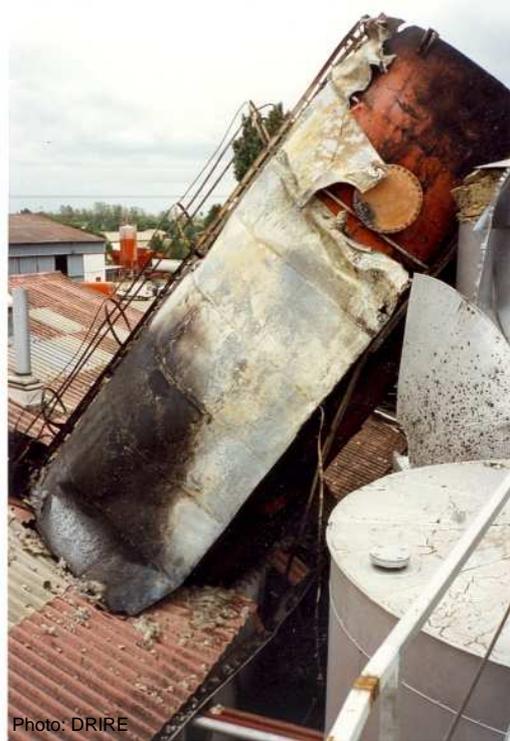
Photo: DRIRE

Around 2:30 pm, two company employees were installing a walkway between the covers of the "cut-back" and oil tanks. They were apparently using a trimming machine near the "cut-back" tank vent when a violent explosion of the tank vapour space occurred, hurling the tank some 20 metres off its base and the 2 employees 30 metres from their location. The liquefied bitumen, which had spread to the surrounding area, caused a fire and, within 5 minutes, an explosion of the adjoining non-degassed, empty bitumen container, which was thrust some 10 metres onto the roof of the neighbouring facility. The tank broke at the level of the shell-bottom junction.

The hydrochloric acid tank melted due to the heat generated. Acid mixed with hydrocarbons overflowed on the site all the way to the entrance parking lot, and the retention basins were destroyed by the blast of the explosion; moreover, a small amount of the spill polluted the sewer network.

Traffic was stopped on the street leading to and from the shopping centre adjacent to the site. Local residents and shoppers, as well as all bystanders, were evacuated. The fire also ignited a row of trees planted on the property line (due to the thrust of the cut-back tank); the emergency response team arrived quickly on the scene to extinguish the blaze.

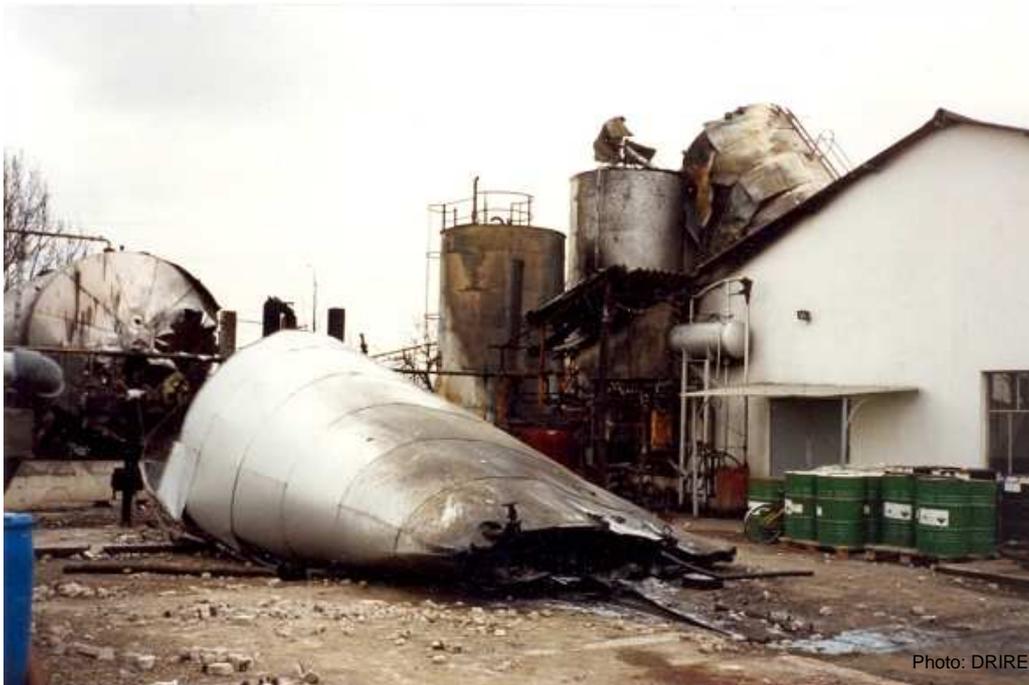
Photo: DRIRE

Besides the 2 exploded tanks plus the melted acid container, 12 other tanks were damaged, 5 of which superficially (thermal insulation); the retention basins also experienced major degradation. The roof on the nearby production plant sustained damage, primarily due to the impact of the bitumen container, and 7 company vehicles were destroyed by fire on the parking lot.

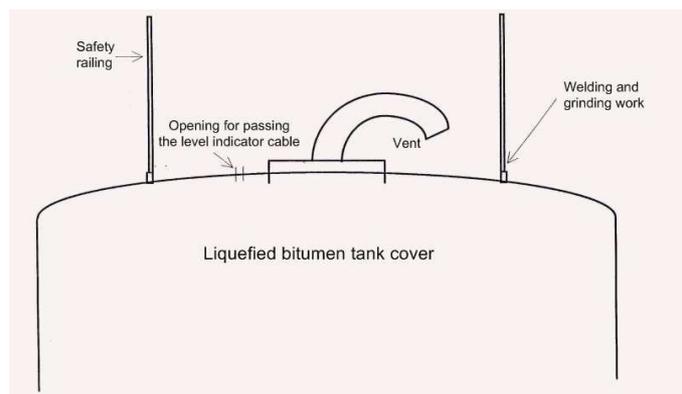
The initial inflammation was likely caused by a spark or hotspot created by works on the walkway, which in turn ignited a vapour space outside the "cut-back" tank. These vapours were able to "form" either at the end of the hose, or at the hose-vent junction (had the hose not been perfectly sealed), or at the tank cover opening designed for instrumentation (level measurement cable). Subsequent to inflammation of the vapour space within an unconfined volume, the flame would have penetrated into the tank, thereby triggering the explosion and ejecting the tank.

The second explosion, occurring once the "cut-back" thrown underneath the tanks had fully ignited, would have been caused by inflammation of the vapour space inside the bitumen container either by flames spreading near the vent (a phenomenon analogous to the 1<sup>st</sup> tank) or by internal overheating of the vapour heating pipes by means of heat conduction from the fire.
